CORROSION FAILURE IN A LINED SOUR GAS PIPELINE - PART 1: CASE HISTORY OF INCIDENT

L. Simon
Shell Canada Energy
Pincher Creek, Alberta

In November 2007 Shell Canada Energy (Shell) experienced a sour gas release on the Waterton Screwdriver Creek Pipeline (the SC pipeline).

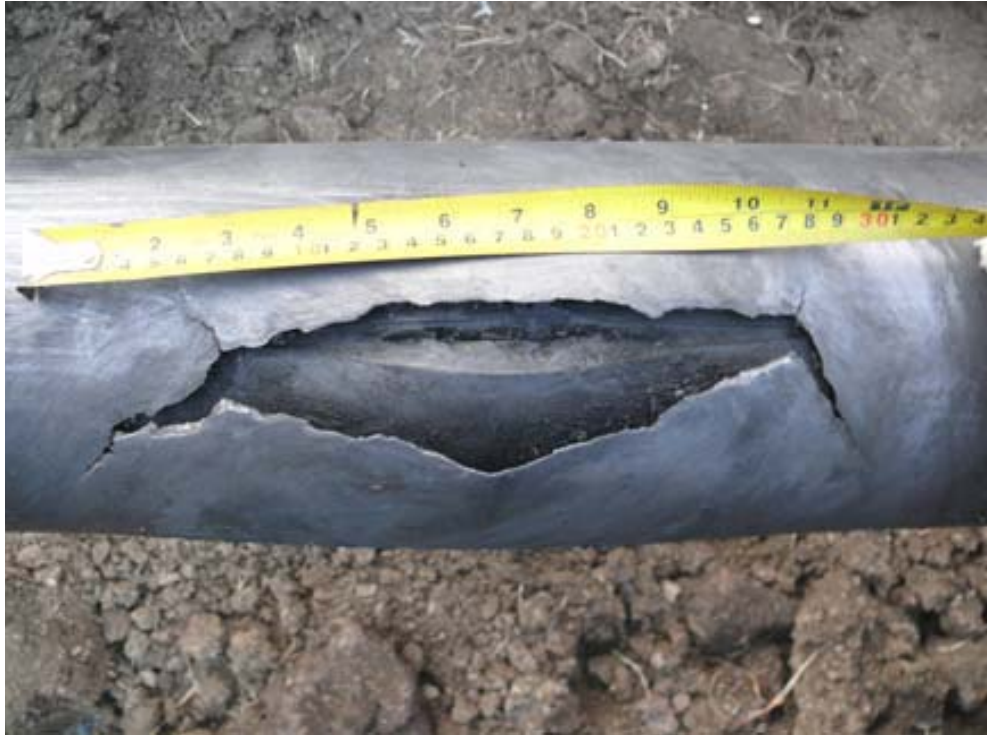
The pipeline failure was the result of an axial split in the steel pipe about 300mm in length with a maximum width of 60mm at centre. The failure occurred 27m downstream of Vent 6 as shown in the elevation profile (Figure 3). It was the result of tensile overload of the steel pipe in a localized area where internal corrosion had removed almost 90 per cent of the pipe wall (Figure 1 and 2).

FIGURE 1 - Failure after insulation and coating removal

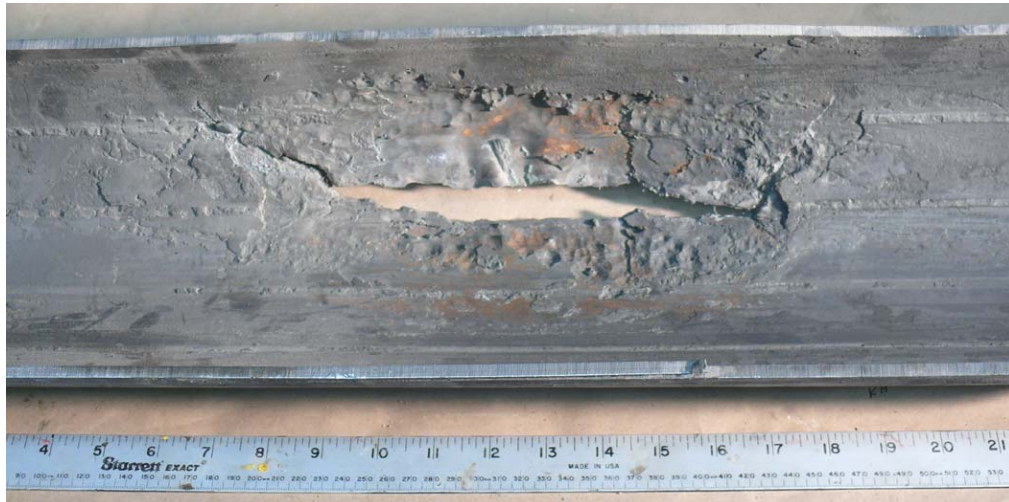
In this case, it appears that the protective iron sulphide scale had not existed in a uniform manner, and as a result corrosion was able to occur in localized patches. In those locations, a paste-like mixture of iron sulphide corrosion product suspended in an acidic liquid, was found sandwiched in the annulus between the HDPE liner and the steel pipe (like the example shown in Figure 4). The liquid component was believed to be primarily methanol, which is used in the pipeline for a variety of purposes, including hydrate control. Methanol was continuously injected into the production fluids to prevent hydrates and also was used occasionally to flush parts of the annulus vent system of the pipeline, thus establishing its presence in the liner annulus. There was no evidence that chlorides, bacteria, or elemental sulphur played a role in the corrosion process.

FIGURE 2 - ID of the Steel Pipe at the Failure

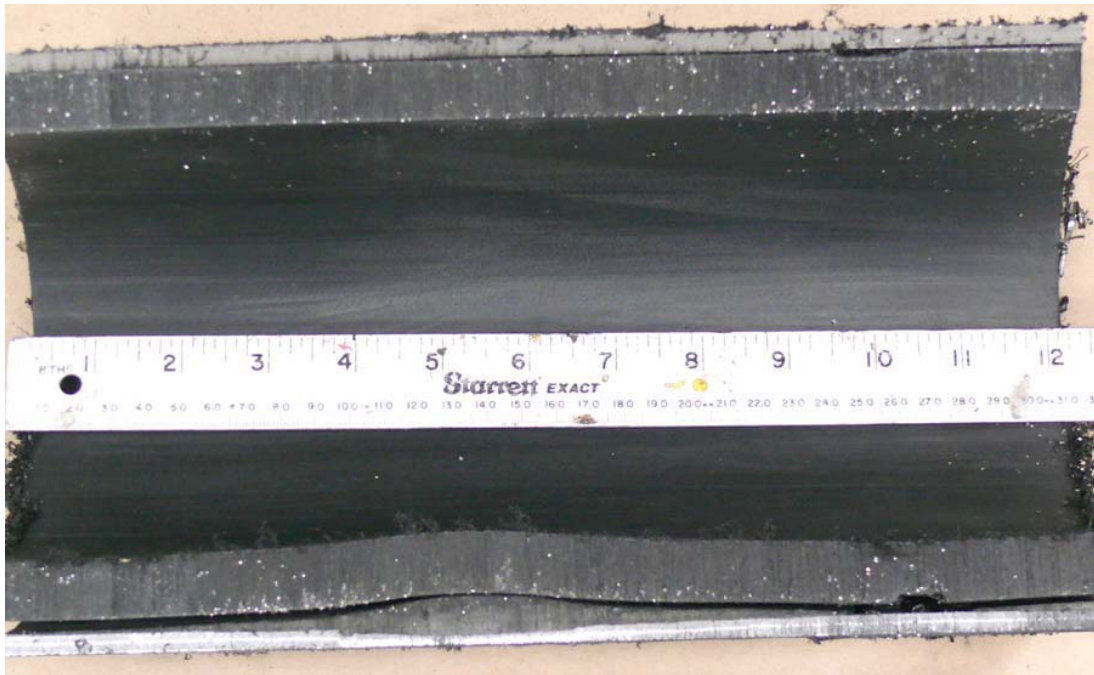
FIGURE 4 - Scale build-up and Metal loss at Bulge in Pipe Cut Out

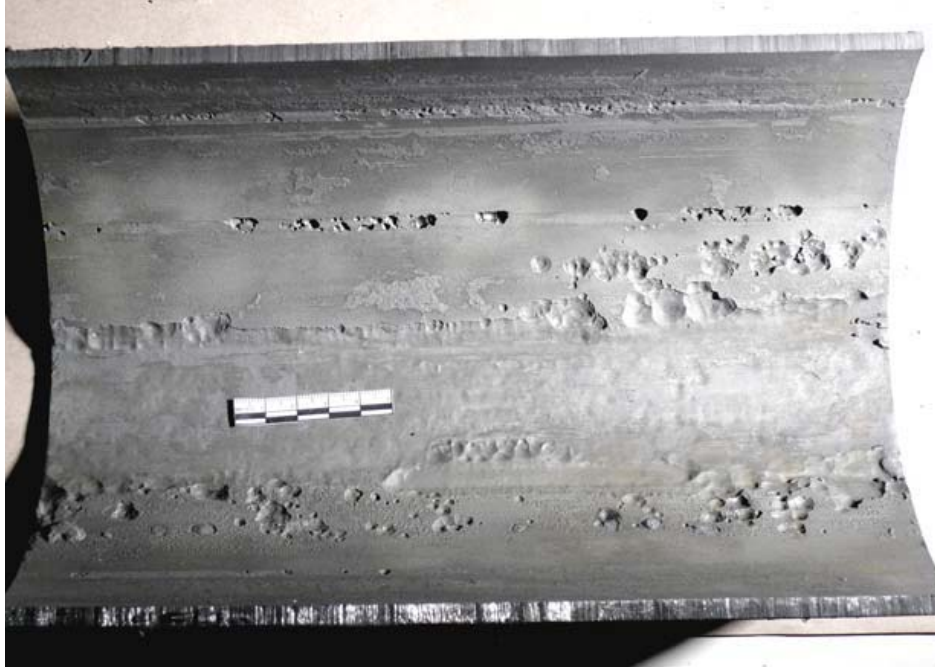
type of damage has been found in lined pipelines of varying age, ie; from 2 to 7 years and all to similar depths. The depth of such pits was as much as 28% of the pipe wall in one pipeline. This pitting is like the axial pitting shown in Figure 5 which is approximately 30% of the pipe wall and adjacent to the external grooves on the HDPE liner.

FIGURE 5 - Band of General Wall Loss (50% Loss) and Isolated Pitting (25-30% Loss) adjacent to external grooves in the HDPE liner

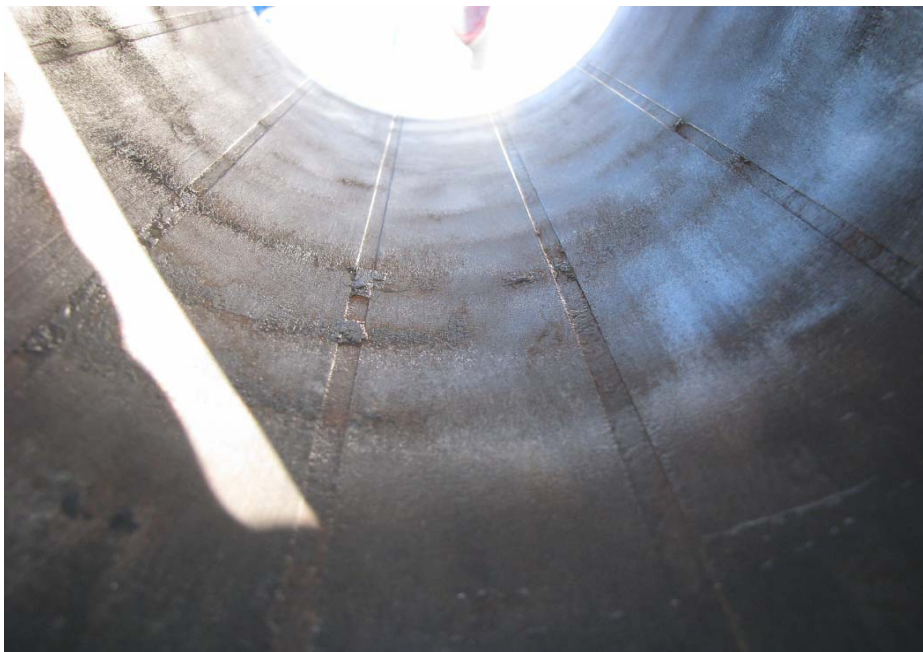
FIGURE 6 - Shallow Corrosion on Steel Pipe ID Adjacent to External Grooves in HDPE Liner
