CORROSION FAILURE OF NI-RESIST PUMPING SYSTEM COMPONENTS

Dr. Alex Tatarov, P. Eng., Frank Gareau, P. Eng.,
Skystone Engineering

Dave Bondarchuk⁽¹⁾, Brent Cymbol
Apache Canada Ltd.

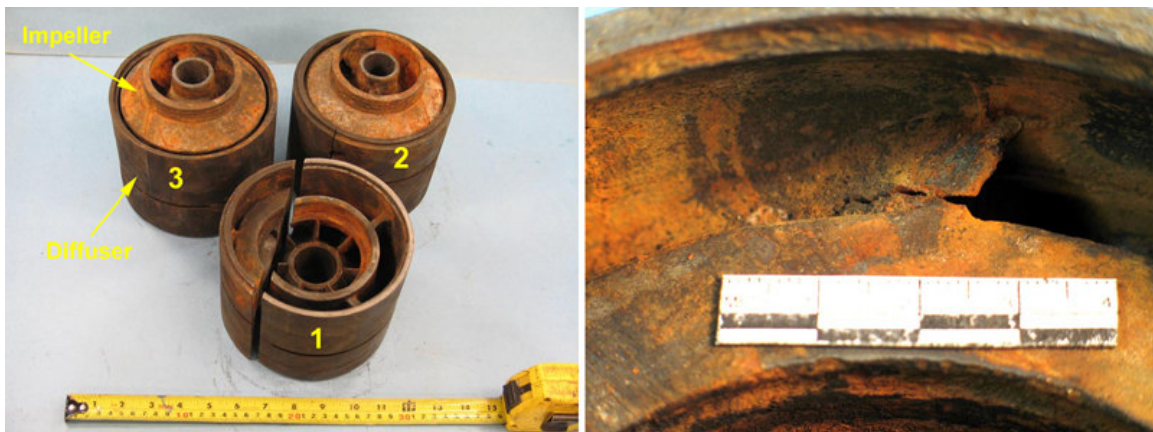
Two modes of failure were observed: overall metal loss corrosion damage and cracking in guideways (Figure 1).

FIGURE 1 – Failed Parts Submitted for Examination

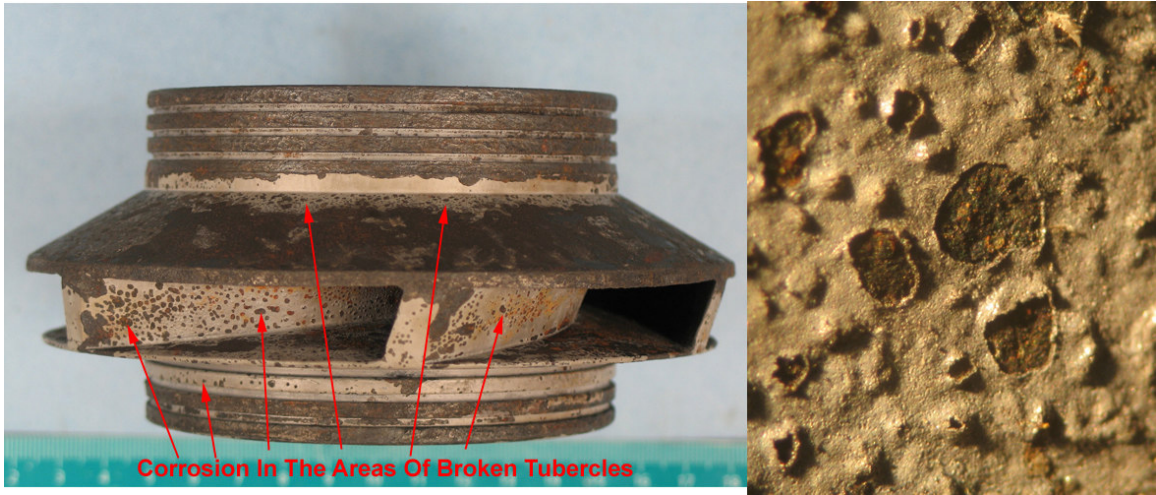
The examination after the cleaning (see Figure 2) showed that the coating failed by the growth and subsequent removal of blisters. The damage was distributed non-uniformly. The coating in the areas closest to centre of the impeller was damaged the least, and the coating in the areas close to the external surface of the impeller was damaged the most.

FIGURE 2 – Impeller: Coating Damage

Thorough cleaning of the surfaces, removing the casting scale and allowing the passive layer to form on the surface would have prevented the observed failure.

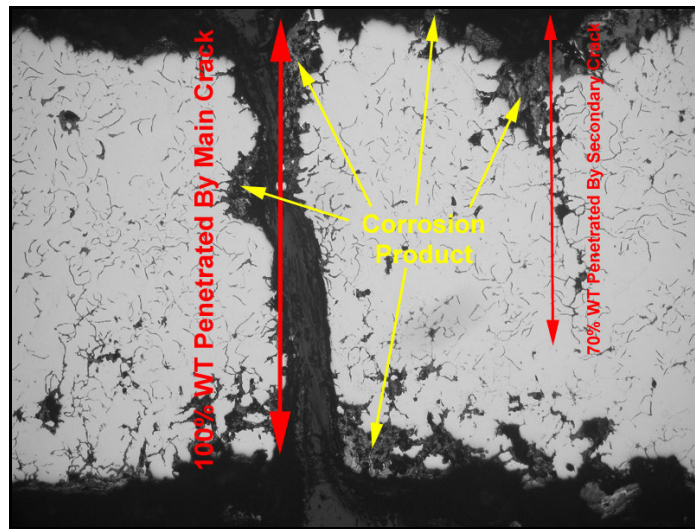
The main crack (shown in Figure 3) was located in the thinnest part of the guideway, in the area of absent coating, and it penetrated the entire wall thickness. The metal surface in the crack initiation area and the fracture surface of the main crack was covered with corrosion products. This indicates the main crack was not created by abrasive wear, as it would result in the absence of corrosion product.

A metallographic examination confirmed the cracks in the diffuser guideways were not associated with either stress corrosion cracking or corrosion erosion, and they were most likely associated with corrosion fatigue. The fatigue cracks started in the corrosion pits, which in turn were created at the locations of the absent or damaged coating. When corrosion pits reached the interconnected network of graphite flakes, the corrosive media reached deeper areas of the base metal. The cyclic loading required for fatigue was due to shaft rotation.

FIGURE 3 – Metallographic Cross-Section Of Crack. Mag. 75X

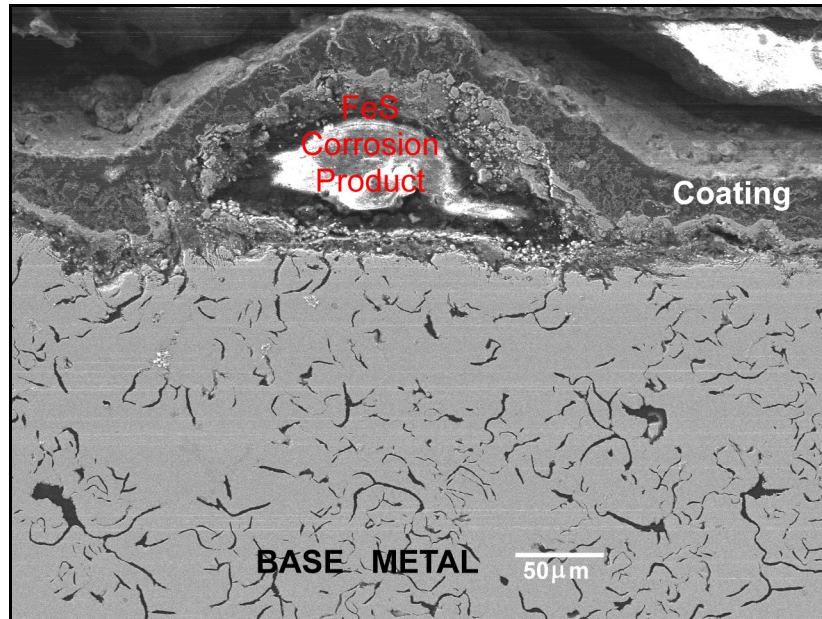
Figures 4 and 5 show the results of SEM examination. The coating thickness varied from 25 to 50 µm (0.001 to 0.002 inches). The fluorocarbon coating was porous and contained pathways for corrosive media to transport to the metal surface. The blisters were filled with corrosion products, mainly iron sulfide.

FIGURE 4 – SEM Image: Coating Blister

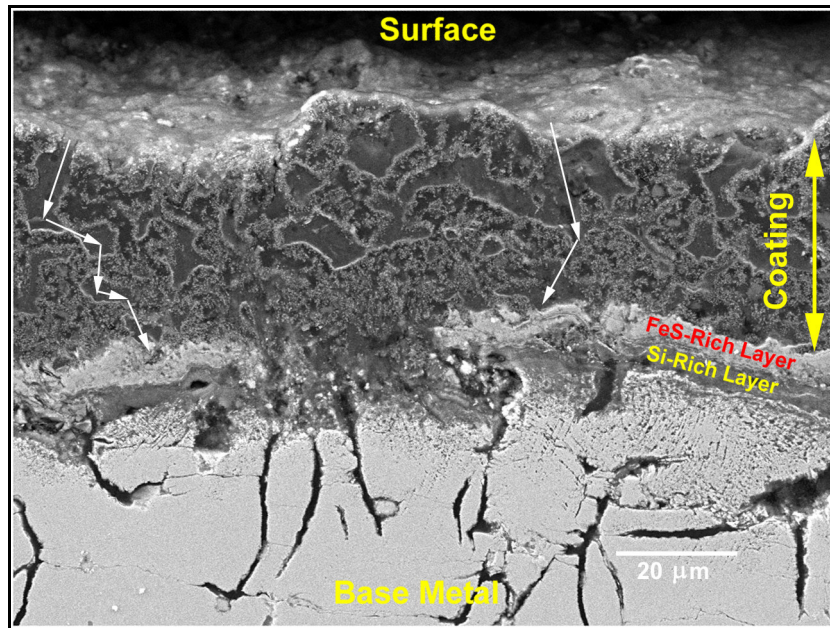
There were two additional layers between the base metal (Ni-Resist) and the coating. They are indicated in Figure 5 as FeS-rich layer and Si-rich layer.

The Si-rich layer was adjacent to the base metal. It contained 30% oxygen and 20% silicon, which indicates that its major component is sand (SiO₂). This layer also contained a high percentage of chromium, nickel and copper. This layer was most likely formed at the time of sand casting.

The FeS-rich layer was adjacent to the coating layer. It contained 28% sulfur, and 57% iron. This indicates the layer is likely a corrosion product which formed in service.

FIGURE 5 – SEM Image: Coating And Additional Layers
