SOUR GAS PIPELINE FAILURE DUE TO THE INTERACTION OF METHANOL WITH PRODUCED WATER

Russell Watts, P. Eng., Dr. Alex Tatarov, P. Eng. and Frank Gareau, P. Eng.
Skystone Engineering

Richard Leon, P. Eng.
Nexen Inc.

Copyright 2010 NACE International

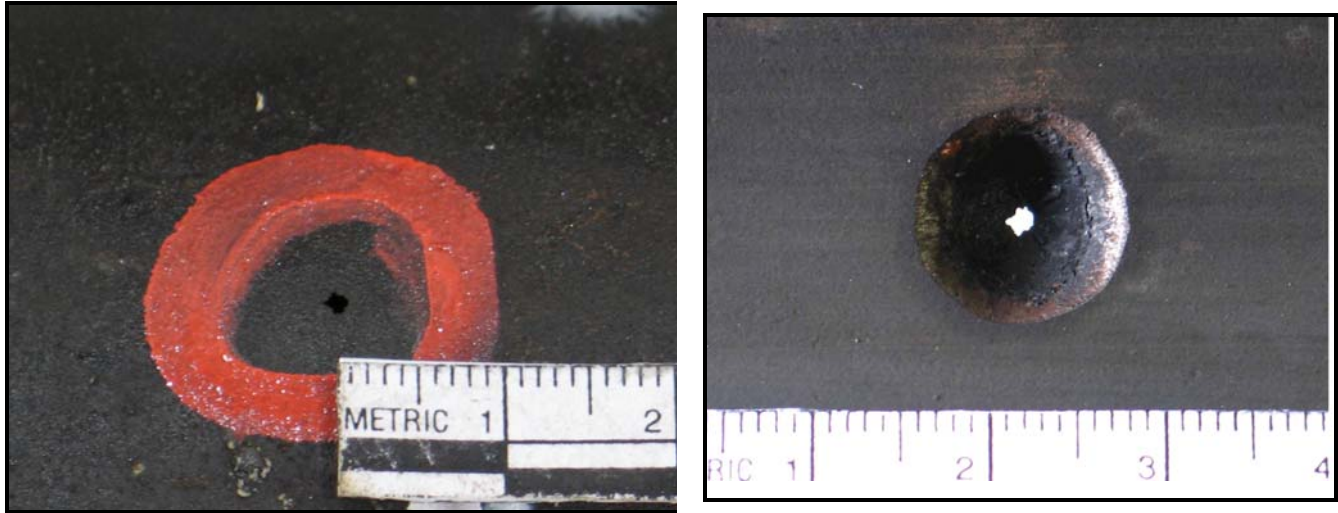
A pinhole opening initiating from the internal pipe surface was discovered at the 5 o'clock position at 55.28 m, where a 98% deep pit was observed by in-line inspection. Pit 1 was circular in shape and 12 mm in diameter. The pit was not filled with corrosion deposit; and just a thin layer of a black corrosion deposit was still adherent to the pit walls. The edges of the pit were smooth and rounded. Figure 1 shows the external and internal surfaces of through-wall Pit 1.

The external polyethylene coating was not compromised and found to be in good condition. The external surface of the pipe was in good condition and not affected by corrosion. The foam insulation was cracked and soaked with hydrocarbon fluid indicating the leak location. The external surface around the pit opening was also in good condition and minimally affected by corrosion.

FIGURE 1 – External and Internal Surfaces of Through-wall Pit 1 at 55.28 m

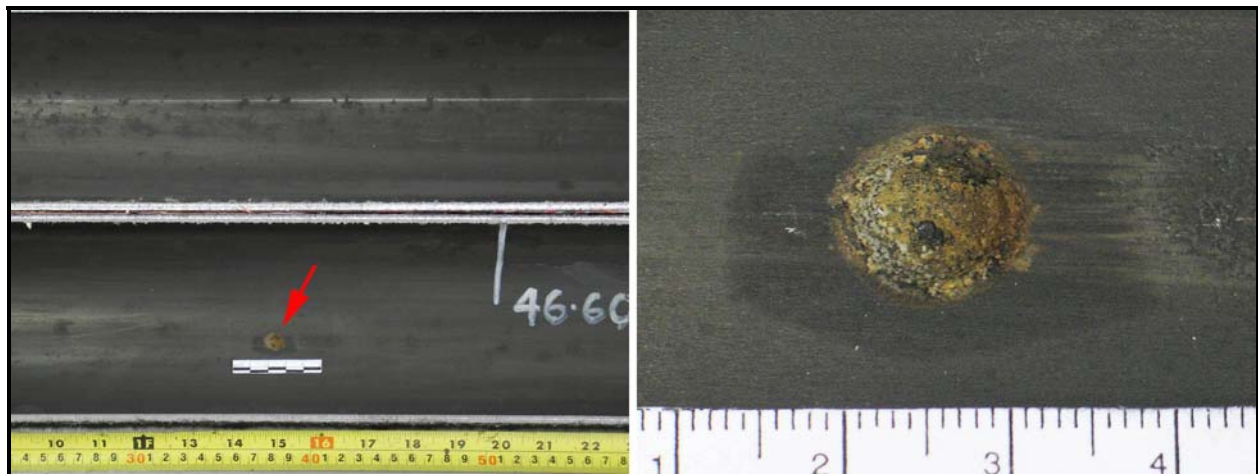
The straight line pipe cut-out section from 43.50 m to 49.60 m contained an in-line inspection indication corresponding to an 89% wall loss pit located at the 46.60 m mark, at the 6 o'clock position. The internal surface of the pipe was covered with a shiny oily layer and contained a pit close to the 46.60 m mark, at the 5 o'clock position (see Figure 2). The internal surface of the pipe between the 7 and the 8 o'clock positions was affected by general corrosion (see Figure 3).

The main pit was located close to the 46.60 m mark. It was round, 12 mm in diameter and located at the 5 o'clock position. The pit was 3.8 mm deep, which corresponded to 95% of the wall thickness. This pit was similar in geometry to the pit at 55.28 m, which suggests similar pitting/corrosion mechanism.

The pit contained a small amount of deposit on its walls. The upper layer of the deposit was yellowish, and the bottom layer was blackish. The difference in color may indicate a difference in the chemical composition. The deposit from the pit shown in Figure 2 was collected for X-ray diffraction examination.

FIGURE 2 – Pit 2 at 46.60 m Under Different Magnifications

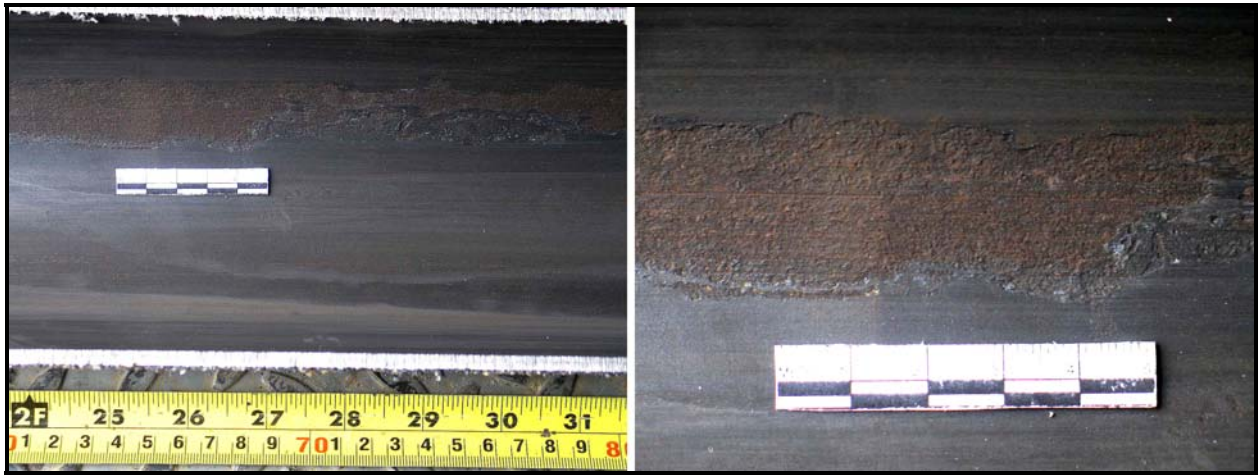
Figure 3 shows the area between the 7 and the 8 o'clock positions which was affected by general corrosion, observed as shallow elongated interconnected corroded areas. The biggest observed area was 460 mm long and 20 mm at the widest part.

- Corrosion pits initiated where the break in the inhibitor is localized. The pit was 12 mm in diameter and 3.8 mm deep, which corresponded to 95% of the wall thickness.
- General corrosion develops where the break takes place over a significant distance. A 0.5 m long and 20 mm wide corrosion groove was observed between the 7 and the 8 o'clock positions.

FIGURE 3 – General Corrosion On Internal Surface Between 7 and 8 O'clock Positions

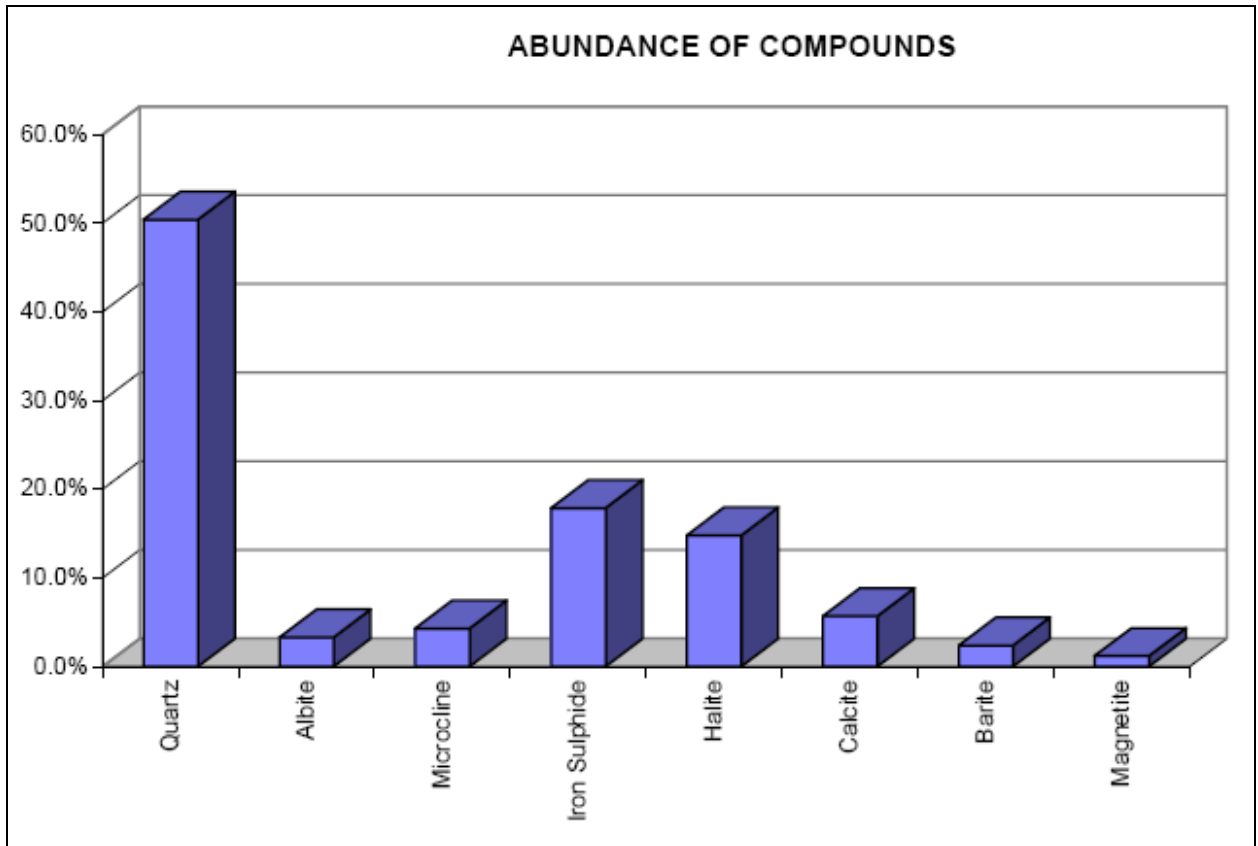
Figure 4 shows the XRD results, and Figure 5 shows an elemental analysis of the deposit within the Pit 2 at 46.60 m. The material generated a moderate quality diffractogram indicating the sample is composed of both crystalline and non-crystalline compounds. X-ray diffraction analysis shows the crystalline components of the sample are composed of 58% formation fines, 18% iron sulfide scale or corrosion products, 15% salt, 6% calcium carbonate scale, 3% barium sulfate and 1% iron oxide corrosion products. Elemental analysis suggests the presence of non-crystalline iron and chlorine bearing compounds.

FIGURE 4 – XRD Results from Pit 2 at 46.60 m

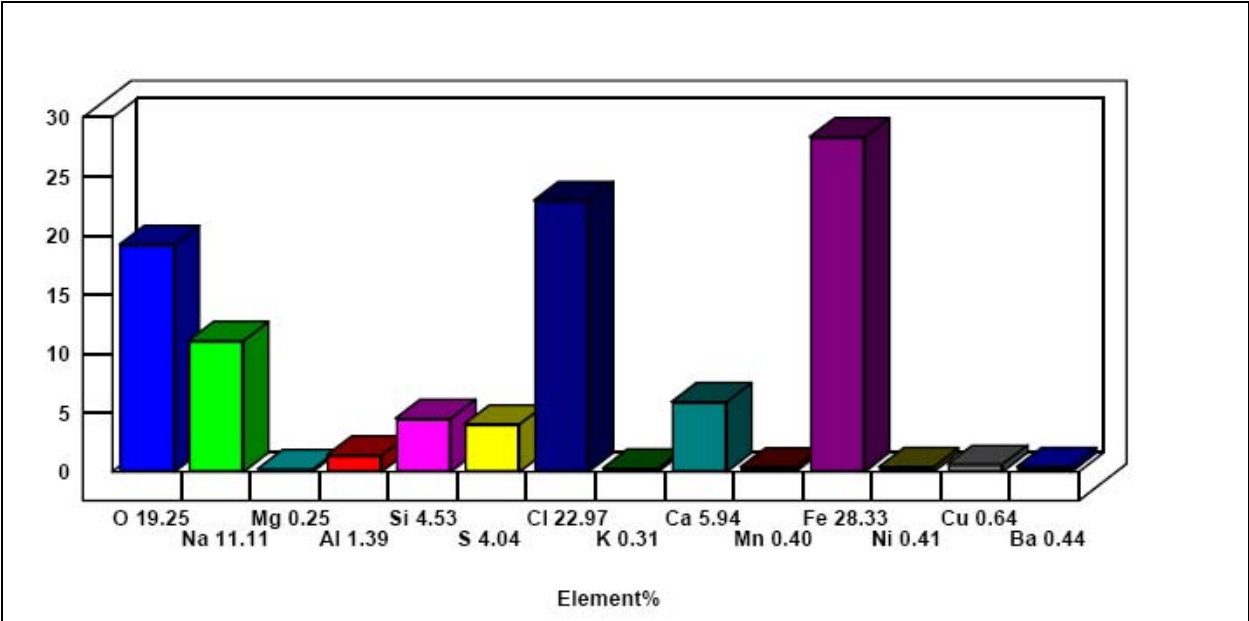
FIGURE 5 – Elemental Analysis of Deposit in Pit 2 at 46.60 m

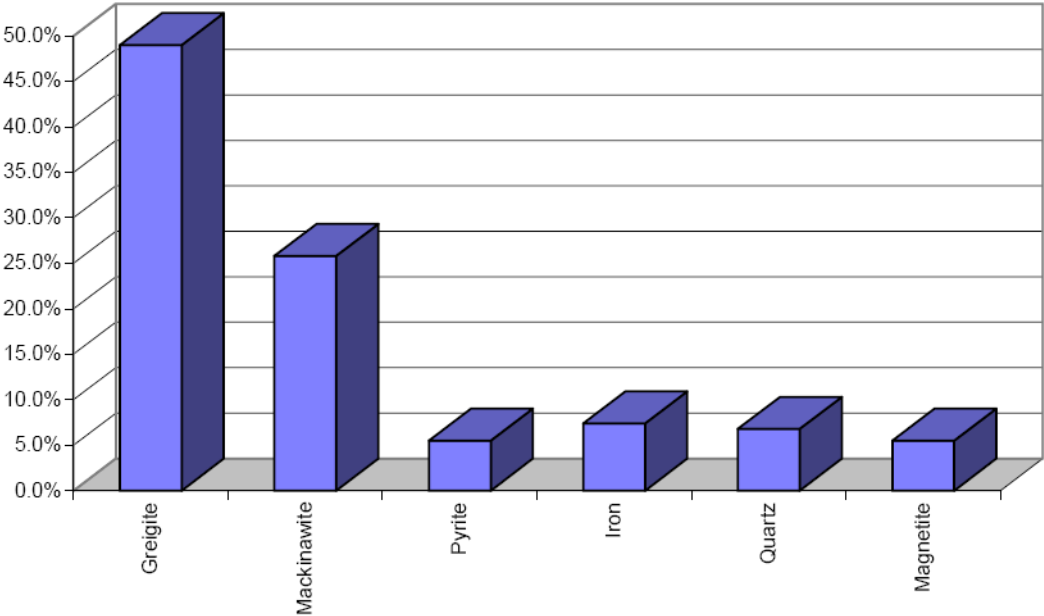
Figure 6 shows the XRD results, and Figure 7 shows an elemental analysis of the deposit from the area affected by general corrosion. The material generated a good quality diffractogram indicating the sample is mainly composed of crystalline compounds. XRD analysis shows the crystalline components of the sample are mainly composed of iron sulfide scale or corrosion products (about 80%). Elemental iron, formation fines and iron oxide corrosion products occur at minor to moderate volumes.

FIGURE 6 – XRD Results from the Area of General Corrosion

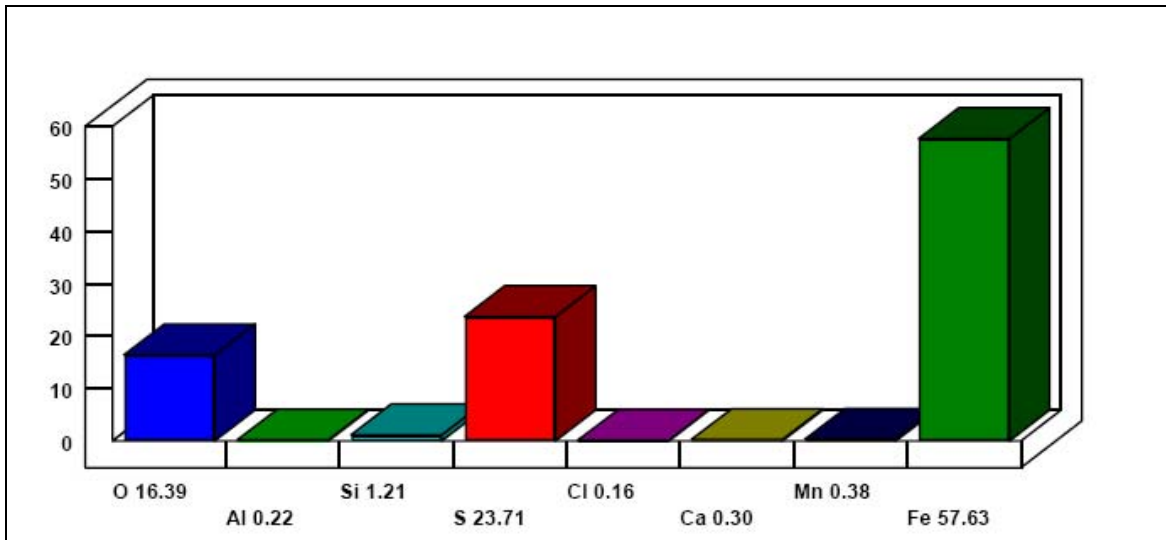
FIGURE 7 – Area of General Corrosion Elemental Analysis

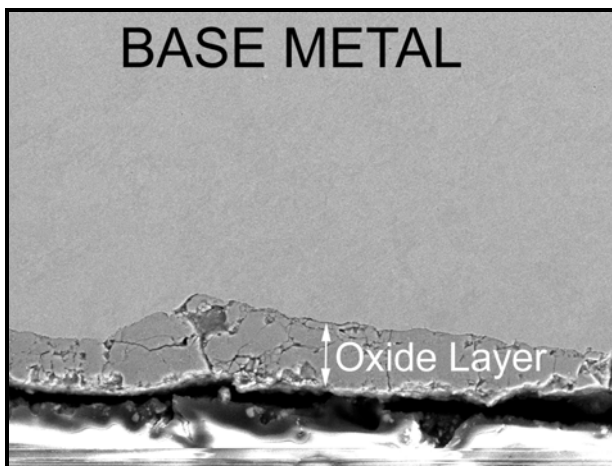
- Stage 1: Uncorroded pipe.
- Stage 2: The internal surface was covered with an oxide layer (mill scale). The oxide layer developed breaks. Chloride ions are known as a potential scale penetration.
- Stage 3: Corrosion pits began to form under the breaks. Small pits were filled with corrosion deposit.
- Stage 4: The oxide layer was not present after the pits grew. Corrosion deposit was near and parallel to the pit surface.

- Iron oxide (mill) scale closest to the surface (see Figure 8).
- Iron sulfide layer revealed by spot testing. The layer was not observed either by SEM or under a metallographic microscope, which indicates that the layer was thin.
- Inhibitor film.

FIGURE 8 – Stage 2: Breaks In Oxide Layer.
Mag. 1000X

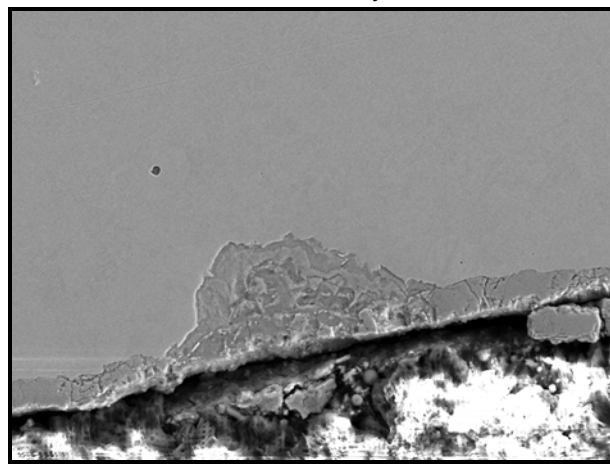
FIGURE 9 – Stage 3: Formation Of Small Pit
below The Breaks in The Oxide Layer.
Mag. 750X

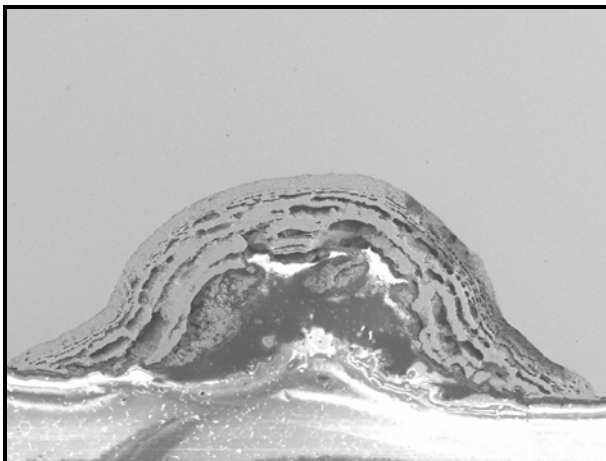
FIGURE 10 – Stage 4: Bigger Pits Are Partially
Filled With Deposit. Mill Scale Not Present.
Mag. 40X

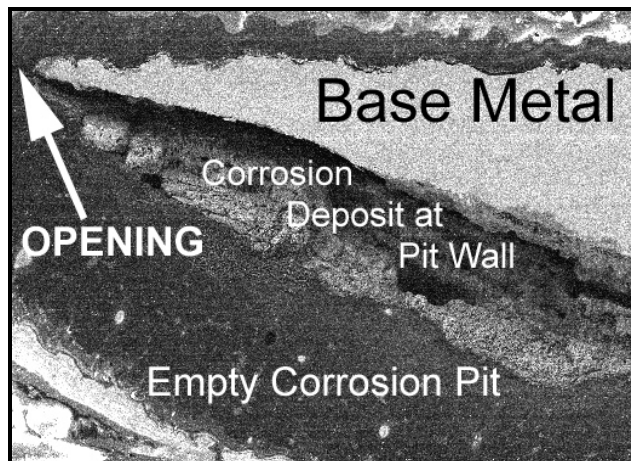
- Stage 5: Large pits contained small amounts of corrosion deposit close to their walls.

FIGURE 11 – Stage 5: Large Pits Are Almost
Empty. Mag. 70X
