UNUSUAL FAILURE OF SPOOLABLE COMPOSITE LINE PIPE INSTALLED IN WINTER

Dr. Alex Tatarov, P. Eng., Frank Gareau, P. Eng.,
Skystone Engineering
McCall Court, 4311 - 12 St. NE
Calgary, Alberta, Canada T2E 4P9

Richard Leon, P.Eng
Nexen Inc.
2900, 801 – 7 Avenue SW
Calgary, Alberta, Canada T2P 3P7

ABSTRACT

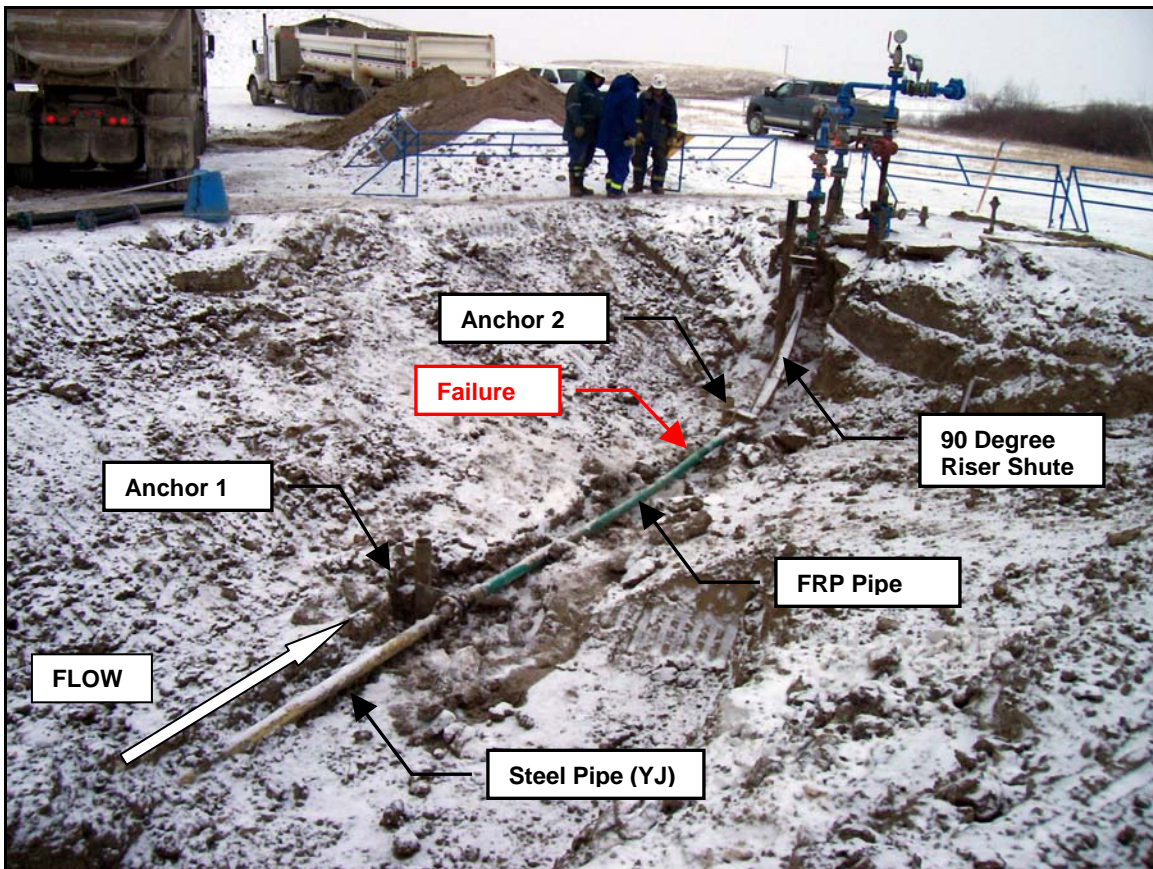
FIGURE 1 – Failure Site

The 3.5 inch nominal, 1,500 psi series SCP line pipe with a high density polyethylene (HDPE) pressure barrier failed after two years in service. Figure 1 shows the dig site at the location of the failure. Operating conditions were:

Figure 1 shows that the flange connection between the steel pipe and the SCP pipe was secured by a flag anchor (Anchor 1 in Figure 1). The flag anchor prevents vertical movement, but does not prevent longitudinal movement. Thus, thermal expansion of the steel pipe would result in additional compression of the SCP pipe, and contribute to the failure.

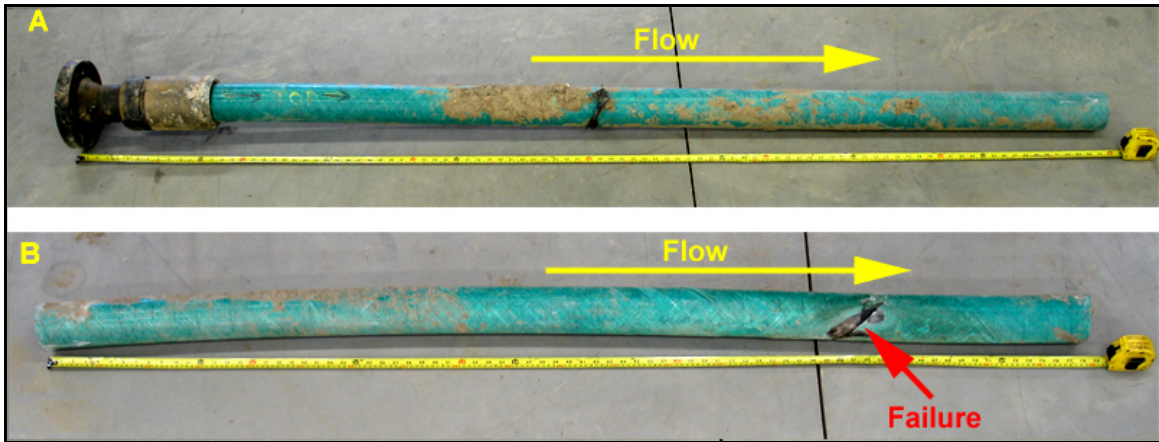
FIGURE 2 – SCP Pipe Sections “As Received”

Visual examination revealed that the failed SCP contained a glass fiber reinforced epoxy laminate (fiberglass) as the external layer. The top part of the failed fiberglass pipe was mechanically damaged (see Figures 2 through 4). The amount of mechanical damage on the top external surface increased closer to the failure. A good and shiny surface away from the failure transformed to the areas of discoloration due to wear, broken glass fibers, delamination, and areas missing two or three layers of winding. Visibly, in the locations of delamination, the fiberglass pipe was “dry” and contained an insufficient amount of epoxy between layers.

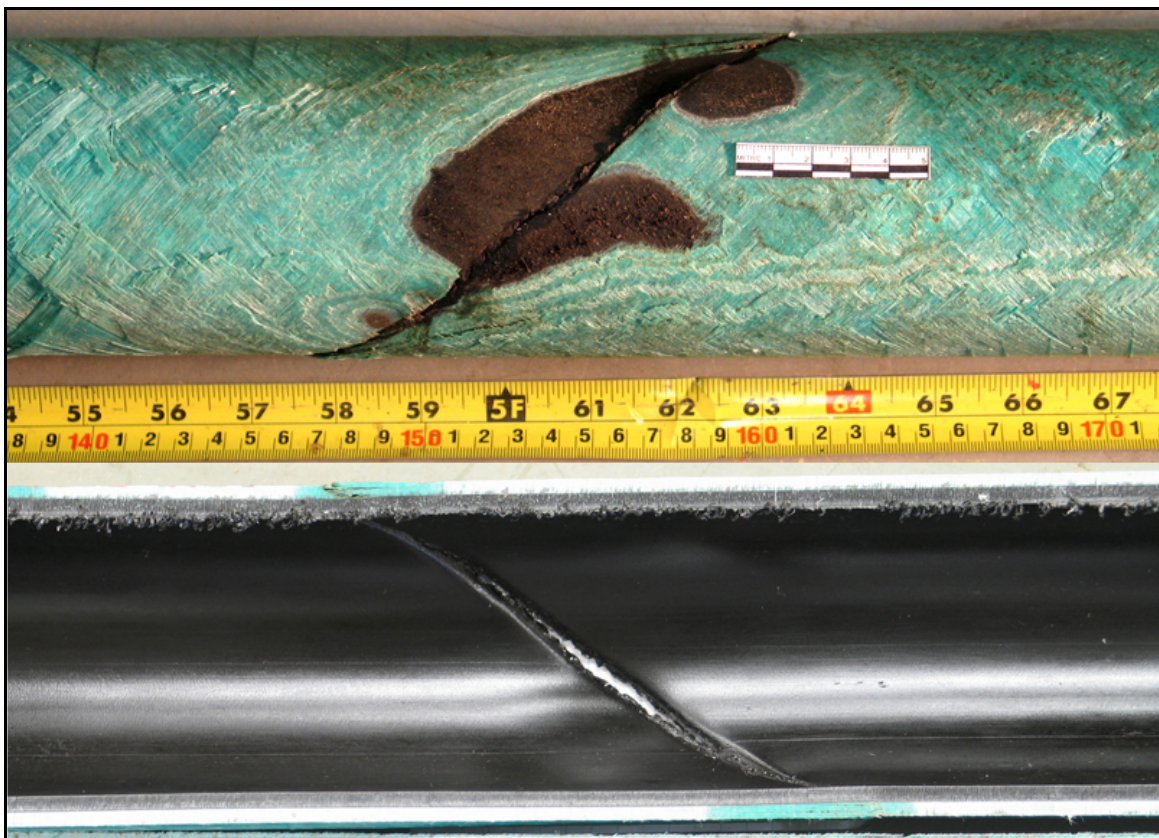
FIGURE 3 – Top Half External and Internal Surfaces: Area Of Failure

The failure initiated from the top part of the external surface along the winding direction of glass fiber, which is typical. The fiberglass pipe adjacent to the failure was affected by erosion, which was the post-failure phenomenon caused by fluids flowing out of the pipe. The erosion removed the original evidence of the mechanical failure.

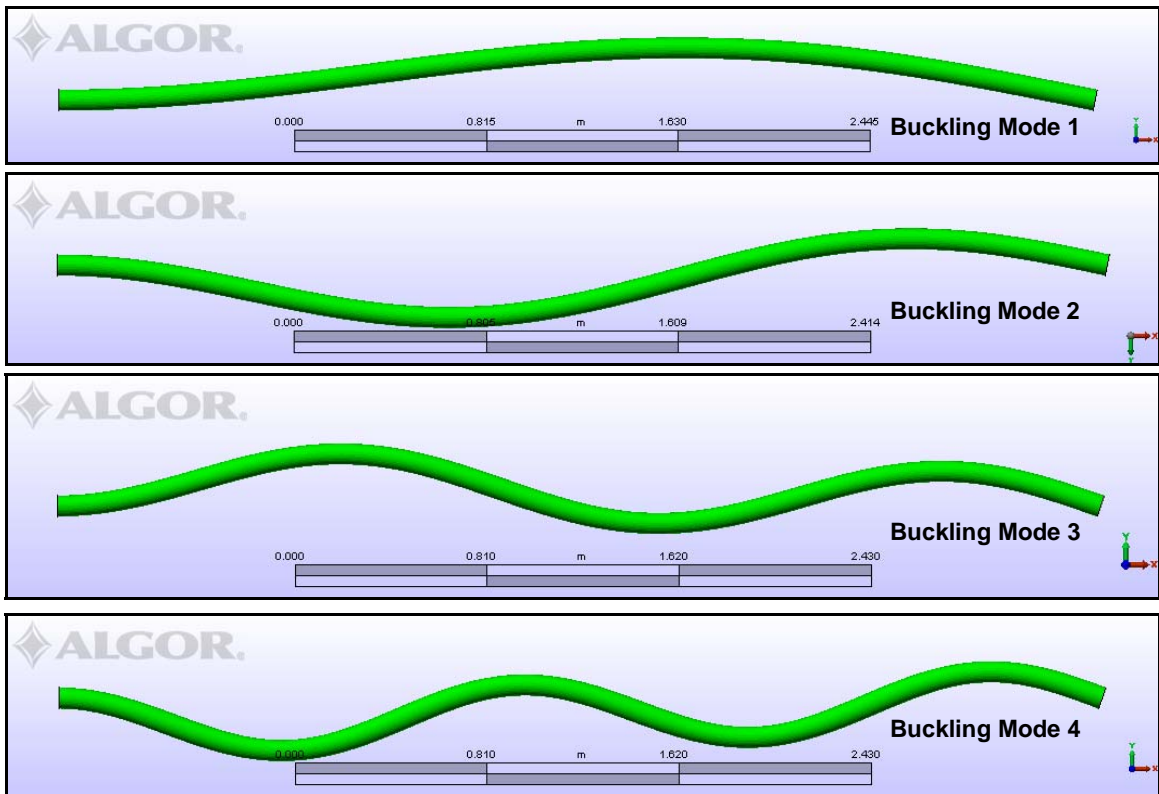
FIGURE 6 – Buckling Of SCP Pipe With Left End Fixed And Right End Pinned

- The pipe changed its shape by buckling, which resulted in movement of pipe surface up to 7 cm in the ground. Figure 6 shows four theoretical buckling modes.
