Brooks/Suffield Shallow Gas
Gathering Pipeline System
Corrosion Mitigation and
Monitoring

Chris Horkoff, Dale Toews
EnCana Corporation
NACE 1-day Seminar
Medicine Hat, AB
11/22/05

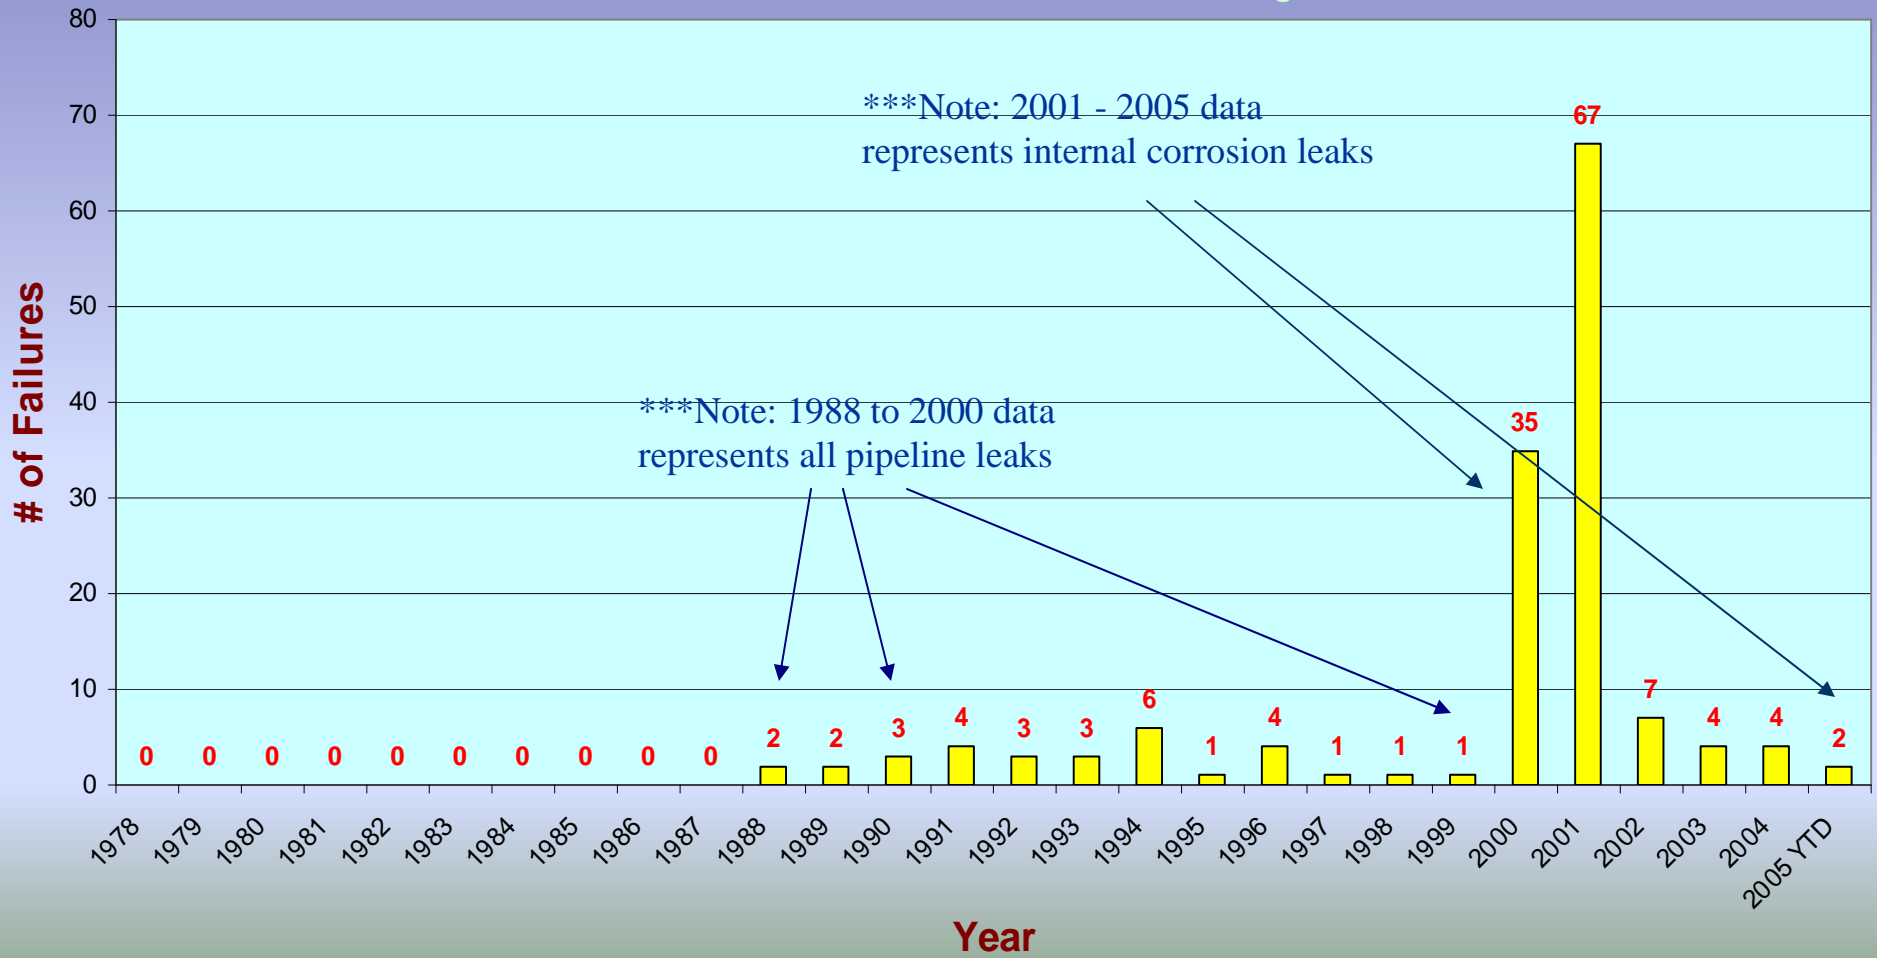
Brooks Shallow Gas Leak Summary

Brooks Shallow Gas Pipeline Leak Summary -
Alderson SYS 1, SYS 3-4, SYS South, GU #3, Monogram

- Leaks in Alderson Gas Unit 3 were reduced from 25 in 2001 to 0 in 2002
- EnCana “Shallow Gas Pipeline Corrosion Mitigation Plan” generated

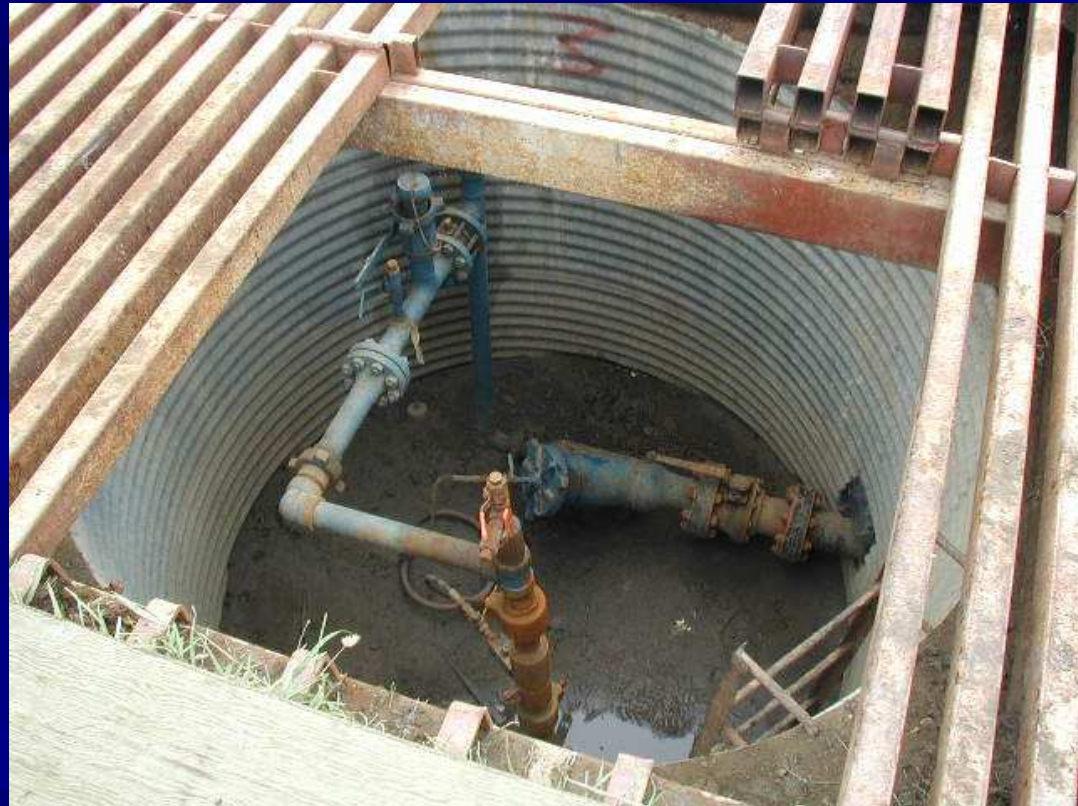
Suffield Shallow Gas

- In military training area, all structures must be underground.
- Military exercises: 60% of wells may be inaccessible for 3 weeks

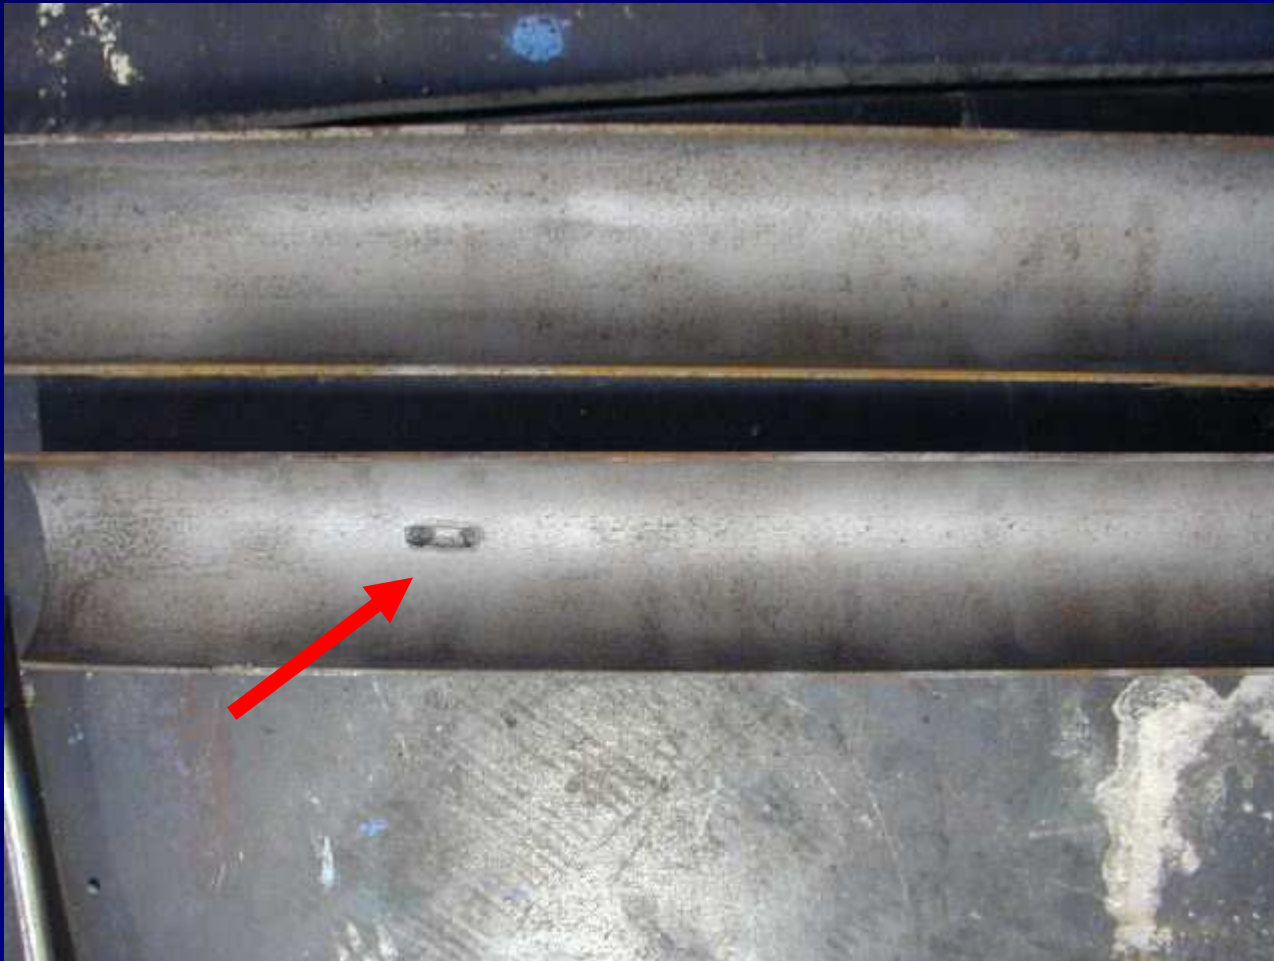
SRB-Related Internal Corrosion Failure – 3" (6 o'clock Position)

- January 2000, almost all steel gathering system, mostly 2" (0.083" wall) with average operating pressures about 70 psi
- Typical gas composition of 0.2 mole % CO₂ (Milk River, SWS, Medicine Hat)
- Chloride levels <5,000 mg/L
- 1980 SRB identified as potential source of corrosion
- Early 1980's, isolated failures, various biocides tried.
- Late 1980's, some siphon string wells, biocide killed planktonic bacteria, failures continued.

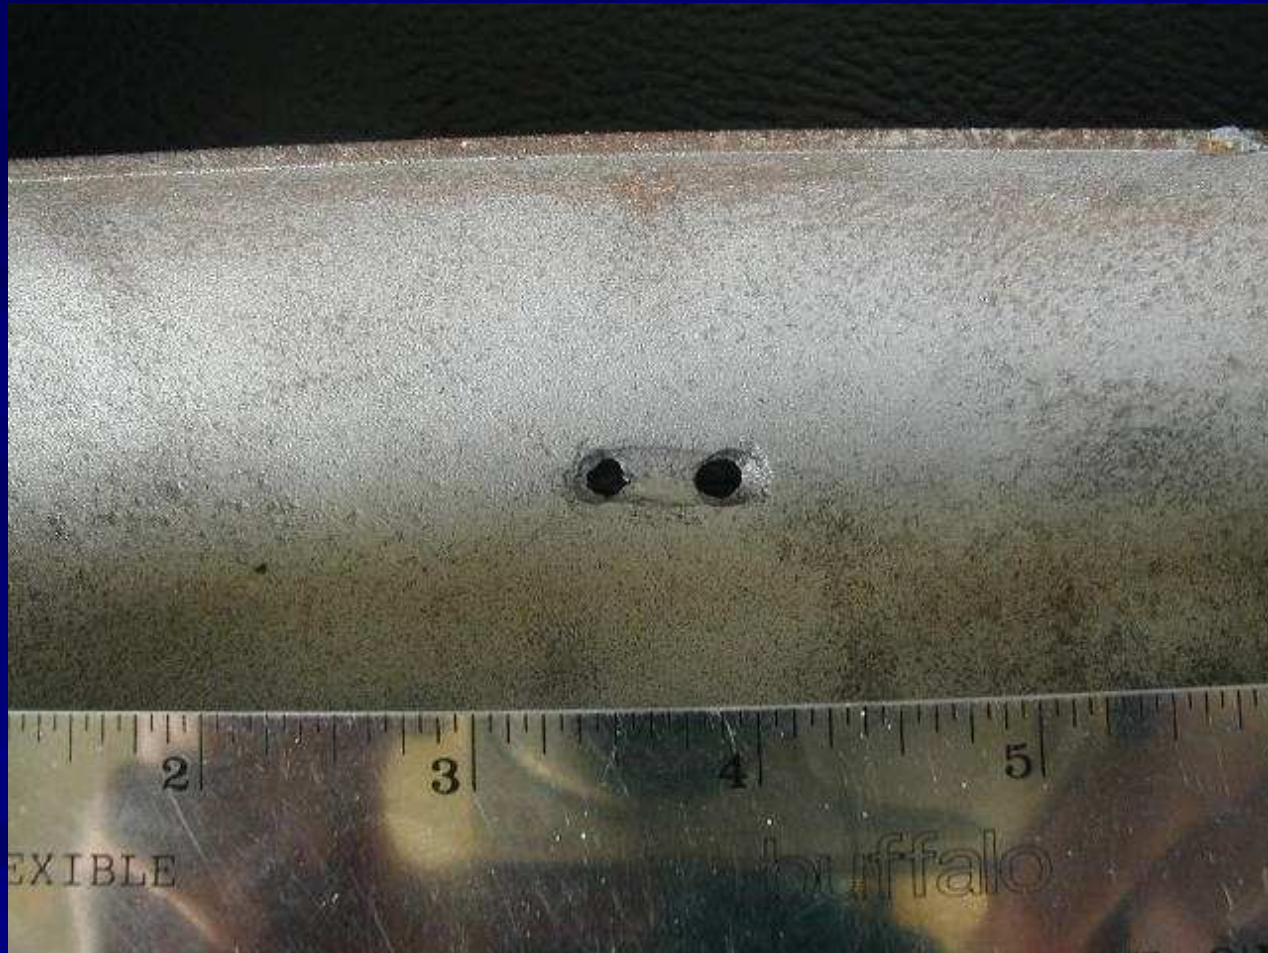
SRB-Related Internal Corrosion Failure – 3" (6 o'clock Position)

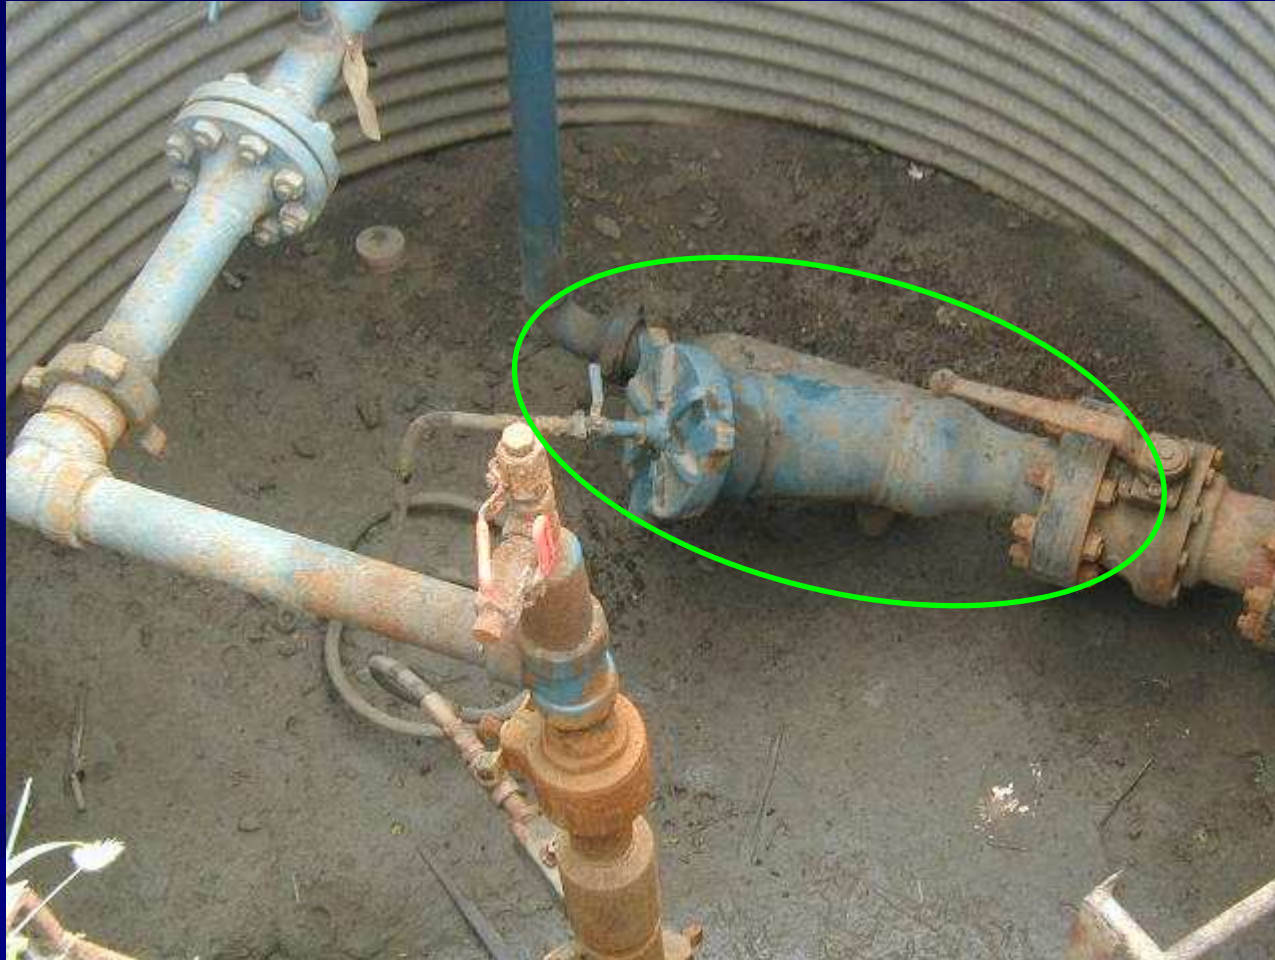
3" Suffield Pipeline Pig Launcher

- Automatic pig launchers
- Careful planning with chemical applicators and piggers

➤ Pig launchers small, no pill treatments.

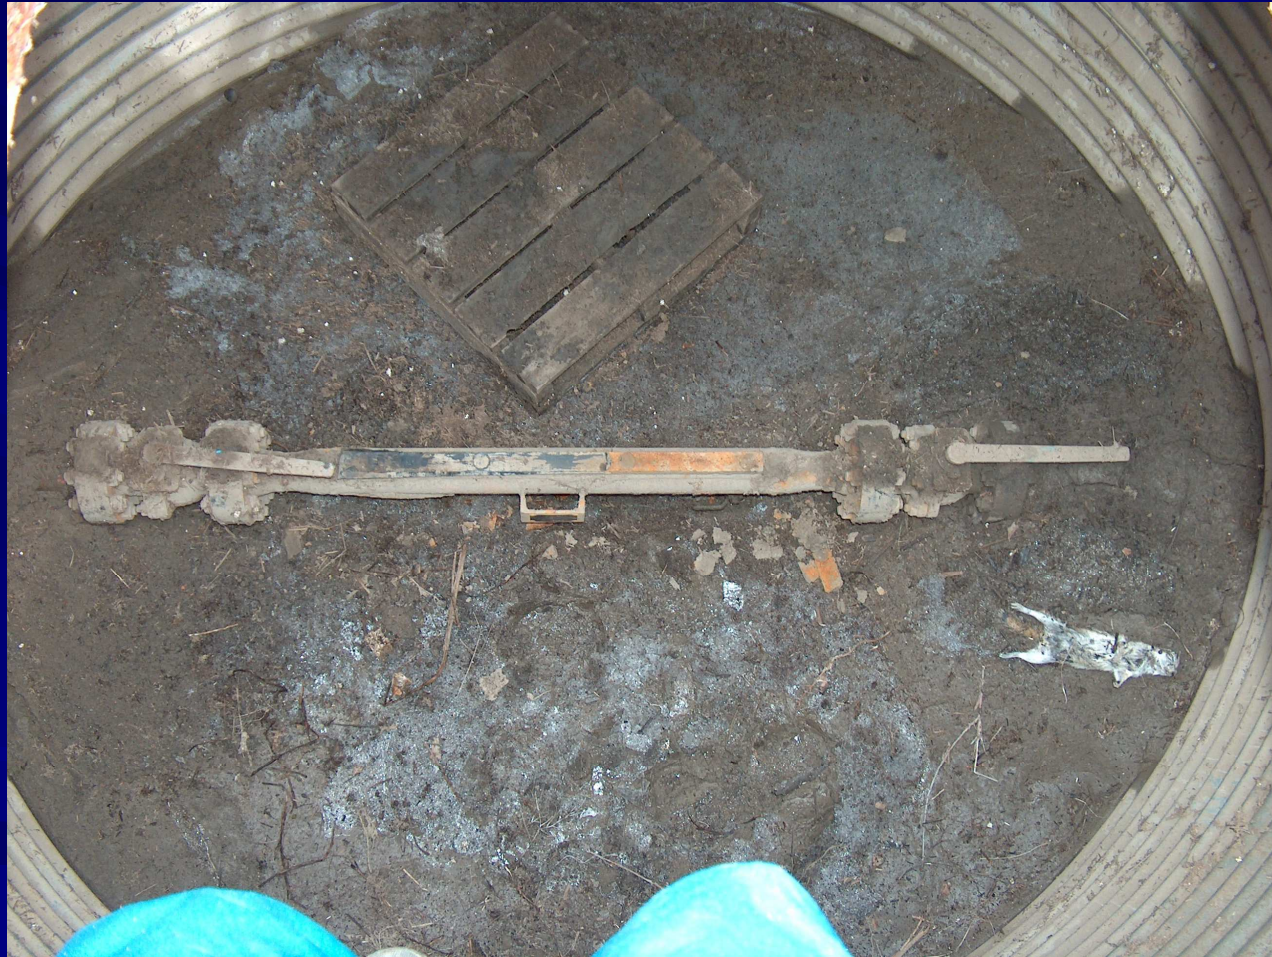
Suffield Caisson Bio-film Spool

- Biospools used in current monitoring of corrosion mitigation.
- Possible changes in water chemistry.
- Due to military activity and early snows, biocide applications sometimes are only 3 months apart.
- Pipelines fed by SWAB wells (potential water)
- Plastic Pipe (935 km since 2000)
 - Normally not treated with chemicals, but these wells are still putting bacteria and water into pipeline
