News about corrosion and the corrosion industry produced quarterly for members of NACE International in the Calgary area

This newsletter features a Canadian case of **Crude Oil Pipeline Rupture - Enbridge Pipelines Inc., near Hardisty, Alberta - 17 January 2001.**

Case – 6: Enbridge Pipelines Inc., 864-millimetre Line 3/4, Mile Post 109.42, Near Hardisty, Alberta - 17 January 2001.

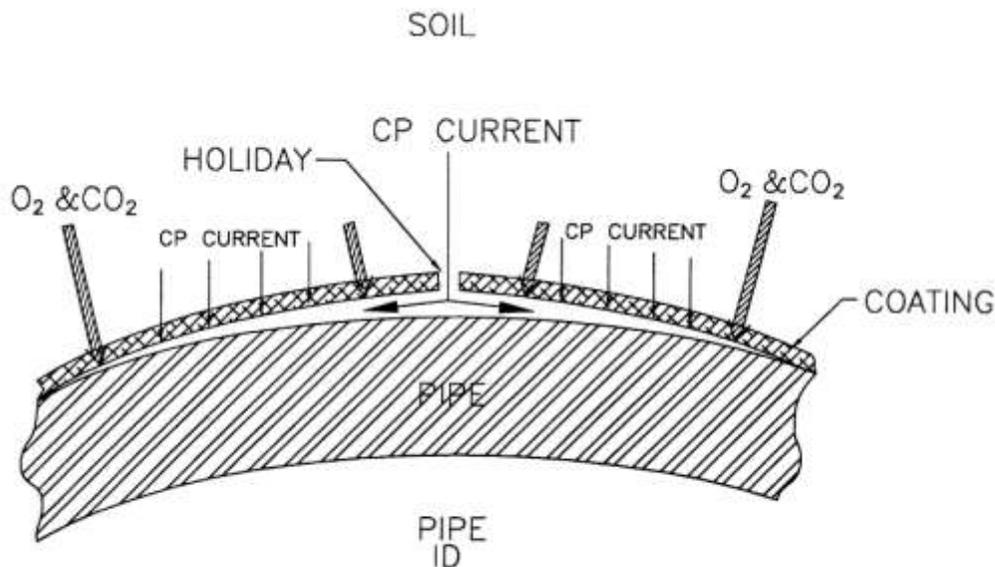
Figure 4. Schematic Showing CP Current Flow And Gas Diffusion Through Coating.

Since the exterior flash of the ERW seam had not been ground-flush with the pipe, the tape coating tented over the seam providing a narrow channel into which groundwater could seep.

The longitudinal seam was located at the three o'clock position where soil stresses are at a maximum. Repeated freeze/thaw cycles, possibly combined with minor pipe settlement, exacerbated the coating disbondment. Although the pipe was cathodically protected, the disbonded tape coating shielded the pipe from the cathodic protection current. Groundwater provided a corrosive environment that contacted the pipe steel and allowed a corrosion cell to be set up.

- The tape coating tented over the untrimmed weld flash of the electric resistance weld (ERW) longitudinal seam and shielded the pipe from the cathodic protection current, allowing a corrosive environment to contact the pipe metal.
