THE INFLUENCE OF INSULATION MATERIALS ON CORROSION UNDER INSULATION

John Williams
Aspen Aerogels, Inc.
30 Forbes Rd., Bldg B
Northborough, MA 01532

Copyright 2010 NACE International

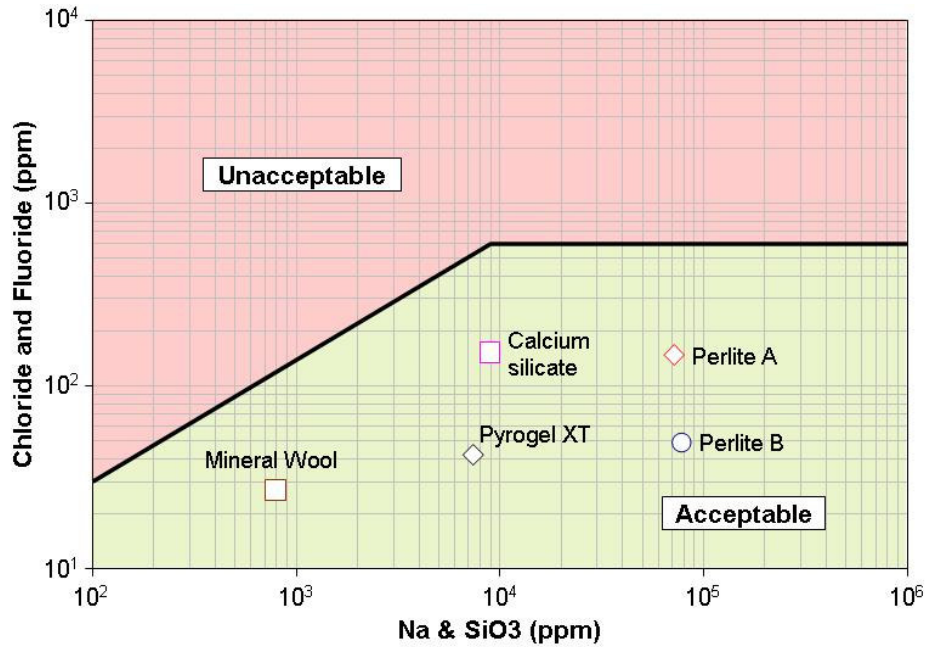
Figure 1: Independently verified extractable anion results according to ASTM C871.

In the event that liquid water penetrates an insulation material, it is important that that material maintain an aqueous chemistry within a specific pH range. Insulation materials with adventitious chloride anions and low pH values can significantly accelerate corrosion rates. To determine the quantity of extractable anions, materials are typically tested according to ASTM C871.⁸ Regions of unacceptable and acceptable anion quantities are described by the Karnes curve, shown in Figure 1.⁹ As part of this study, independent, third-party testing has been carried out on calcium silicate, mineral wool, Pyrogel XT, and two different brands of expanded perlite. The results are plotted in Figure 1, which shows that all the materials tested passed the requirements of ASTM C795 for extractable anion quantities.

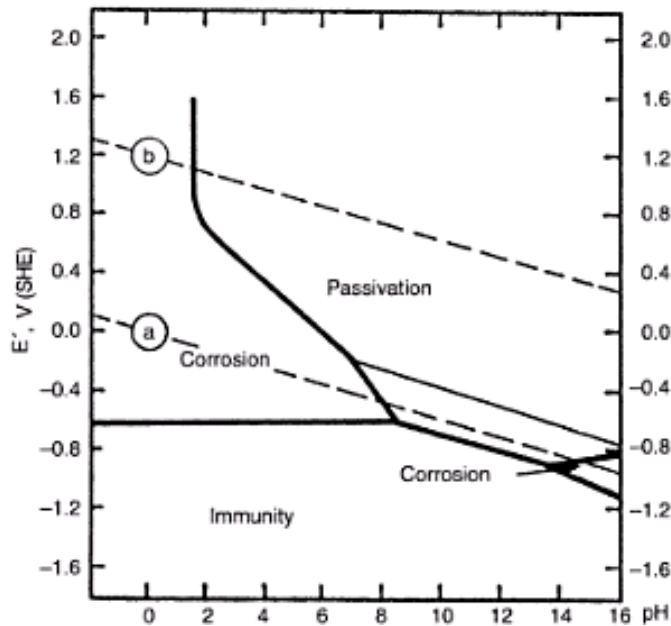
Figure 2: Pourbaix diagram of an iron-water system at 25°C.¹⁰

Also plotted in Figure 2 are two dashed lines (a) and (b). These lines represent the EMF potential for the oxidation and reduction of water, respectively. The dashed lines thus bracket the practical region of stability for an aqueous system, outside of which water will begin to decompose. It is evident from the diagram that an aqueous system with a pH value ranging 8 to 13.5 only exhibits regions of immunity and passivation. In other words, corrosion will only occur at pH values lower than 8, and can become severe for $\text{pH} < 4$.

Beyond the extractable anion quantities, the aqueous pH is another critical parameter. The influence of pH on corrosion behavior can be demonstrated by the simplified Pourbaix diagram of Figure 2. These diagrams plot the most thermodynamically stable products as a function of pH and reduction potential. The diagram indicates three distinct regions of interest: 1) immunity, 2) passivation, and 3) corrosion. The regions of corrosion are associated with the oxidation of iron metal to soluble Fe^{+2} or Fe^{+3} ions, whereas regions of passivation are associated with the formation of insoluble oxide layers. Likewise, regions of immunity are indicative of the presence of iron metal with no signs of chemical reactivity.

Pyrogel XT uses a more durable, magnesium-based corrosion inhibitor with a much lower solubility in water (0.062g/mL at 25°C). Yet, despite the low solubility, it is highly capable of maintaining an aqueous pH value above 8.0, ensuring that the insulation environment is consistently in a region of stability associated with passivation or immunity (refer to Figure 2).

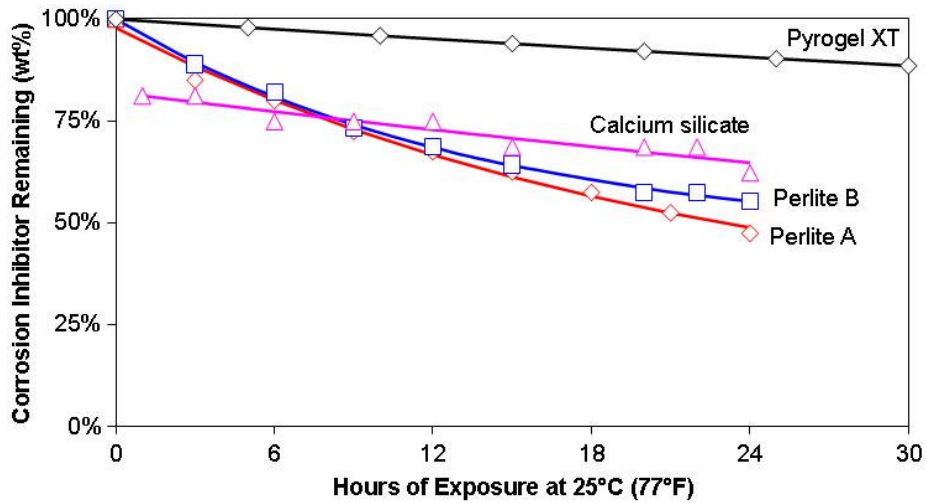
Figure 3: Corrosion inhibitor durability at 25°C (77°F).

The results are shown in Figure 3, Figure 4 and Figure 5 as the percent of corrosion inhibitor remaining in the insulation over time at 25, 45 and 90°C (77, 113, and 195°F), respectively. Materials employing sodium silicate lost much or most of their corrosion inhibitor after just 24 hours exposure. After 48 hours at 90°C , the perlite and calcium silicate retained only 25% and 5% of their inhibitor, respectively, while Pyrogel XT retained 94%.

This testing points to a potential discrepancy between the aqueous chemistry of pristine materials (as they are tested in C692 and C1617) and in-service materials, and validates field measurements reported previously in the literature.¹² At a minimum, one can infer that the pH values of materials inhibited with sodium silicate may drift downward over time with continuous or repeated exposure to water, potentially leading to an increase in the risk for CUI. In contrast, the pH values beneath Pyrogel XT should be more stable over time.

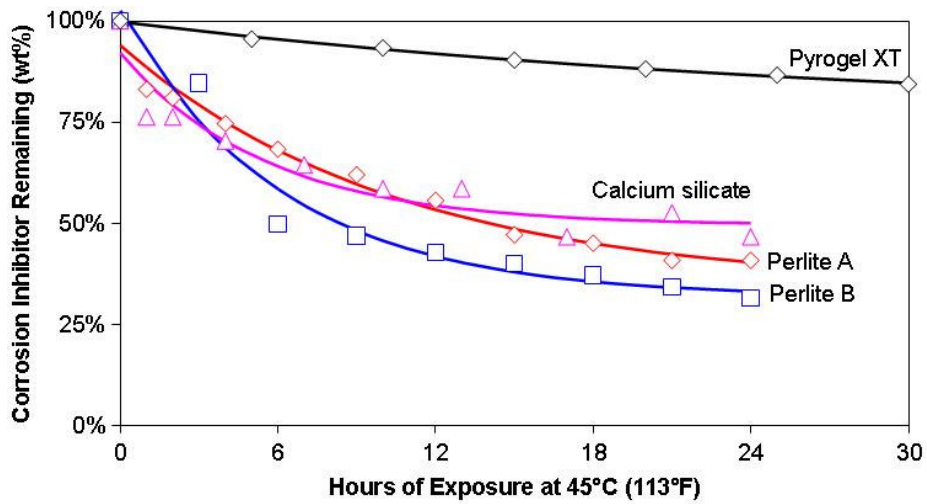
Figure 4: Corrosion inhibitor durability at 45°C (113°F).

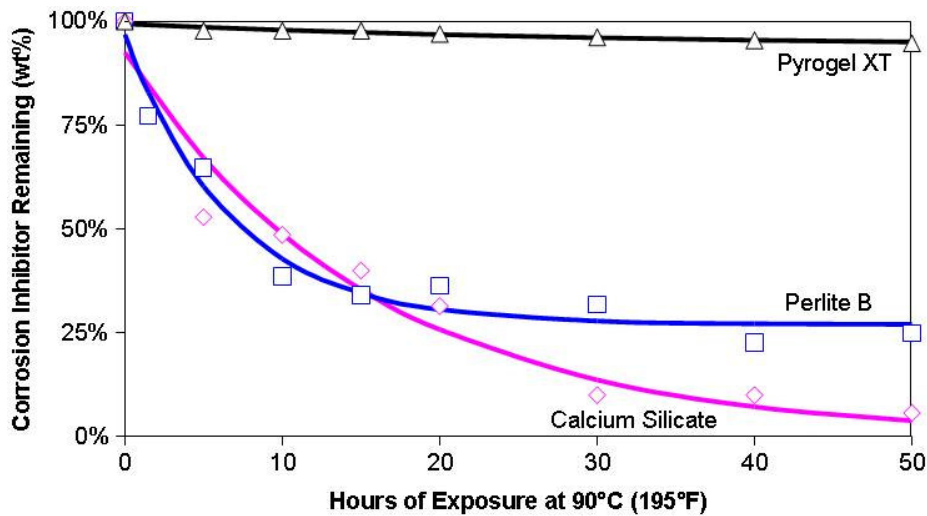
Figure 5: Corrosion inhibitor durability at 90°C (195°F).

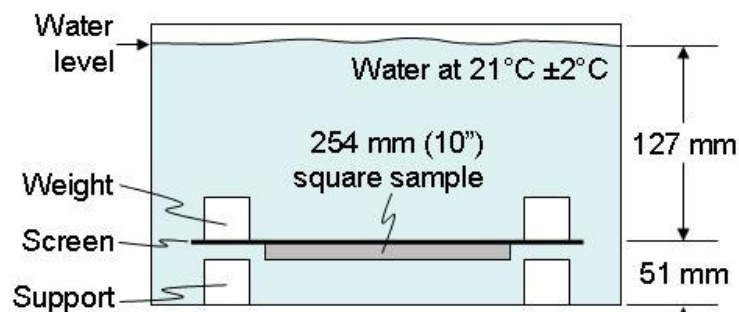
Figure 6: Test apparatus for ASTM C1511.¹³

To better understand these limits, an assessment was made of hydrophobe stability at various temperatures. Sample coupons of WRG mineral wool, Pyrogel XT, and two brands of expanded perlite were baked in ovens at temperatures ranging from 300 to 430°C (572 to 806°F) for up to 385 days. Periodically, the coupons were removed, cooled to ambient temperature, tested for water uptake, and then returned to the oven. Water uptake was assessed according to the method of ASTM C1511, whereby a sample is submerged under 127 mm (5 in.) of water for 15 minutes (see Figure 6). The sample’s weight is measured both before and after submersion, and the weight uptake is reported as the percent increase over the dry weight of the sample.

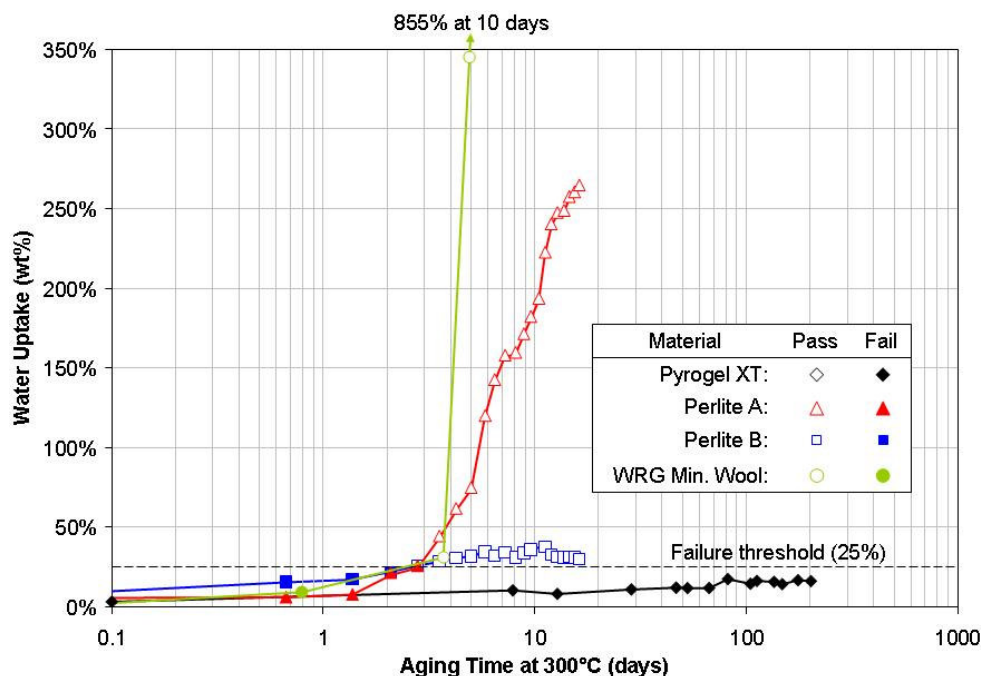
Figure 7: Water uptake vs. aging time at 300°C.

- The WRG mineral wool and perlite A samples fail much more catastrophically than the perlite B sample or, for that matter, the Pyrogel XT sample, which hasn't failed at all after 200 days. The WRG quickly soars to its saturation value of 855% uptake after 10 days exposure. The perlite A sample degrades to 264% uptake after 16 days. The perlite B stabilizes near 33% uptake after the first 4 days of exposure.

- The WRG mineral wool and both perlite samples all cross the failure threshold after about 3 days exposure. This is to be expected, as the hydrophobicity of these three materials is imparted via a coating process involving the use of aqueous silicone (polydimethylsiloxane) emulsions. Controlled thermogravimetric analyses have shown that polydimethylsiloxane will, when heated in air for 5 hours, exhibit a 15% degradation at 300°C and 85% degradation at 350°C.¹⁴

- The Pyrogel XT shows very little hydrophobe loss over the 200 days studied. Again, this performance is tied to hydrophobe chemistry which, in the case of Pyrogel XT, is based on a highly crosslinked methylsiloxane resin. This proprietary treatment is covalently bonded to the aerogel backbone via robust Si-O-Si linkages. The unique thermooxidative stability of the material is thus derived from an increased polymethylsiloxane crosslink density (relative to standard polydimethylsiloxane emulsions) in combination with an integral bonding of the methylsiloxane resin to the material.

Representative data from such testing is shown in Figure 7, which plots the water uptake of each sample as a function of the total time of aging at, in this case, 300°C. Also plotted in Figure 7 is a failure threshold of 25wt% (dashed line). Although this value is somewhat arbitrary, having a defined threshold is necessary for predicting the useful hydrophobe lifetime.

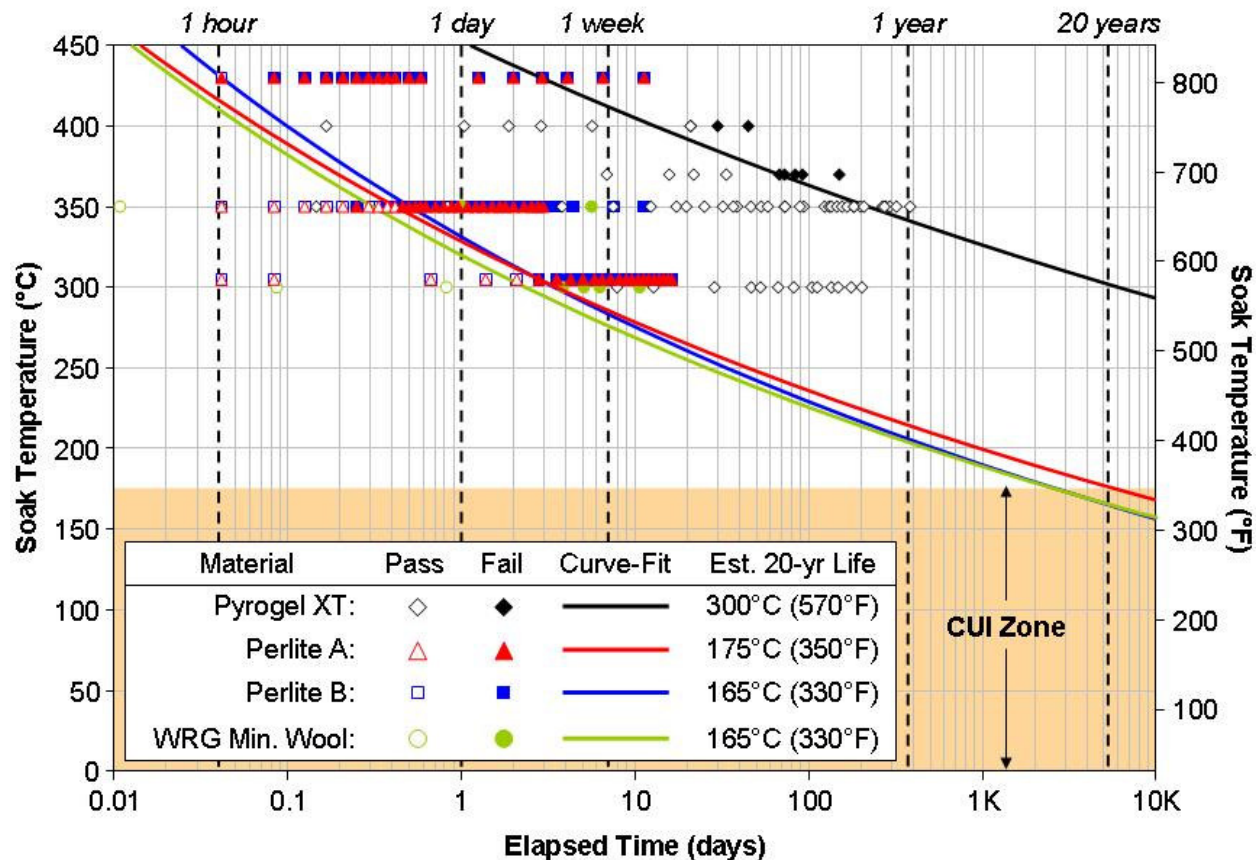
Figure 8: Arrhenius decomposition curves showing the influence of temperature on hydrophobe lifetime for three water-repellent insulation materials.

The next step for predicting hydrophobe lifetime is to aggregate the water uptake data taken at all the different temperatures. This is shown in Figure 8, which plots all the paired sets of exposure temperature and exposure time for each material. By discriminating the samples that have passed (open shapes) from those that have failed (closed shapes), an Arrhenius-based curve fit can be made for the time-to-failure as a function of temperature (solid lines). This curve-fit allows us to predict how long the hydrophobe will remain effective based on the service temperature of the pipe or equipment.

By establishing a 20-year hydrophobe lifetime as the relevant metric of performance, a prediction can be made as to the maximum temperature for which that lifetime can be achieved. The results (inset table, Figure 8) show that the WRG mineral wool and two brands of perlite cluster together at a 20-year survivability temperature of 165 to 175°C (330 to 350°F). Again, this clustering is to be expected since all three products are based on the same polydimethylsiloxane hydrophobe chemistry. Pyrogel XT, being based on the more stable crosslinked methylsiloxane resins, should remain water repellent for 20 years at service temperatures up to 300°C (570°F).

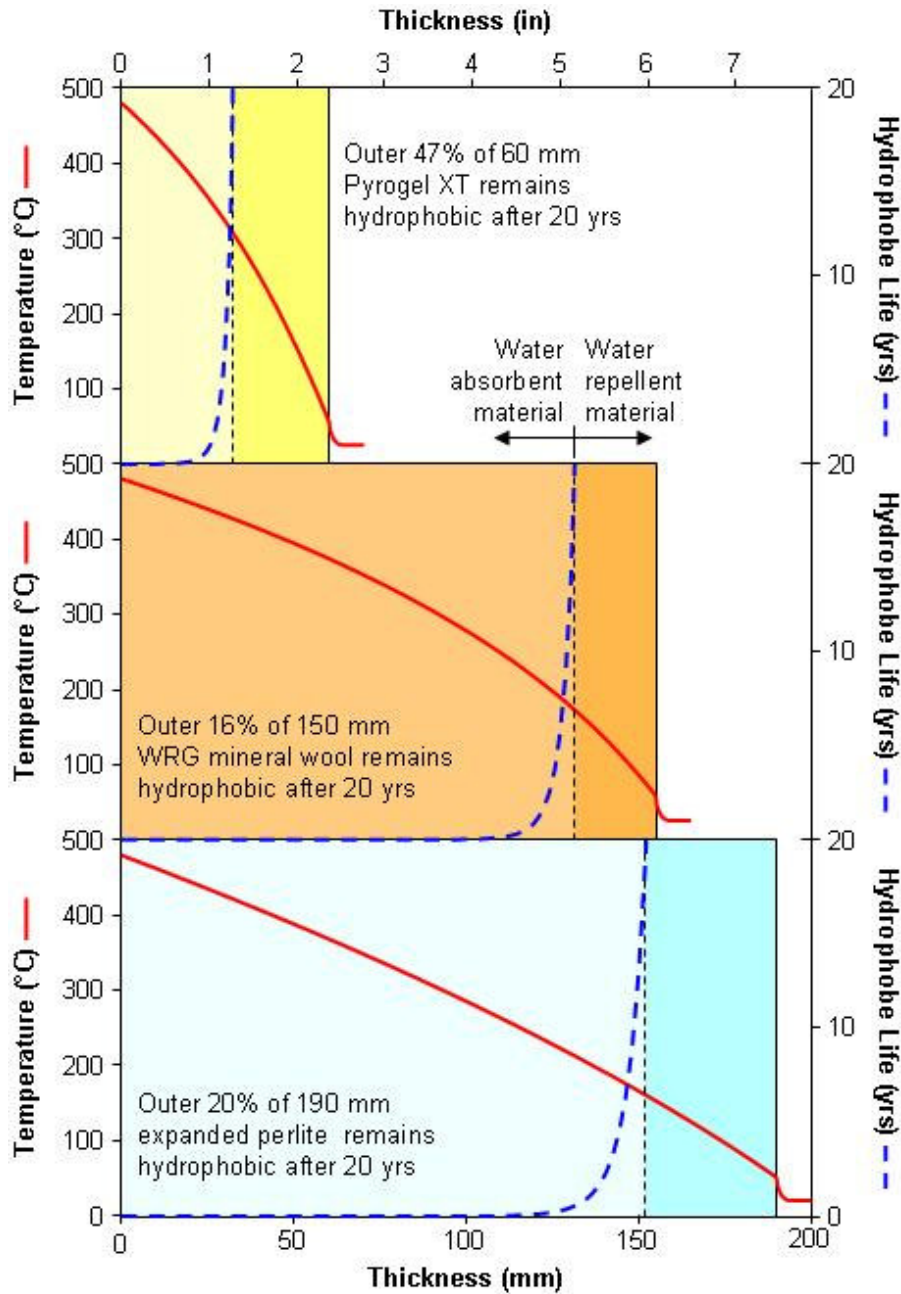
would be expected to become hydrophilic through the innermost 126 mm (84%). Expanded perlite would lose 152 mm (80%) of its water repellency. Pyrogel XT would lose only the inner 32 mm (53%) of hydrophobicity.

Figure 9: Illustration of hydrophobe burnout on a delayed coker unit. All three insulations begin their service life with the same thermal efficiency.

For example, a delayed coker unit cycling between 480 and 93°C (900 to 200°F) could be insulated with 150 mm (6 in) of WRG mineral wool, 60 mm (2.4 in) of Pyrogel XT, or 190 mm (7.5 in) of expanded perlite. Because of the high service temperature, any organic constituents (e.g., hydrophobe, mineral wool binders) near the hot-face will quickly oxidize and burn out. The depth of the burn-out region is dependent on the volatility of those organics and the shape of the material's thermal conductivity curve. This is illustrated in Figure 9, where the mineral wool

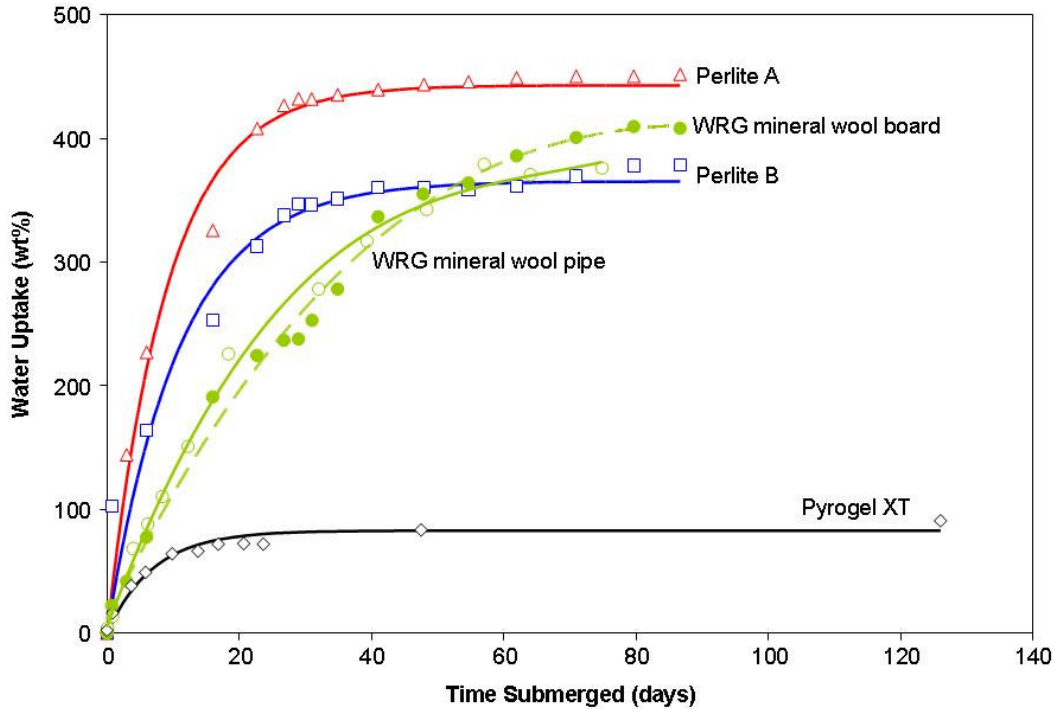
Figure 10: Water uptake vs. time submerged under 127 mm (5 in.) of water.

Given sufficient time and water pressure (e.g., flooded conditions), even hydrophobic insulation materials can become saturated. To assess the performance of various materials under these extreme conditions, a modified version of ASTM C1511 (refer to Figure 6) was employed whereby the coupons were left submerged for as long as 17 weeks rather than the specified 15 minutes. Typical results for hydrophobic materials are shown in Figure 10. For wetting materials, saturation is reached too rapidly to be shown on such a long axis, but the maximum water uptake values measured for all materials are given in Table 1.

However, the results in Figure 10 and Table 1 don't tell the whole story because the "weight-percent" metric obscures the fact that different materials have different densities and thicknesses and, therefore, different starting or "dry" weights. Take for example, a 3" pipe operating at 105°C (220°F), typical of condensate service and squarely in the heart of the CUI danger zone. A typical facility might insulate this piping with one of the materials illustrated in Figure 11. If that line is located in a trench that sees winter flooding, what would the post-flooding water uptake look like for each of these materials? The answer is shown in Figure 12, which charts the dry weight, wet weight, and total weight for each of the various insulation materials.

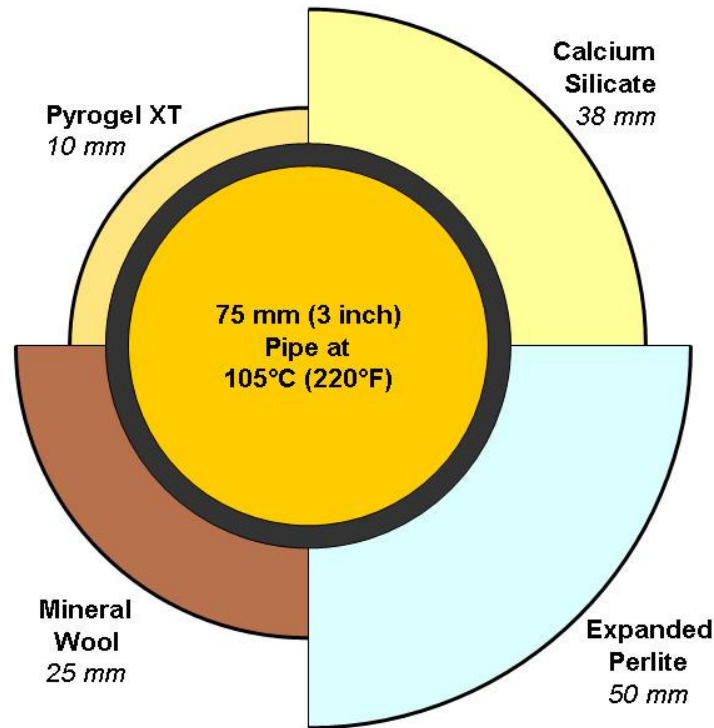
Figure 11: Thermally equivalent insulation thicknesses on a typical condensate line.

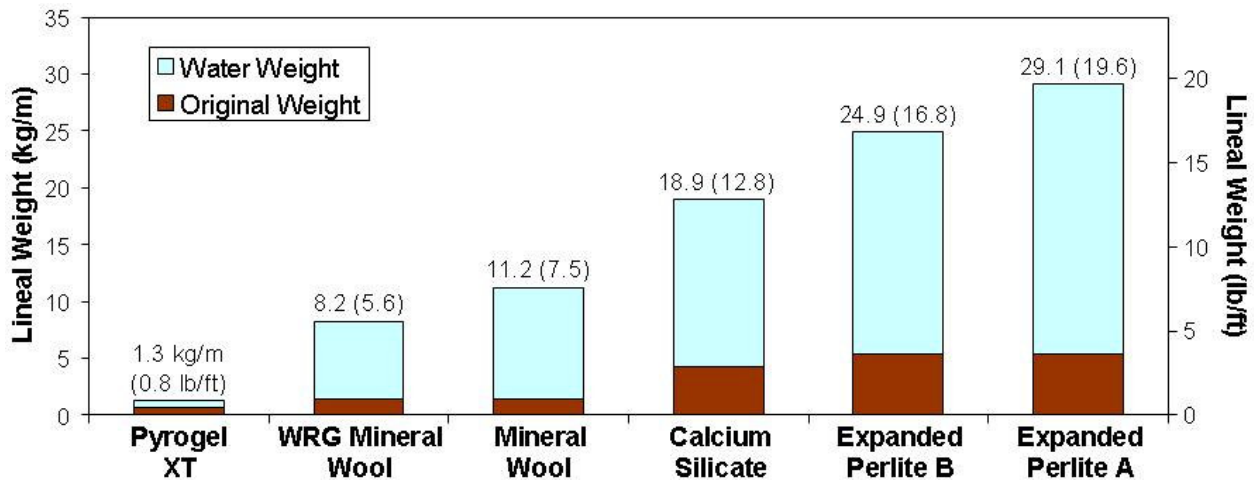
Figure 12: Water uptake at 100% saturation for the 75 mm (3 in.) pipe example. Total weight (wet + dry) is noted above each column.

The potential for dramatic weight increase raises a number of issues for the designer. The first is structural. Shoe spacing for a 3” condensate line would typically be based on the lineal weight when the line is full – 17.4 kg/m (11.7 lb/ft) – plus the dry weight of the insulation. In a post-flooding scenario, water uptake can exceed the design weight value by as little as 3% for Pyrogel XT, or as much as 104% for one brand of expanded perlite. The additional weight, if unaccounted for, could potentially overstress the pipe, shoes and surrounding structure.

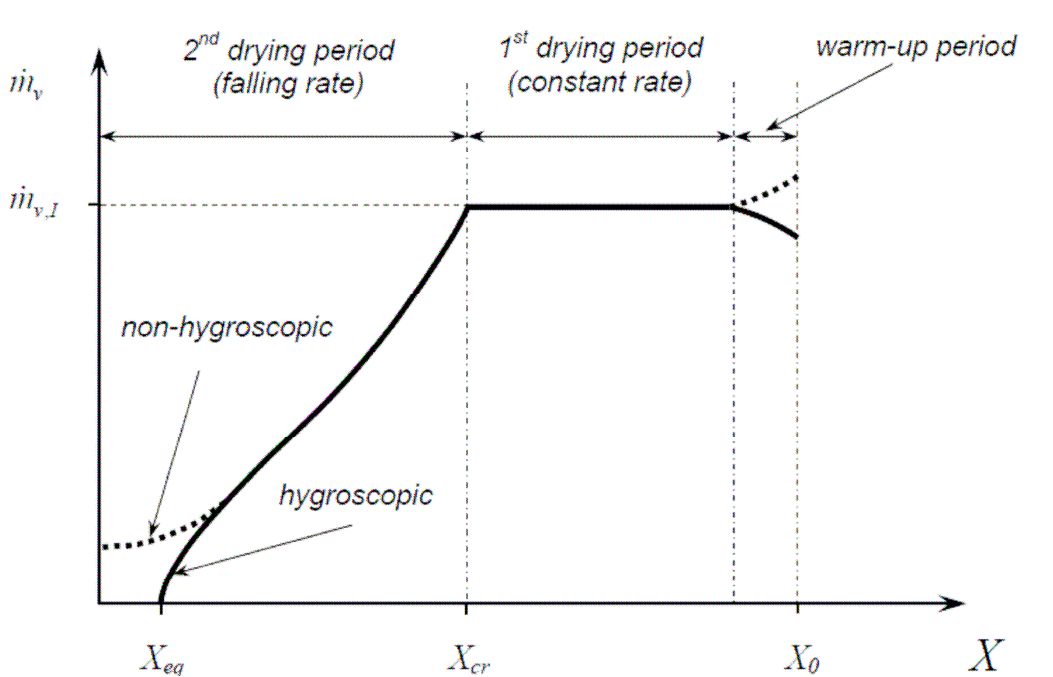
Figure 13: An idealized drying rate curve indicating two regions of drying behavior.¹⁵

Drying-rate curves for porous materials generally exhibit two distinct regions of behavior. Figure 13 illustrates the relationship between water content (X) and drying rate (\dot{m}_v) for a non-reacting porous solid. The first drying region occurs after a brief warm-up period, when moisture is removed at a constant rate because a film of liquid water persistently exists at the surface of the material. Because the surface mass transfer rate is the controlling resistance, the drying rate during this period is independent of material type. At a certain critical moisture content (X_{cr}), the drying rate begins to fall as the material’s internal transport mechanisms begin to dominate the overall resistance to mass transfer. During this period, the surface of the material becomes partially unsaturated until it reaches the equilibrium moisture content (X_{eq}) for that specific drying condition (i.e., temperature, RH, air velocity).

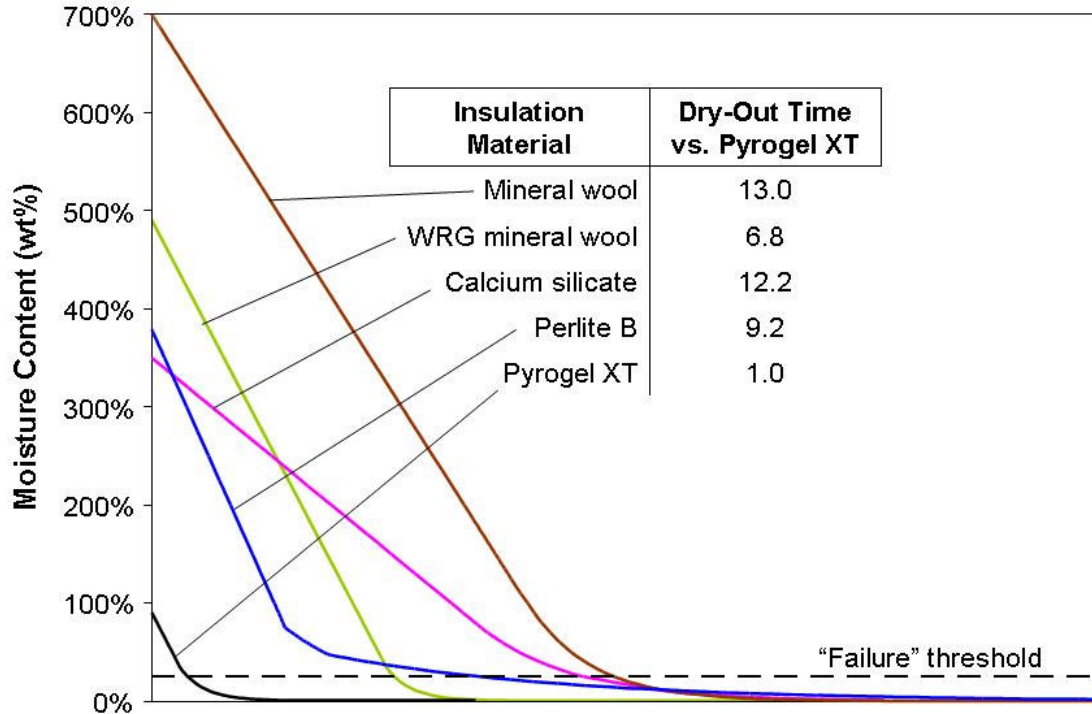
Figure 14: Relative drying curves vs. arbitrary units of time for post-saturation insulations.

where M_s is the material mass, A is the surface area, and N is the drying rate. Although absolute drying times are highly specific to actual drying conditions, the *relative* drying times among materials exposed to similar environment will be fairly consistent. Figure 14 illustrates just this, plotting the various material drying curves against arbitrary units of time. This shows that mineral wool is the slowest material to dry, while Pyrogel XT is the fastest. The spread between the two is such that if it takes Pyrogel XT one day to dry, an equivalent thickness of mineral wool would require 13.0 days. Beyond Pyrogel XT, WRG mineral wool is the next fastest to dry (6.8 days to every one for Pyrogel), followed by perlite B (9.2-to-1), and calcium silicate (12.2-to-1).

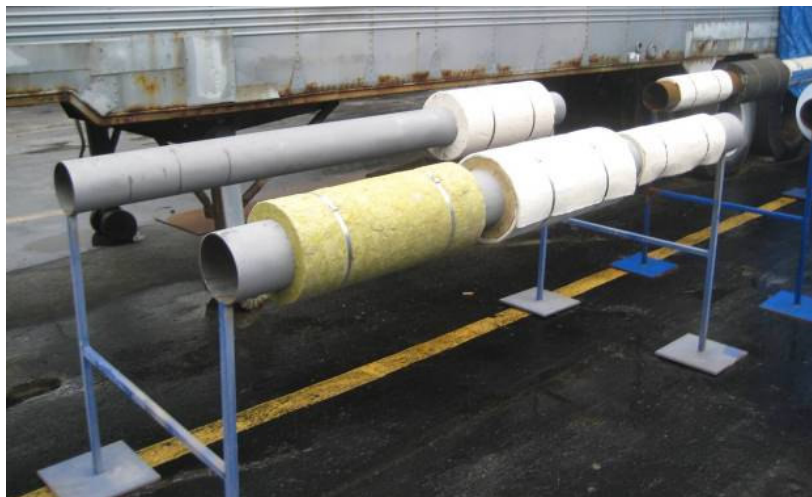
Figure 15: Outdoor pipe stands with the various insulation test sections.

A study was performed to gauge the level of corrosion that occurs beneath insulation materials on uncoated, carbon steel pipe when exposed to the elements. As pictured in Figure 15, two pipe stands, each with two 150 mm NPS x 2.4 m (6 in NPS x 8 ft) horizontal pipes, were placed outside in Northborough, MA, during the late spring and summer of 2009. Each pipe was covered with sections of insulation of various types, with each insulated section measuring 600 mm (2 ft) long and separated by 150 mm (6 in) of bare steel. Each of the insulation sections were fastened onto the pipe with two 13 mm (1/2 in) stainless steel bands.

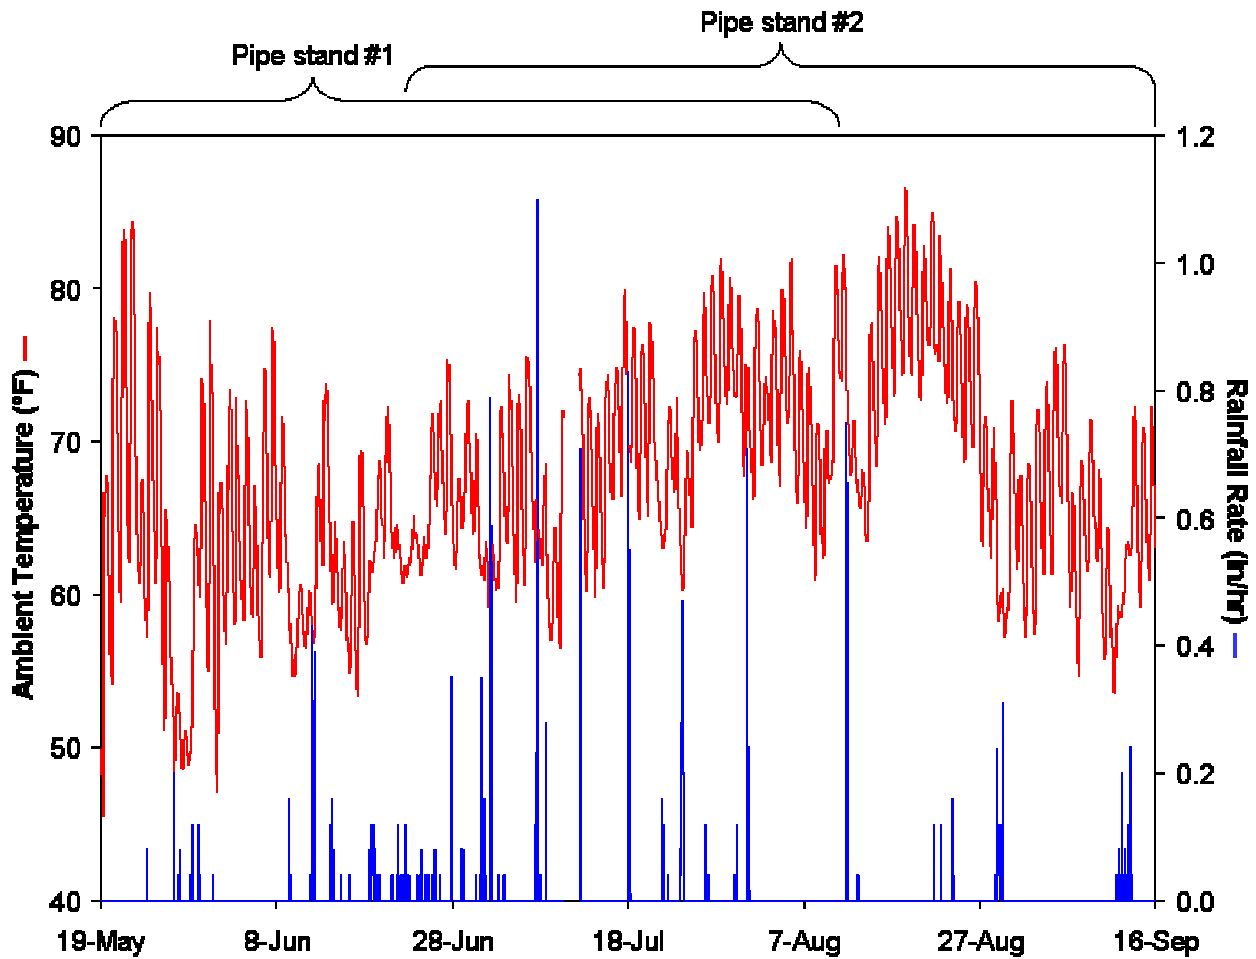
Figure 16: Meteorological data for Northborough, MA, from 19-May to 16-Sept., 2009.

The period of exposure occurred during one of New England’s wettest summers on record. As shown in Table 4, each pipe stand experienced dozens of precipitation events and 42-46 cm (16.5-18.0 in) of total rainfall. The mean time between precipitation events, or dry-out period, averaged just over two days. The rainfall and temperature pattern during this time is plotted in Figure 16. Note that at no point did the ambient temperature drop below 0°C (32°F), so any degradation phenomena were clearly not the result of freeze-thaw mechanics.

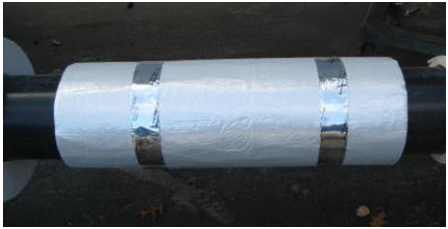
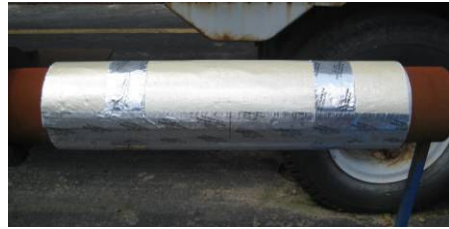
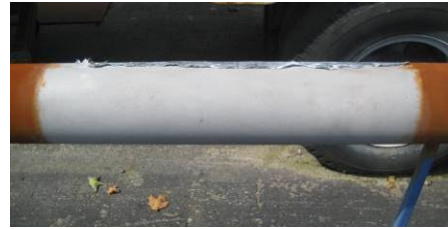
Observations	Day 1	Day 84	Day 84, insulation removed
<p>Cryogel Z <i>No corrosion</i></p>

The Cryogel Z area was the cleanest of all the test sections, with no visible corrosion beneath the insulation. This was as expected because the factory-applied mylar vapor barrier provided an impermeable rain screen. The only possible route of water ingress was via the edges, but that was effectively shut off by the aerogel's natural hydrophobicity, and its ability to be wrapped tightly with no gaps. The only exception to this was the small area where the second layer of material lapped over the first, leaving a small triangular tunnel between the insulation and the pipe. At that location, a small amount (6 cm^2 , or 1 in^2) of edge corrosion is seen on either side of the test section.

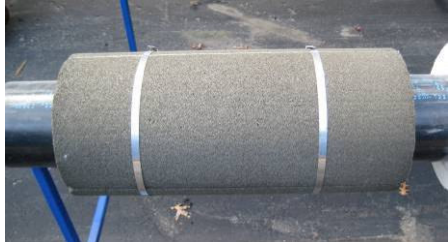
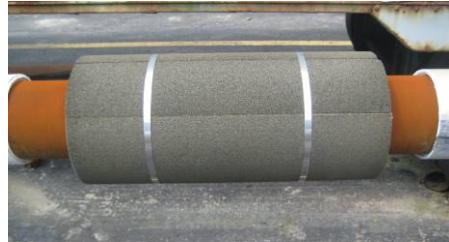
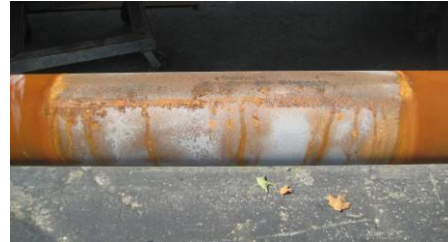
<p>Cellular Glass <i>Heavy general corrosion, concentrated at the top of the pipe</i></p>

The pipe beneath the cellular glass insulation showed the highest level of CUI. The corrosion was concentrated most heavily at the *top* of the pipe, on either side of where the rainwater penetrated the vertical seam between the two half-shells, as pictured in Figure 17. The most likely explanation for this phenomenon is that a small volume of rainwater, upon entering the system, becomes trapped within a thin, wedge-shaped space bounded by the pipe wall, the impermeable insulation material, and a thin meniscus (see Figure 17, inset).

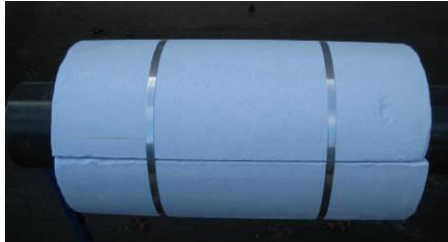
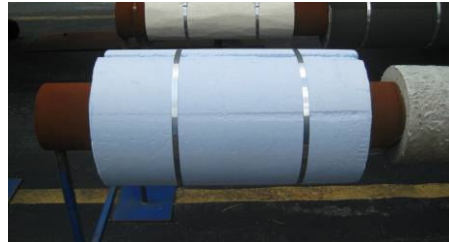
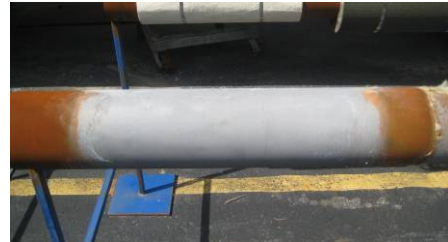
<p>Expanded Perlite <i>Very little corrosion observed except at 6:00 position, where water streaking occurred along the annular gap</i></p>

The expanded Perlite showed almost no corrosion after the insulation was removed. The only area that showed any significant rust was a thin line running along the 6-o'clock position. Here, rainwater would enter from the side following a slight grade, and run along the bottom of the pipe, through the annular space. Otherwise the surface was nearly pristine after 84 days of continuous exposure, owing primarily to this material's intrinsic hydrophobicity.

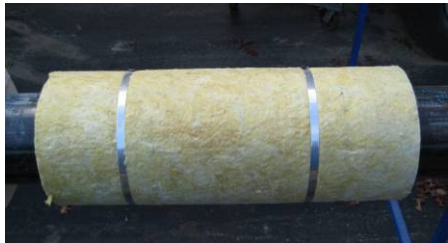
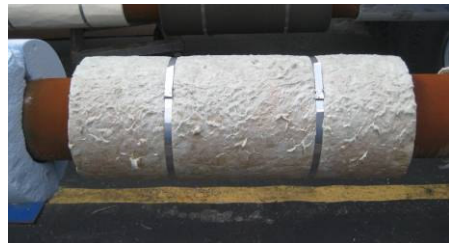
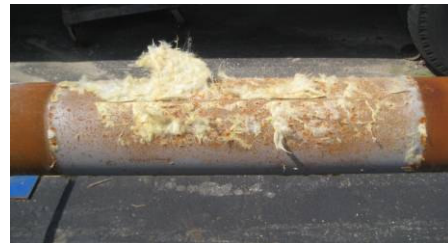
<p>Mineral Wool <i>Moderate corrosion over top one-third. Material was damp to the touch upon removal.</i></p>

After 84 days of direct exposure to the elements, the surface of the mineral wool insulation was quite weathered and the material was damp to the touch. Upon removal, the surface corrosion was observed to be concentrated on the top of the pipe. Here the mechanism is slightly different than with the cellular glass. Rather than forming a wedge shaped space for water to reside in, the fiber simply absorbed the rainfall and thereby provided a nearly constant source of water to the pipe's upper surface, despite periodic dry-out periods.

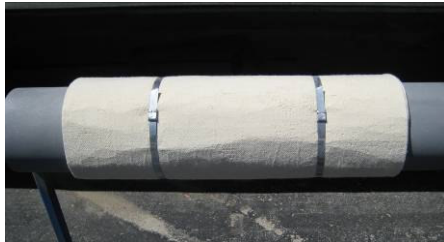
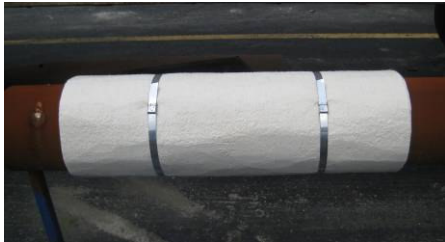
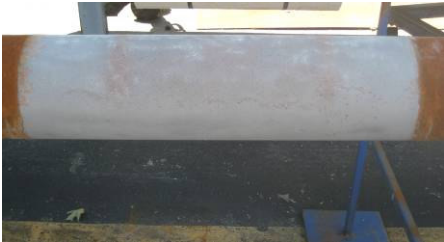
Observations	Day 1	Day 85	Day 85, insulation removed
<p>Pyrogel XT <i>No corrosion observed except for a thin area directly beneath the two clamp bands</i></p>

Pyrogel XT showed very little evidence of corrosion upon removal from the pipe. The only areas of discoloration were mild and were concentrated at the top of the pipe, directly beneath each of the bands.

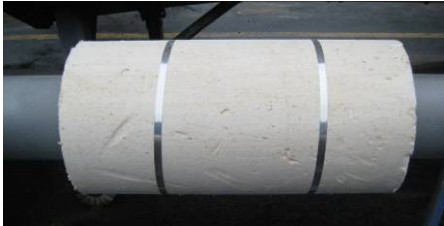
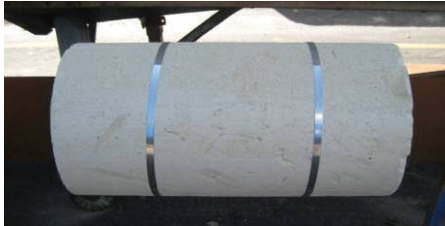
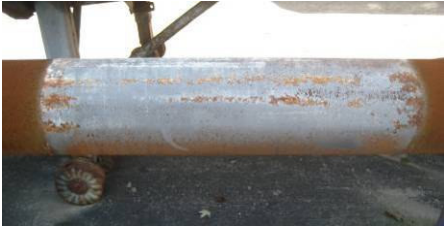
<p>Calcium Silicate <i>Heavy corrosion on top and bottom. 157% water uptake measured upon removal.</i></p>

Over the 85-day exposure, the calcium silicate – which had begun at a weight of 6.3 kg (14 lbs) – had absorbed an additional 10.0 kg (22 lbs) of water, for a final water uptake of 157%. The pipe surface under the calcium silicate had also taken on an unusual rust pattern. It had significant corrosion along the bottom one-third (roughly 4-o'clock to 8-o'clock) of the pipe. While this was the opposite of the corrosion pattern of the cellular glass, it should be noted that the fit between the calcium silicate and the pipe was much tighter. Also, because the calcium silicate is porous, absorbed water would naturally tend to congregate near the bottom of the pipe.

There were also four longitudinal bands of corrosion along the top of the pipe (see picture in Table 6). Although high spots along the insulation ID are suspected, the magnitude was smaller than could be resolved with the naked eye, so the reasons for the patterning remain unresolved.

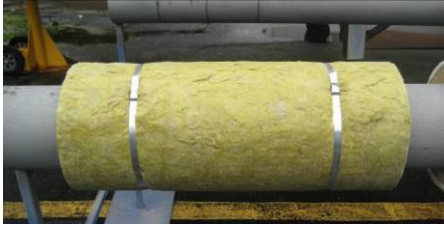
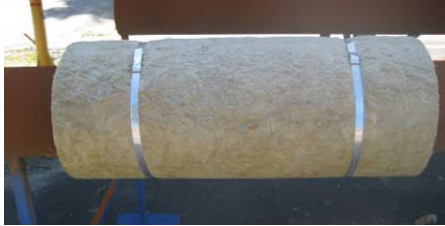
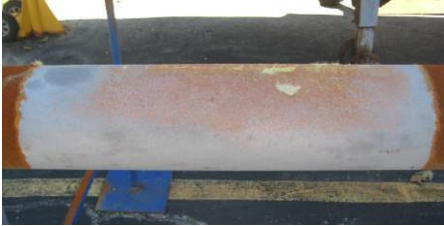
<p>WRG Mineral Wool <i>Some corrosion on top of pipe. Material was discolored after several weeks' exposure.</i></p>

Water-repellent mineral wool performed much better than untreated mineral wool, but still showed some mild corrosion along the top one-third of the pipe. The color of the material changed significantly over the course of the test, possibly indicating some sort of chemical change in the binder.

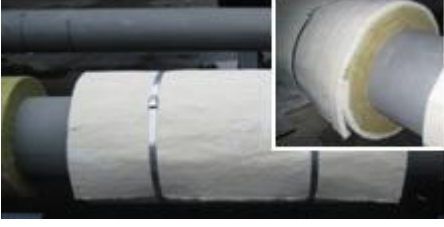
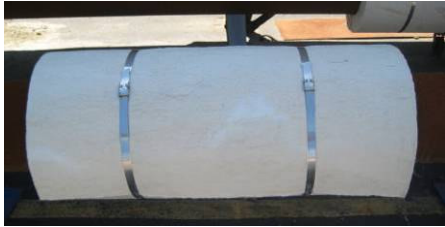
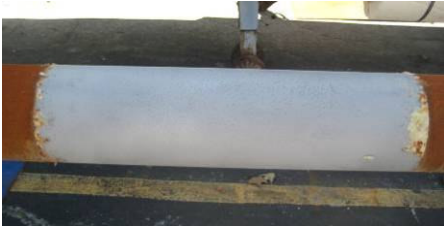
<p>Pyrogel XT over Mineral Wool <i>No evidence of corrosion on the pipe, or water uptake by the mineral wool.</i></p>

The composite design of Pyrogel XT over mineral showed zero evidence of corrosion after 85 days, and the mineral wool had not absorbed any water. Note that this result validates the findings of previous laboratory experiments done by a major oil company in The Netherlands. That study found that, of eight different pipe insulation systems exposed to 80°C (176°F) process temperatures and a constant salt-water drip, only Pyrogel XT and Pyrogel XT over mineral wool were found to be free of corrosion after 90 days.

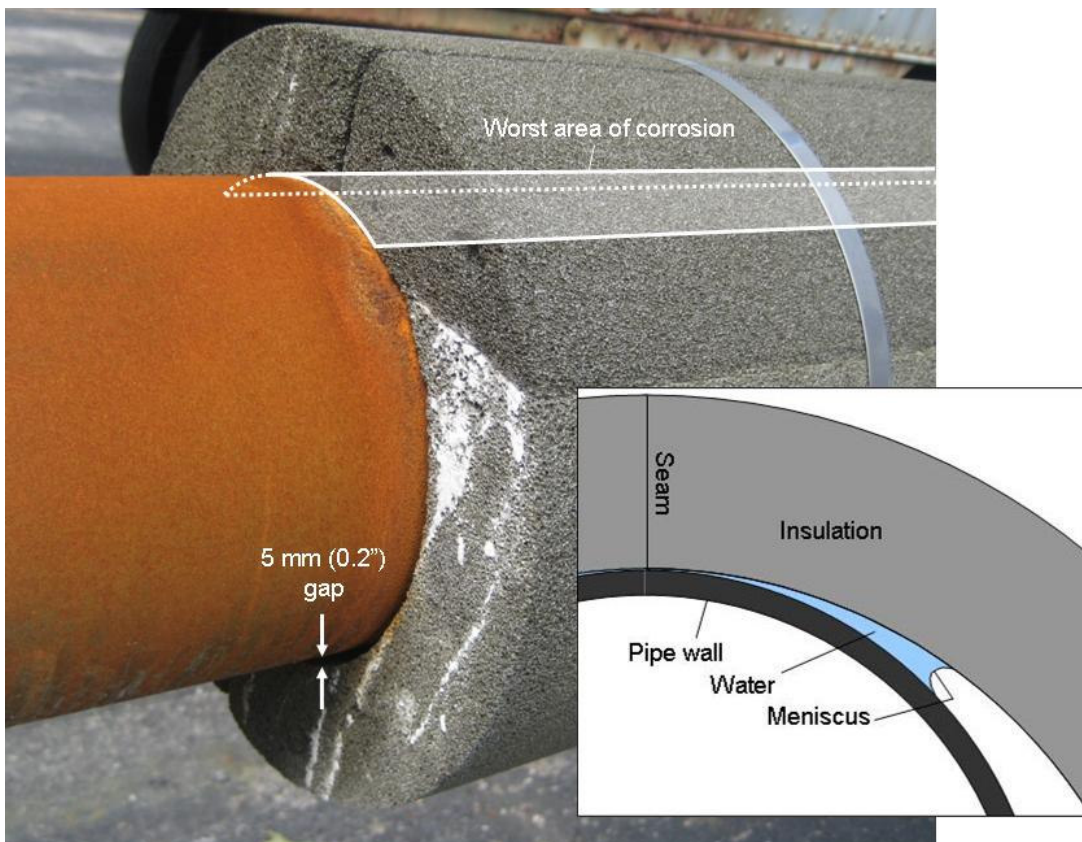
Figure 17: Area of worst corrosion under cellular glass.

This phenomenon illustrates the double-edged sword of using closed-cell materials like cellular glass in hot work. Because they shut off the natural pathways for liquid- and vapor-phase migration, they're nearly as effective at keeping water in as they are at keeping it out.
