CORROSION FAILURE IN A LINED SOUR GAS PIPELINE - PART 2: ROLE OF METHANOL IN CORROSION BEHIND LINER

R. MacDonald
Shell Canada Energy
Calgary, Alberta

As part of a recent failure investigation on a lined sour gas pipeline (Refer to Corrosion Failure in a Lined Sour Gas Pipeline Part 1: Case History of Incident), the corrosion mechanism was key to understanding why this failure occurred, and provided important information on how to manage the internal corrosion threat in other pipelines. In addition to the failure analysis and comparison of attributes on other lined pipelines, corrosion tests were performed in order to understand the corrosion mechanism. The corrosion testing helped to determine the failure cause and also supported the revision of integrity reference plans for existing and new lined sour gas pipelines. The role of methanol in the corrosion process that led to this internal corrosion failure in a lined sour gas pipeline is described. The presence of formic acid is considered as a possible minor contributor to the corrosion experienced in the Screwdriver Creek Pipeline (SC pipeline), but not essential to the main threat of methanol with the sour gas.

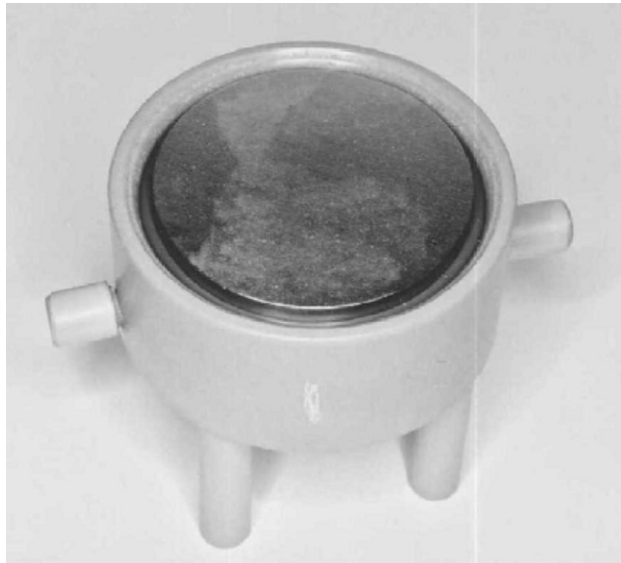
FIGURE 2 - Bare Corrosion Coupon in Holder

The test program was designed to address several scenarios that may give insight to the probable corrosion mechanism(s) that led to the pipeline failure. Some tests were conducted using bare carbon steel coupons (Figure 2) and others were conducted using lined carbon steel coupons (Figure 3).

A specially designed flat, disc-like coupon (C1018 carbon steel) was employed and fitted in a custom-made holder. A 600-grit polished finish was applied to the coupon. The coupon was cleaned in an ultrasonic bath using a sequence of methanol and acetone. Following the test the coupon was cleaned and weighed. Corrosion rate was calculated based on weight loss data.

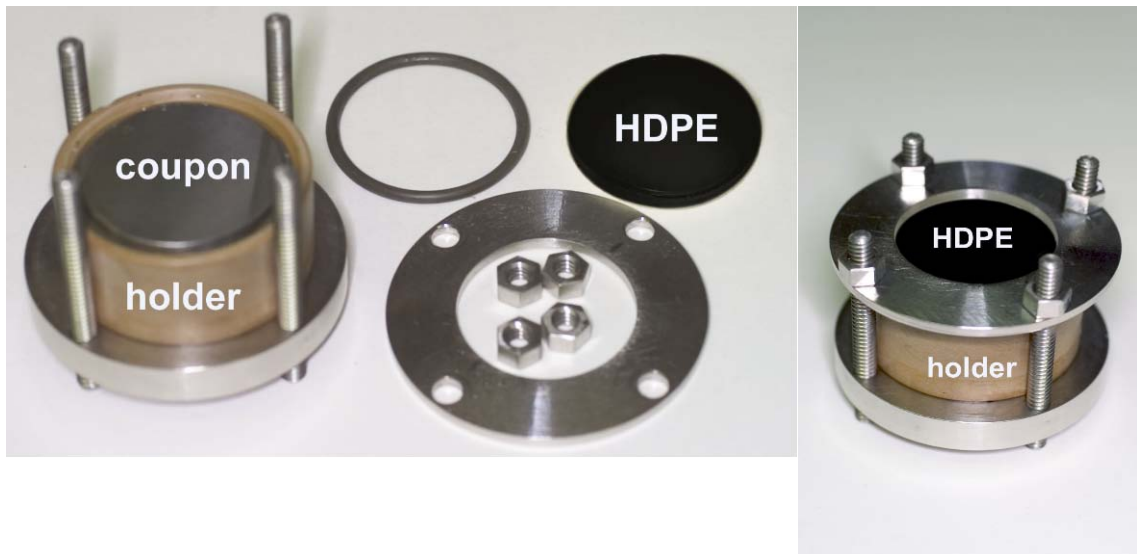
FIGURE 3 - Setup used for corrosion tests in which HDPE was placed on the top of carbon steel surface

For the tests conducted on the lined carbon steel coupons; a piece of 'grooved' HDPE was placed on the top of the coupon surface and tightly clamped to reflect the design of a lined pipeline. Following the tests, the coupons were cleaned and weighed as described earlier. Figure 3 shows the setup in detail. For the tests simulating the breached liner scenario, a hole was made in the center of the liner sample.

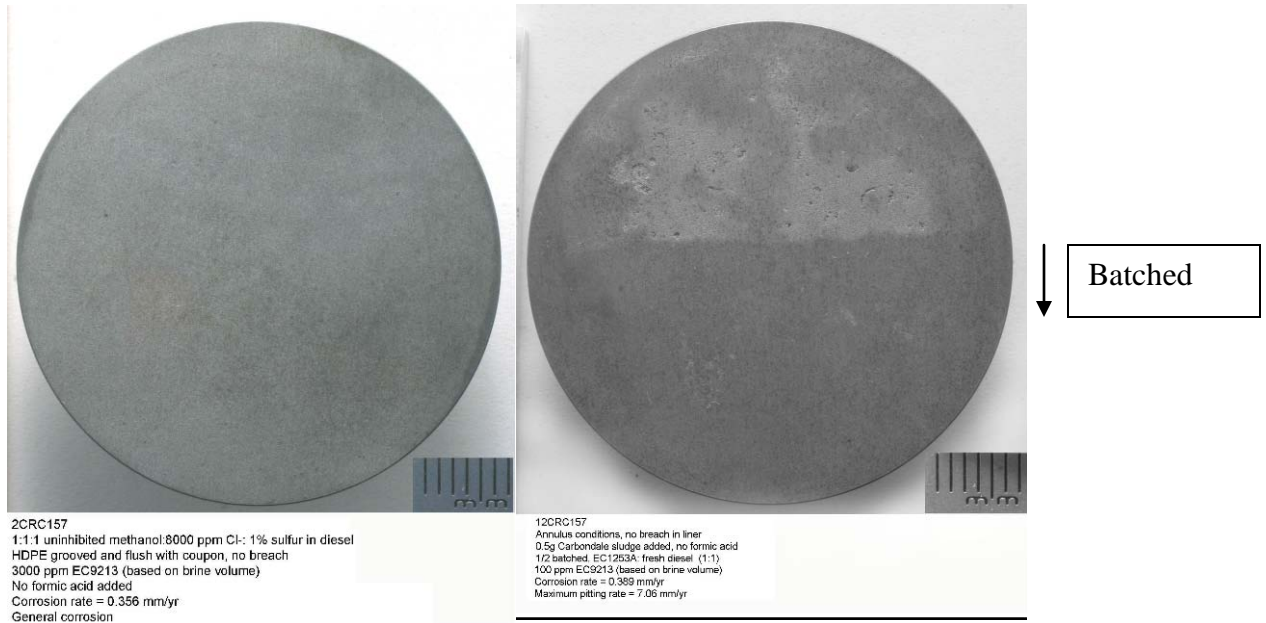
FIGURE 4 (left) - Surface morphology of a coupon exposed to pipeline conditions (Test #1)

FIGURE 5 (right) - Surface morphology of a coupon exposed to pipeline conditions (Test #3)

- without non-protective scale present, no pitting was observed (Figure 4)
- the test with the non-protective scale (Figure 5) from the SC pipeline showed pitting and corrosion damage similar in appearance to that which occurred at the failure location
- the test with the non-protective scale from the SC pipeline shows corrosion product that is predominantly mackinawite iron sulphide species.
- pitting corrosion was only observed where there had been no batch inhibitor applied to the coupon.
- the addition of a small amount of formic acid to the mix, increased the pitting corrosion rate in the non-protective scale from the pipeline slightly.

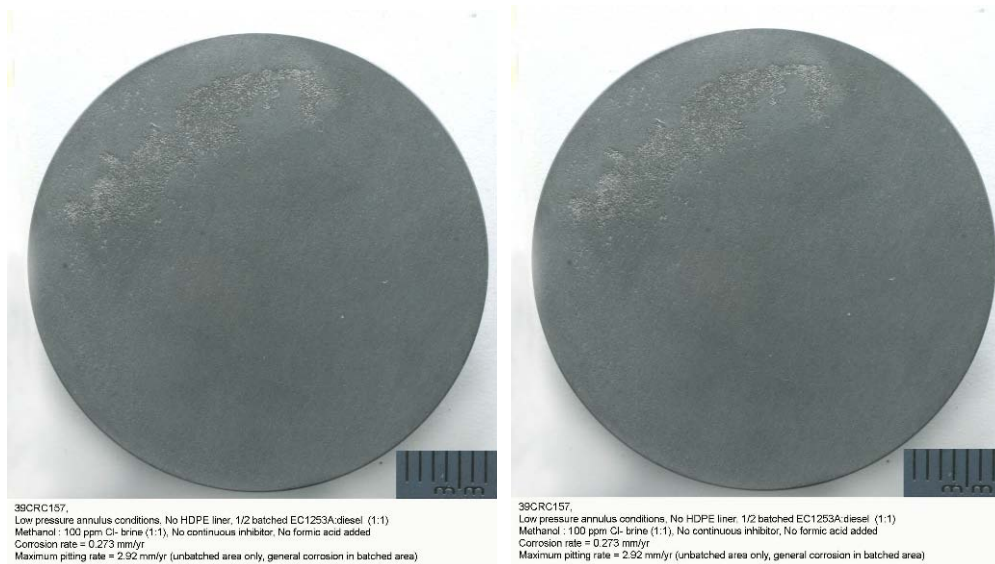
FIGURE 6 (left) - Surface morphology of a coupon exposed to low-pressure annulus conditions (Test # 5).

FIGURE 7 (right) - Surface morphology of a coupon exposed to high-pressure annulus conditions (Test # 9).

- 50% methanol-water mixtures were more corrosive than the 90% methanol-water mixtures under both pressures.
- The 50% methanol/water mixture showed pitting and corrosion damage similar in appearance to that which occurred at the failure location under both pressures (Figure 6)
- the results with 50% methanol/water mixture under high pressure show similar corrosion to the Case 1 tests with non-protective scale from the SC pipeline (Figure 7).
- pitting corrosion only occurs in the area on the coupon where no batch inhibitor was applied.

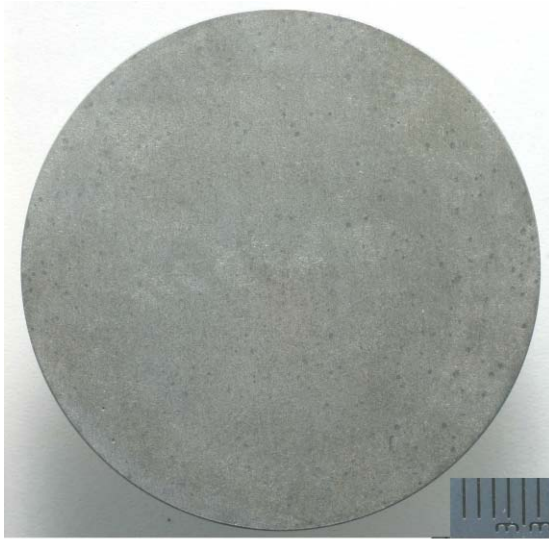
3CRC157
1:1:1 uninhibited methanol:8000 ppm Cl⁻: 1% sulfur in diesel
HDPE grooved with space between coupon and liner, breach in the liner
3000 ppm EC9213 (based on brine volume)
No formic acid added
Corrosion rate = 0.413 mm/yr
Maximum pitting rate = 4.02 mm/yr

FIGURE 8 (left) - Surface morphology of a coupon exposed to breached liner conditions (Test #15).

- For a breached liner condition, the corrosion rate was found to be similar to the unbreached liner condition. (Figure 8)
- The presence of 1000ppm formic acid caused a significant increase in the pitting corrosion rates (5X). (Figure 9)
- Pitting corrosion only occurs in the area on the coupon where no batch inhibitor was applied.
- The appearance of the corrosion in these tests was noticeably different than either the corrosion noted in connection with the SC pipeline failure or the corrosion in the Case I and Case II tests.

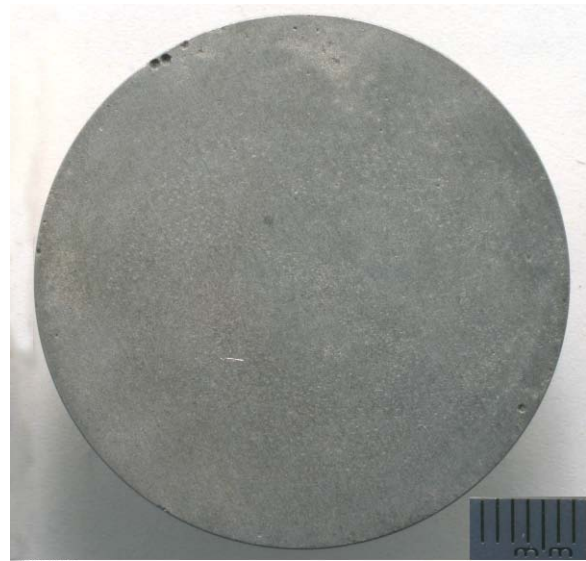
4CRC157
1:1:1 uninhibited methanol: 8000 ppm Cl⁻: 1% sulfur in diesel
HDPE grooved with space between coupon and liner, breach in the liner
3000 ppm EC9213 (based on brine volume)
1000 ppm formic acid added
Corrosion rate = 0.420 mm/yr
Maximum pitting rate = 21.1 mm/yr

FIGURE 9 (right) - Surface morphology of a coupon exposed to breached liner conditions in the presence of formic acid (Test # 16).
