**FROM TRAUMA TO TRANSCENDENCE:
CORROSION UNDER INSULATION**

Mike O'Donoghue PhD
Vijay Datta MS
&
Terry Aben MASc PEng

International Paint LLC
6001 Antoine Drive
Houston, Texas
USA, 77091

Copyright 2010 NACE International

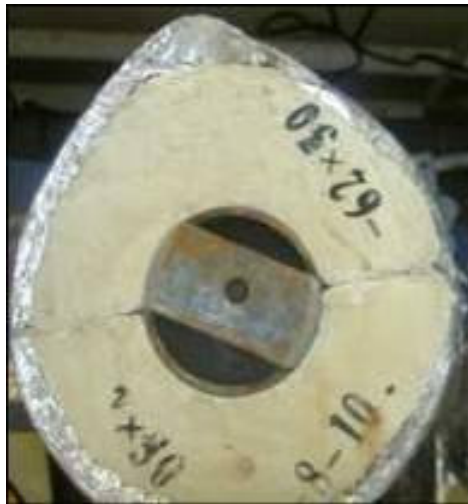
FIGURE 1 – End view of a Cyclic Pipe Test assembly showing the cross-sectional structure.

A new test method was developed, the Cyclic Pipe Test, where sections of steel pipe are abrasive blast cleaned to an SSPC-SP10 near white metal standard and then coated with the candidate coating by spray application (7). After curing for 7 days at 25°C (77°F) the coated pipe is then insulated with a 2-inch thick wrap of calcium silicate insulation and the exterior of the assembly sealed with aluminum foil. This construction simulates the worst case scenario for cladding and insulation used in industrial applications, as calcium silicate readily wicks moisture and can hold 20-40 times its weight in water. An end view of a cyclic pipe test assembly showing the cross-section structure is shown in Figure 1.

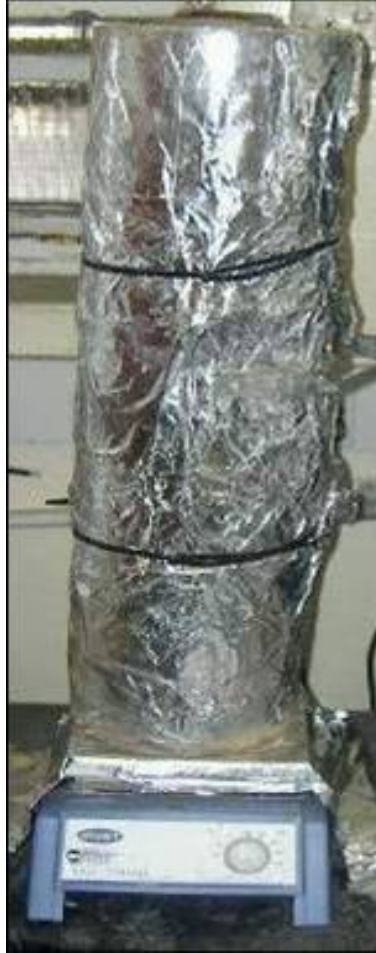
FIGURE 2 – View showing Cyclic Pipe Test Assembly placed on a hot plate for testing.

The accelerated exposure component of the test method consists of saturating the insulation with a solution of 1% sodium chloride. Once the insulation is thoroughly wetted, one end of the pipe assembly is heated on a hot plate to 450°C (852°F) for 8 hours, creating a temperature gradient along the length of the pipe down to 60°C at the opposite end of the pipe. (Figure 2). After the 8 hours is complete, the insulation is re-saturated with the salt solution, removed from the hot plate and allowed to cool under ambient conditions for 16 hours. This regime of exposure represents 1 cycle, which is graphically represented in Figure 3. In this study the coated and insulated pipe sections were exposed to 30 cycles before being evaluated for corrosion resistance.

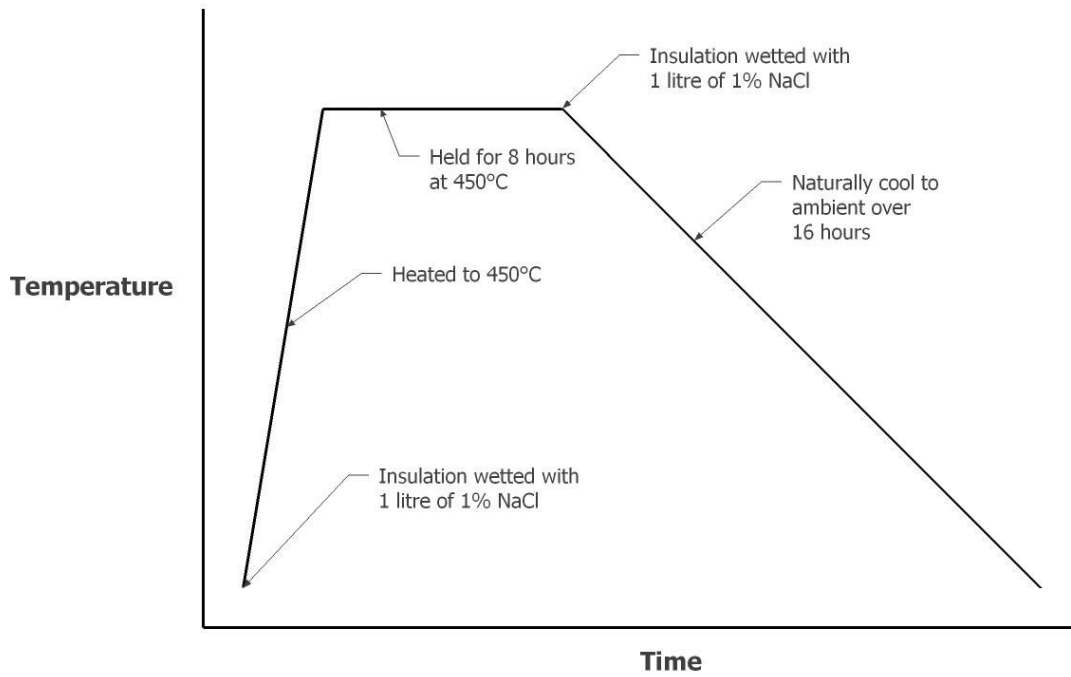
FIGURE 3 – Exposure cycle for Cyclic Pipe Test.

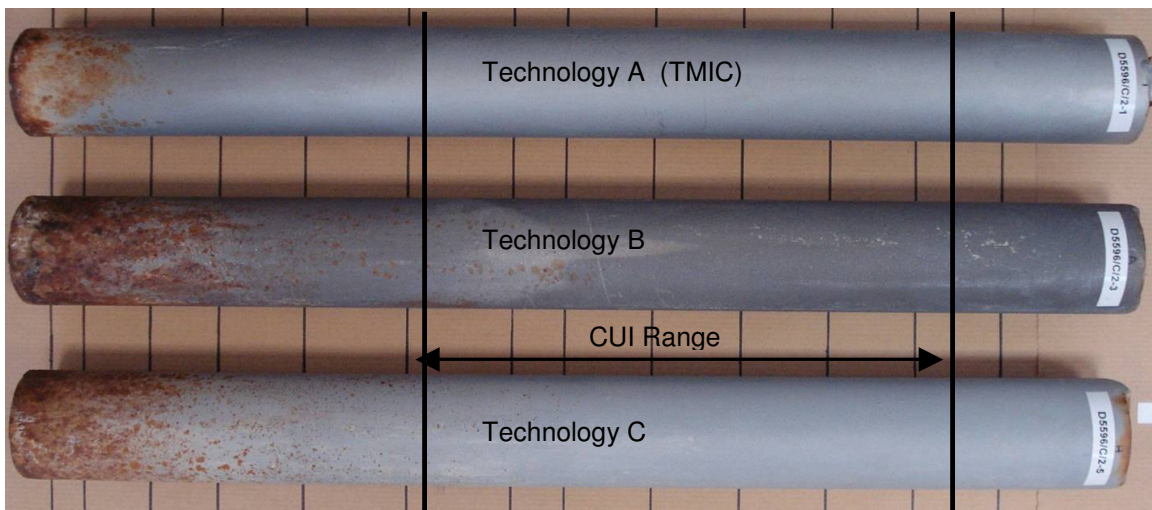
FIGURE 4 – End view of a Cyclic Pipe Test assembly showing the cross-sectional structure.

After each coating was subjected to 30 cycles of the Cyclic Pipe Test, the pipe assemblies were dismantled and the condition of the coating evaluated. Figure 4 shows a comparison of the condition of the three coatings after 30 cycles were completed. In the photo the maximum temperature exposure is at the left side (450°C), with the lowest temperature exposure (60°C) at the right side. For reference, the critical CUI temperature range is also indicated. Please note the corrosion on the left-hand end of the pipe was due to the pipe-end remaining uncoated during the test to provide thermal coupling between the hot plate and pipe sample. Therefore, the corrosion at the immediate pipe end is not considered within the evaluation. At first glance the performance of the Technology A (TMIC) does not appear to be much different in comparison to that of Technologies B and C. However, upon closer inspection significant performance was observed as outlined below.

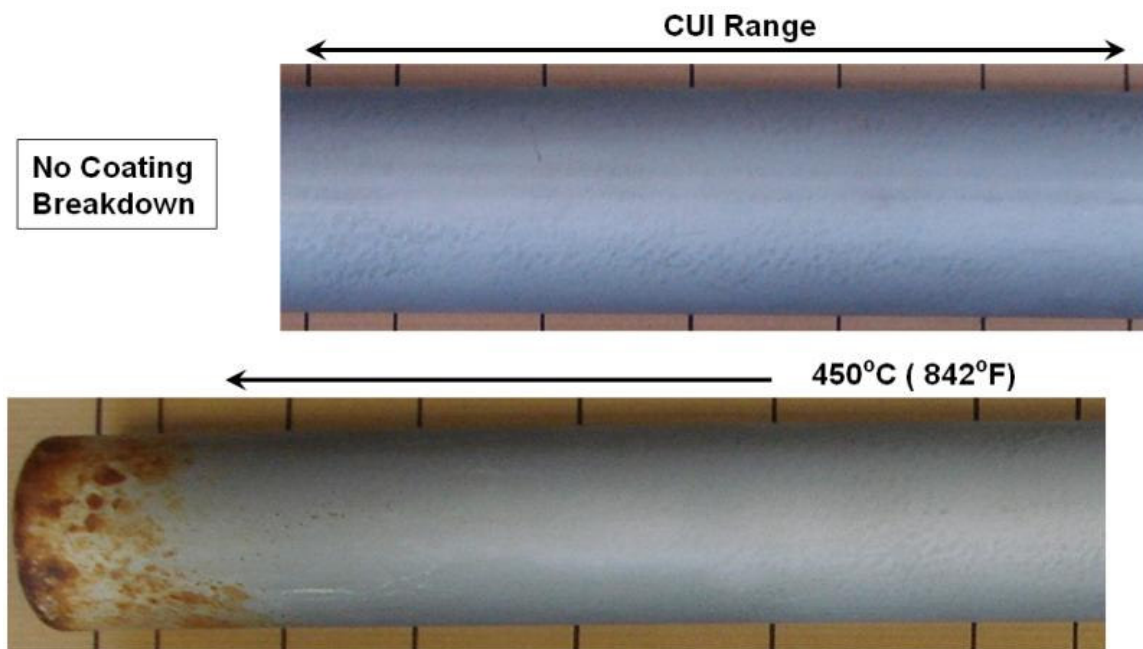
FIGURE 5 – Condition of Technology A after 30 exposure cycles.

Closer views of the coatings after test exposure are presented in Figures 5 through 10. It is noteworthy as evidenced by Figures 5 and 6 that Technology A (TMIC), did not exhibit breakdown within the CUI range. In addition, Technology A performed very well at the higher temperatures of 235 and 300°C.

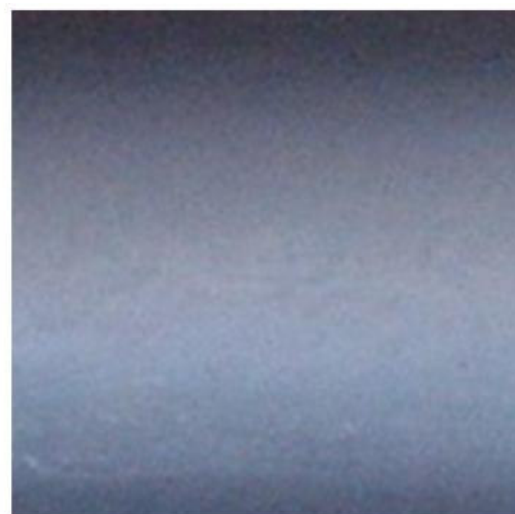
Temperature: 235°C (455°F)

**Temperature range: 275 to 300°C
(527 to 572°F)**

FIGURE 6 – Closer view of Figure 5 at specific temperatures.

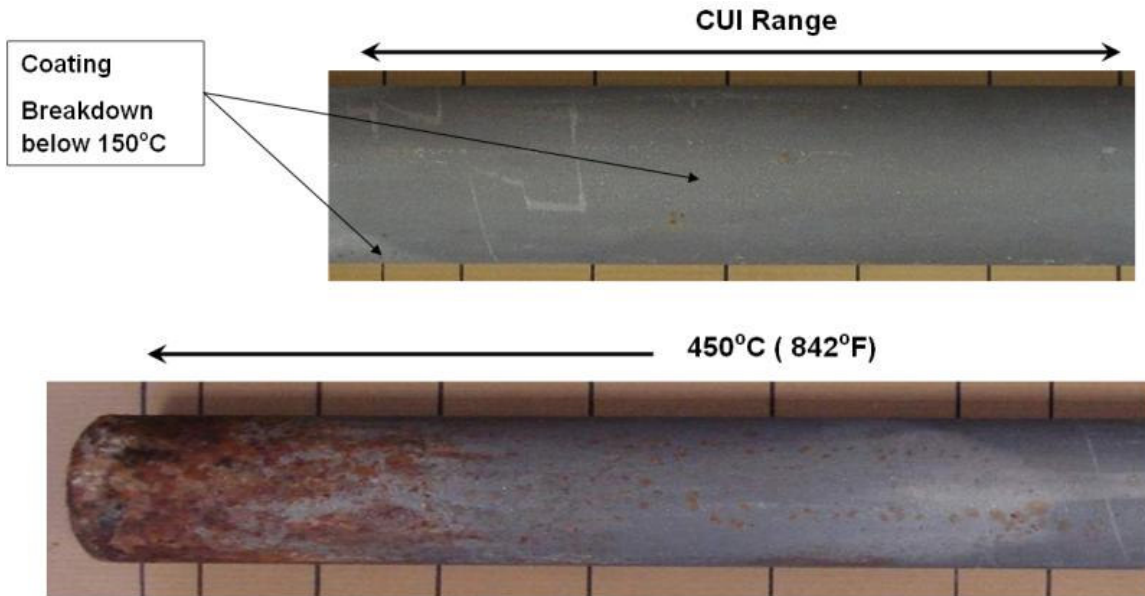
FIGURE 7 – Condition of Technology B after 30 exposure cycles.

Figures 7 and 8 show the test results of Technology B (inorganic polymer with MIO). Technology B exhibited small areas of rust development in the critical CUI temperature range, below 150°C. Further, it showed a marked coating breakdown at 235°C, and almost complete coating deterioration at 300°C. This indicated that increasing temperature exposure put additional stress on the coating.

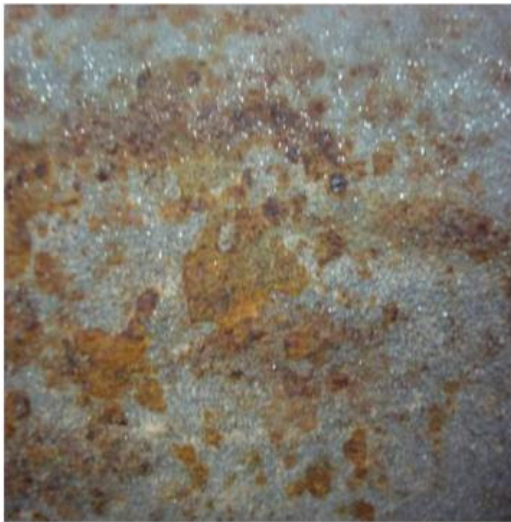
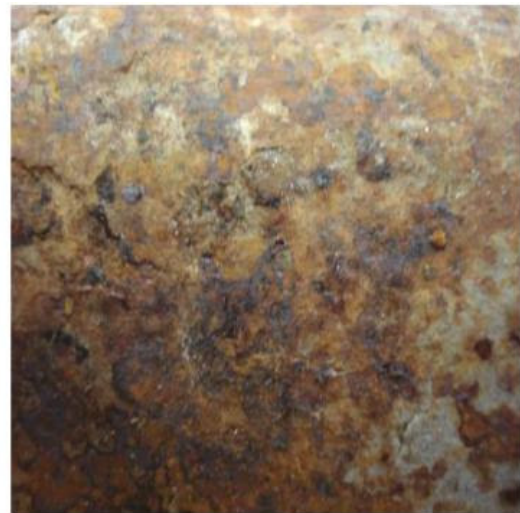
Temperature: 235°C (455°F)

**Temperature range: 275 to 300°C
(527 to 572°F)**

FIGURE 8 – Closer view of Figure 7 at specific temperatures.

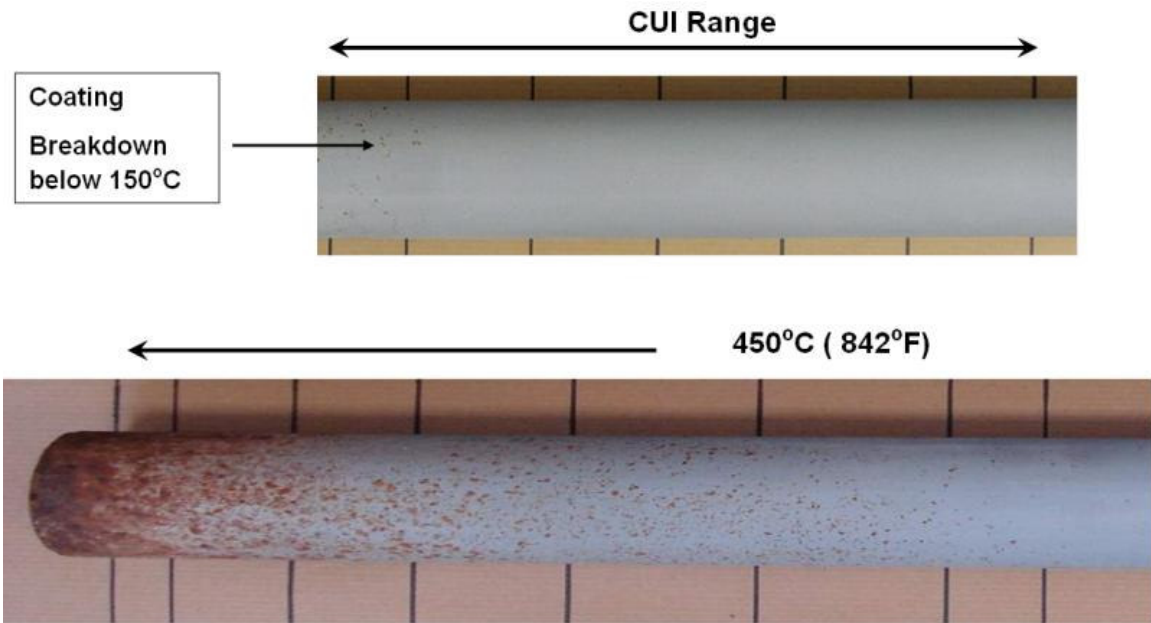
FIGURE 9 – Condition of Technology C after 30 exposure cycles.

The thermal stability and corrosion protection afforded by Technology C (modified silicone copolymer) is shown in Figures 9 and 10. It can be seen that Technology C exhibits

several spots of rust development below 150°C, within the critical CUI temperature range. Additionally, it shows pronounced rust breakthrough and staining at 300°C, and severe rust development at 235°C. This indicates that while the coating is temperature resistant, its protective barrier properties are limited under the conditions tried.

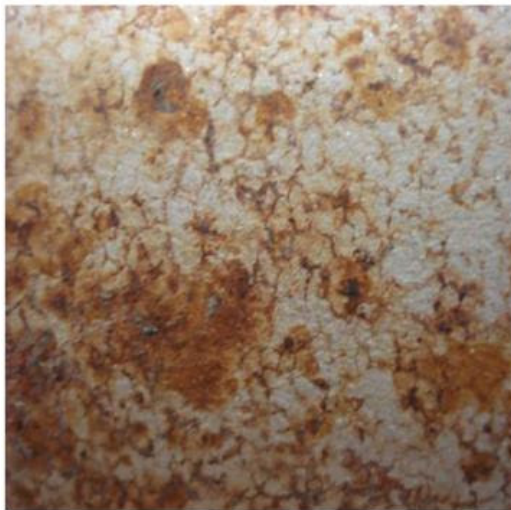
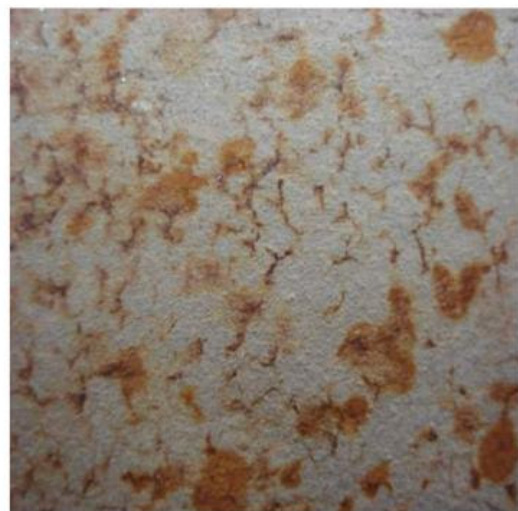
Temperature: 235°C (455°F)

Temperature range: 275 to 300°C (527 to 572°F)

FIGURE 10 – Closer view of Figure 9 at specific temperatures.

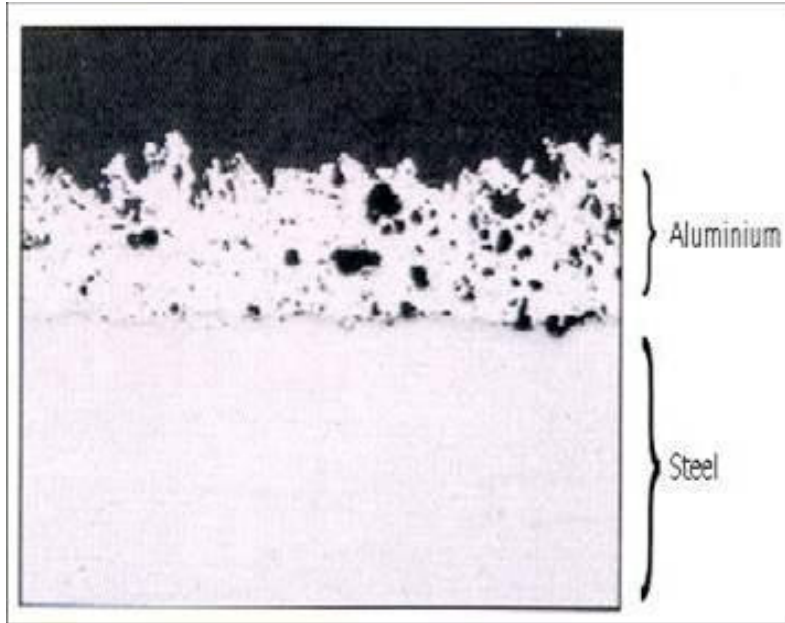
FIGURE 11 – Cross-section view of TSA showing porosity in the coating.

Notwithstanding, the impressive performance of TSA is only achieved with its proper application to properly prepared substrates. In actuality, TSA requires a minimum NACE No.1 / SSPC-SP5 white metal abrasive blast with a profile of 3.5 – 5.5 mils (85-135 microns). TSA also requires specialized application equipment and training to apply it correctly. Without tight application control, TSA can experience loss of adhesion, blistering and premature failure. So these factors make TSA far more suitable for application in controlled shop conditions for new construction projects. An important consideration is that plasma or electric-arc spray application methods needed to successfully apply TSA can also result in a porous coating structure that is likely the limiting factor on an anticipated 20 year plus service life. Certainly, without the coating porosity, even longer coating service life could be expected from TSA.

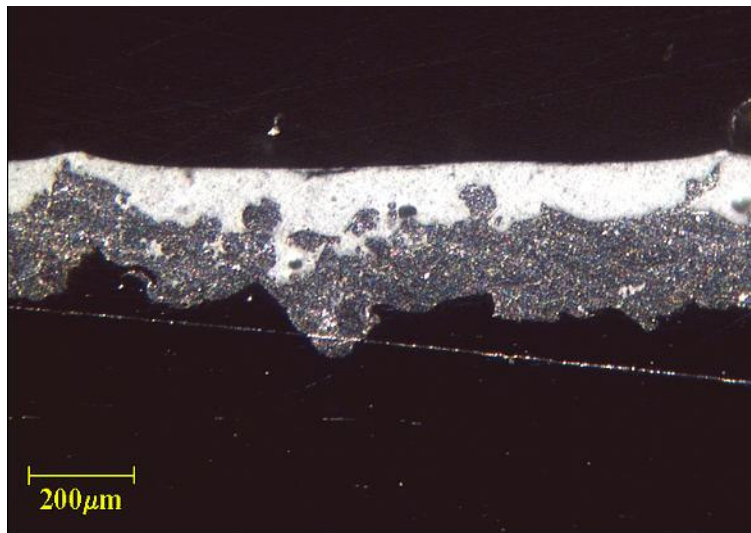
FIGURE 12 – Cross-section view of TSA sealed with a topcoat of TMIC.

Figure 12 presents a cross-section view of this transcendent solution, namely a TSA coating with the porosity sealed by a topcoat based on TMIC. The TSA coating applied at 6-8 mils (150-200 microns) is first “mist coated” with a thin layer of TMIC, equivalent to 1-2 mils (25-50 microns) DFT. The mist coat penetrates the TSA porosity and consolidates the matrix. Next a full barrier coating of TMIC is applied at 3-4 mils (75-100 microns) DFT to embed and seal the TSA. It should be noted that the application of the “mist” coat is a necessary and critical step. Without the mist coat, some porosity within the TSA would remain open and thus remain as potentially weak points that could suffer premature failure.

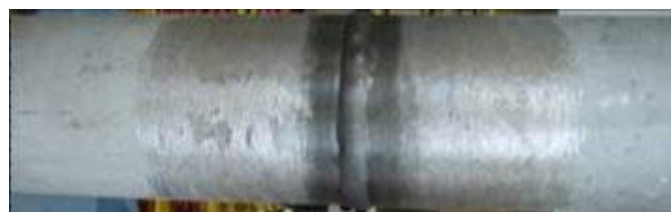
FIGURE 13 – TSA coated pipe with welded joint.

Supporting the combined use of TSA and TMIC is a laboratory evaluation for the weld repair of a TSA coated pipe. Two sections of the latter were welded together (Figure 13). The weld joint area was prepared to SSPC-SP11, power tool cleaning to bare metal (Figure 14) and then coated with TMIC (Figure 15). The pipe sample was then subjected to two 8 hour cycles of 400°C and examined (Figure 16). As can be seen, there is no identifiable degradation of the TMIC or TSA.

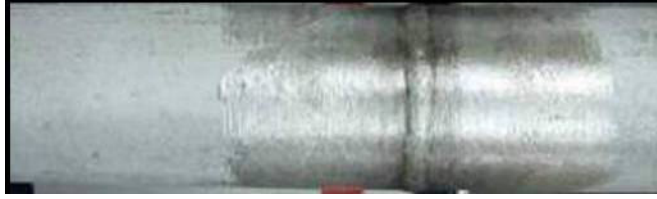
FIGURE 14 – Welded pipe joint after surface preparation to SSPC-SP11.

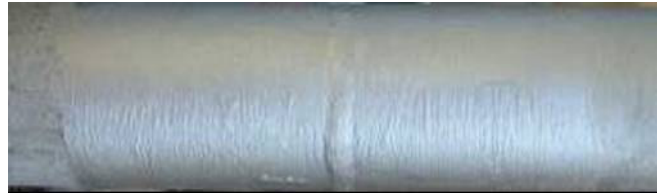
FIGURE 15 – Welded pipe joint after application of TMIC over bare steel and TSA.

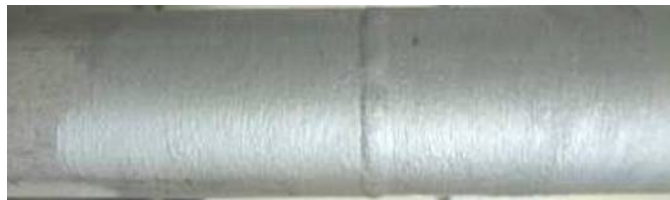
FIGURE 16 – Evaluation of TMIC and TSA after thermal cycle exposure.

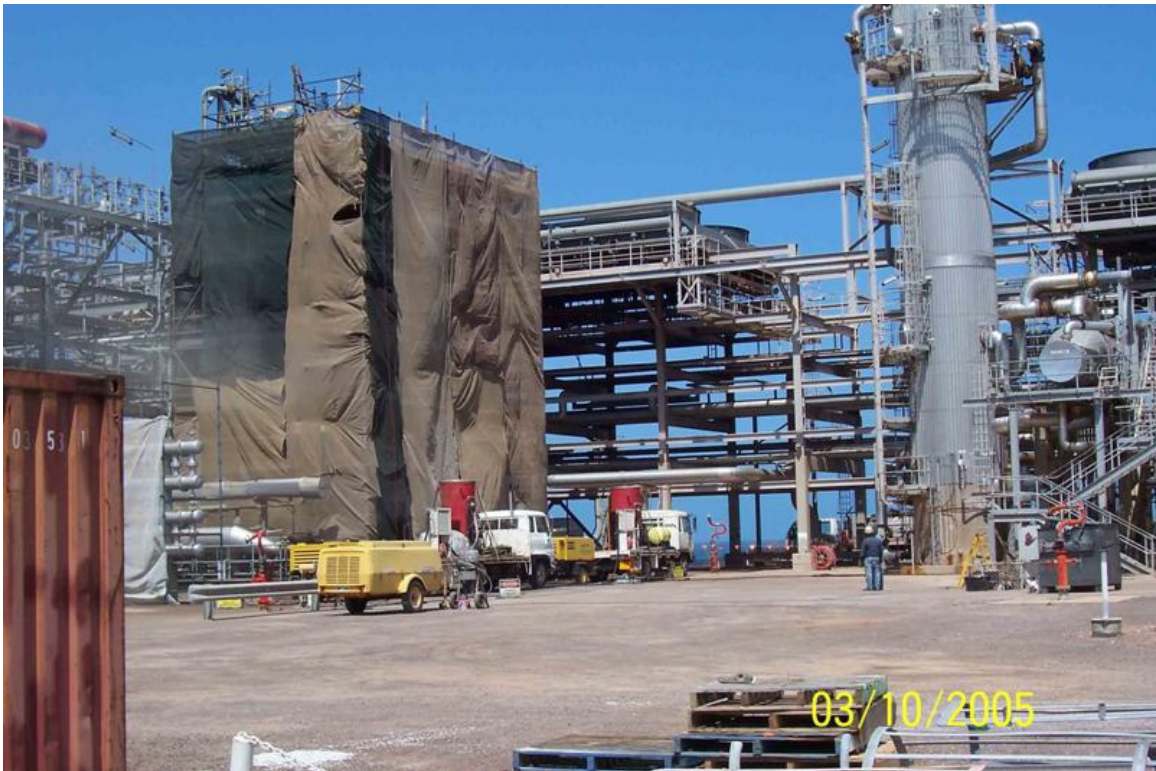
FIGURE 17 – Propane Treater Vessel.

Two insulated mild steel propane treater vessels shown in Figure 17, are located at Port Bonython, Australia, and had previously been coated with an inorganic zinc silicate product. The surface area of the vessels totalled approximately 200 m². The vessels operate under a

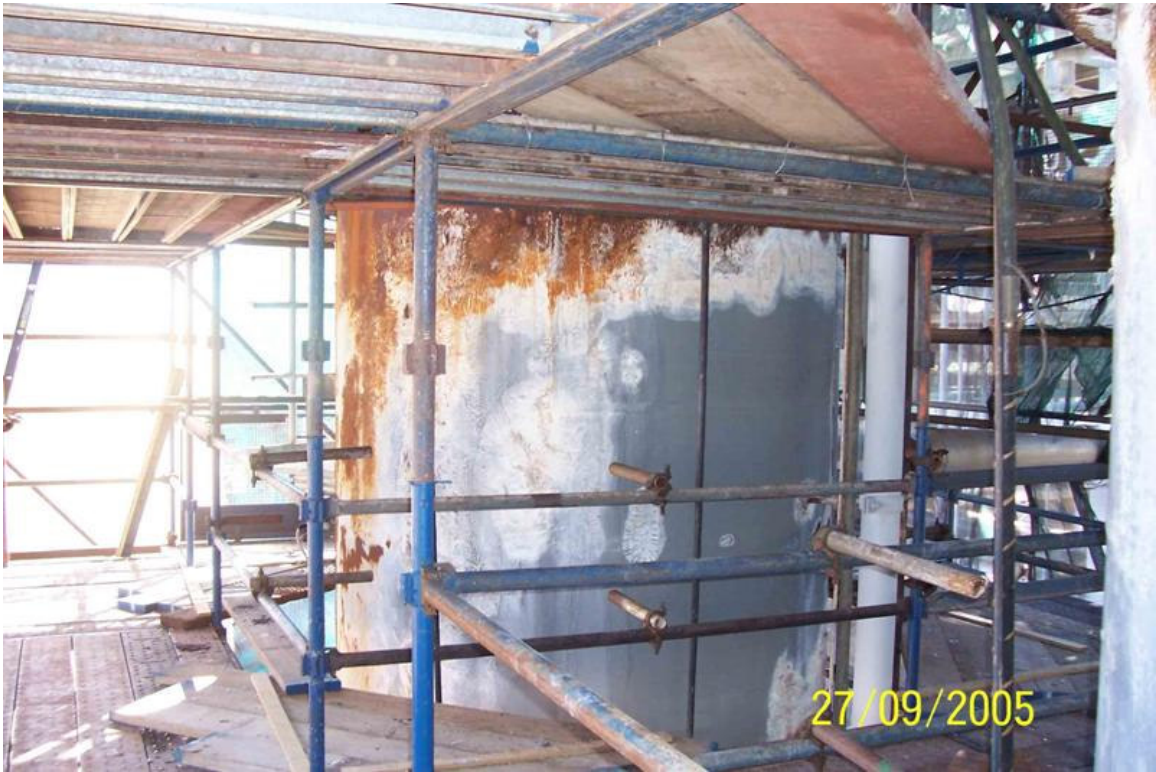
FIGURE 18 – Propane Treater Vessel – Failure of IOZ and subsequent CUI.

cycling temperature profile consisting of a rise from 40 °C to 260 °C instantly, remain at 260 °C for 3 hours, slowly decrease over 3 hrs to 80 °C, then rise from 80 °C to 260 °C instantly, remain at 260 °C for 21hrs, and then slowly decrease to 40 °C for 140 hrs. Both vessels experienced widespread failure of the zinc silicate coating and aggressive CUI. This is shown in Figure 18.

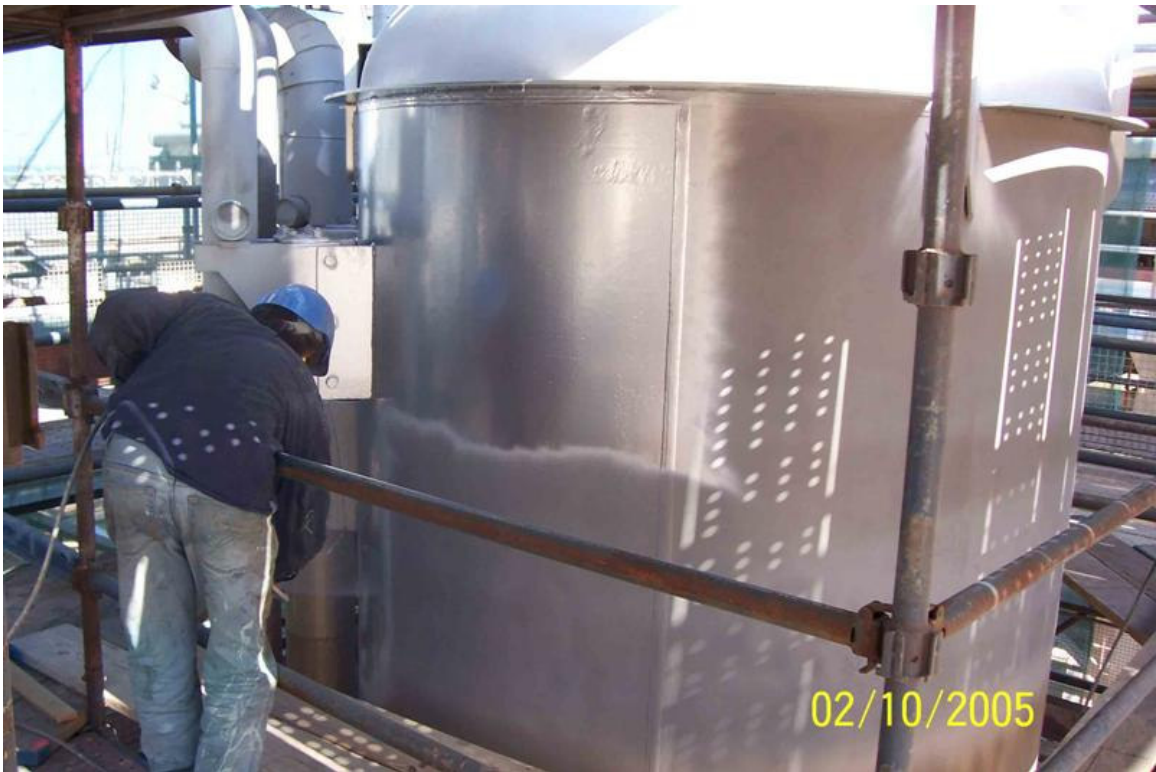
FIGURE 19 – Propane Treater Vessel – TMIC being applied.

In 2005 the vessels were exposed, abrasive blasted to SSPC-SP6 with a profile of 1.5 mils (35microns) and coated with a single coat of TMIC at a DFT of 6-8 mils (150-200 microns) using airless spray equipment (Figure 19). The vessels were re-insulated and put back into operation.

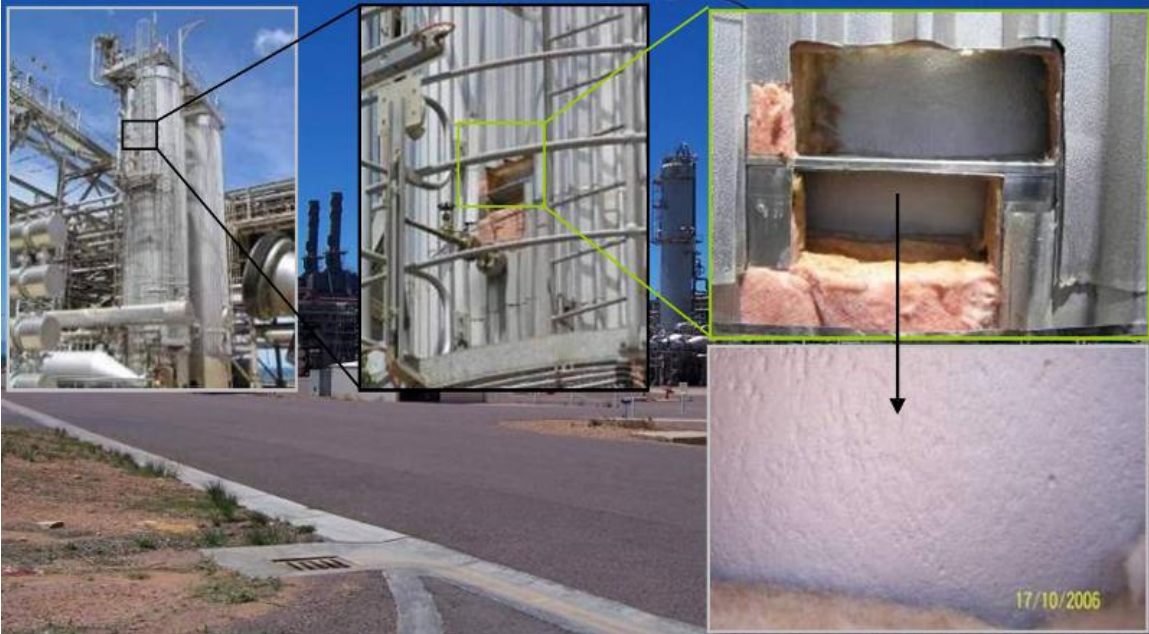
FIGURE 20 – Propane Treater Vessel –inspection of TMIC condition after 1 year service.

One and two years after application of the TMIC, an area that had previously experienced severe CUI was exposed and the condition evaluated. Figure 20 shows the TMIC intact and exhibiting no signs of deterioration or CUI activity.

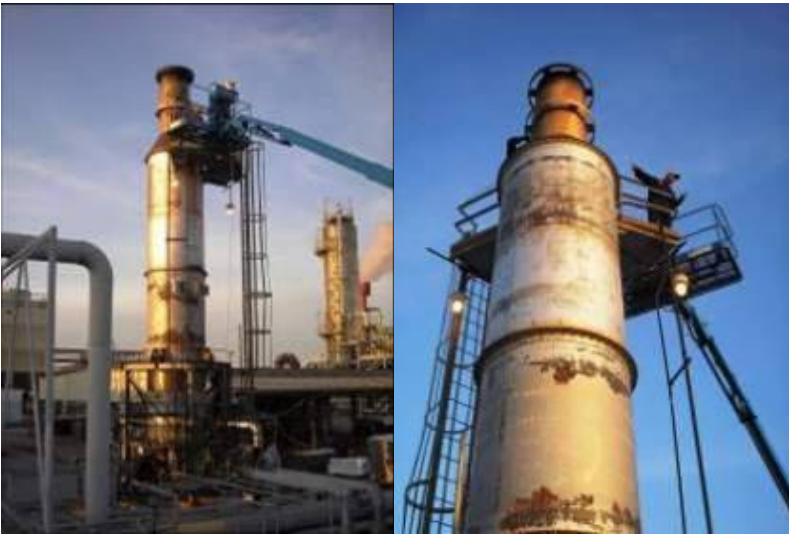
FIGURE 21 – Incinerator after CUI failure

In 2007, a newly constructed incinerator tower failed after only 7 months in service due to severe CUI. The unscheduled shutdown resulted in a loss of profit of \$100,000 USD per day until the incinerator could be repaired and adequately protected.

The condition of the incinerator before and after the application of TMIC is presented in Figures 21 and 22.

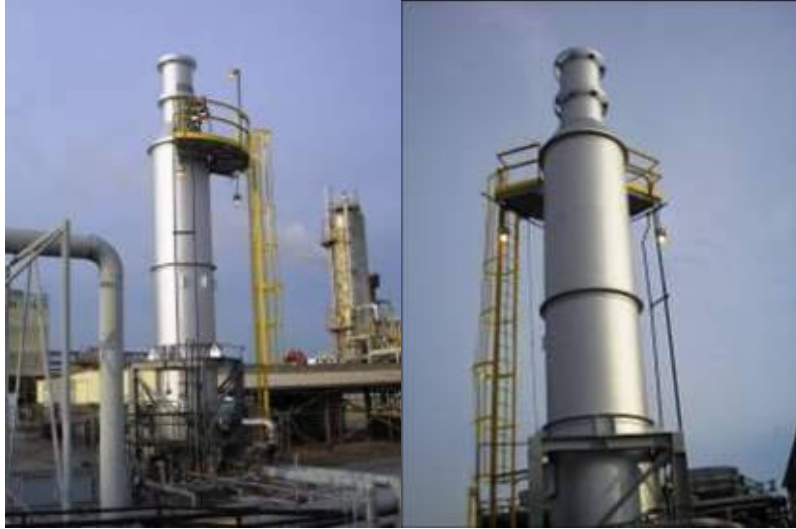
FIGURE 22 – Incinerator after remediation and TMIC application.

The remediation included abrasive blasting the tower to an SSPC-SP5 white metal blast and applying TMIC by brush and roller in 4 coats to a total system DFT of 8 mils. To date the incinerator has operated without any problems, indicating the CUI has been effectively arrested.

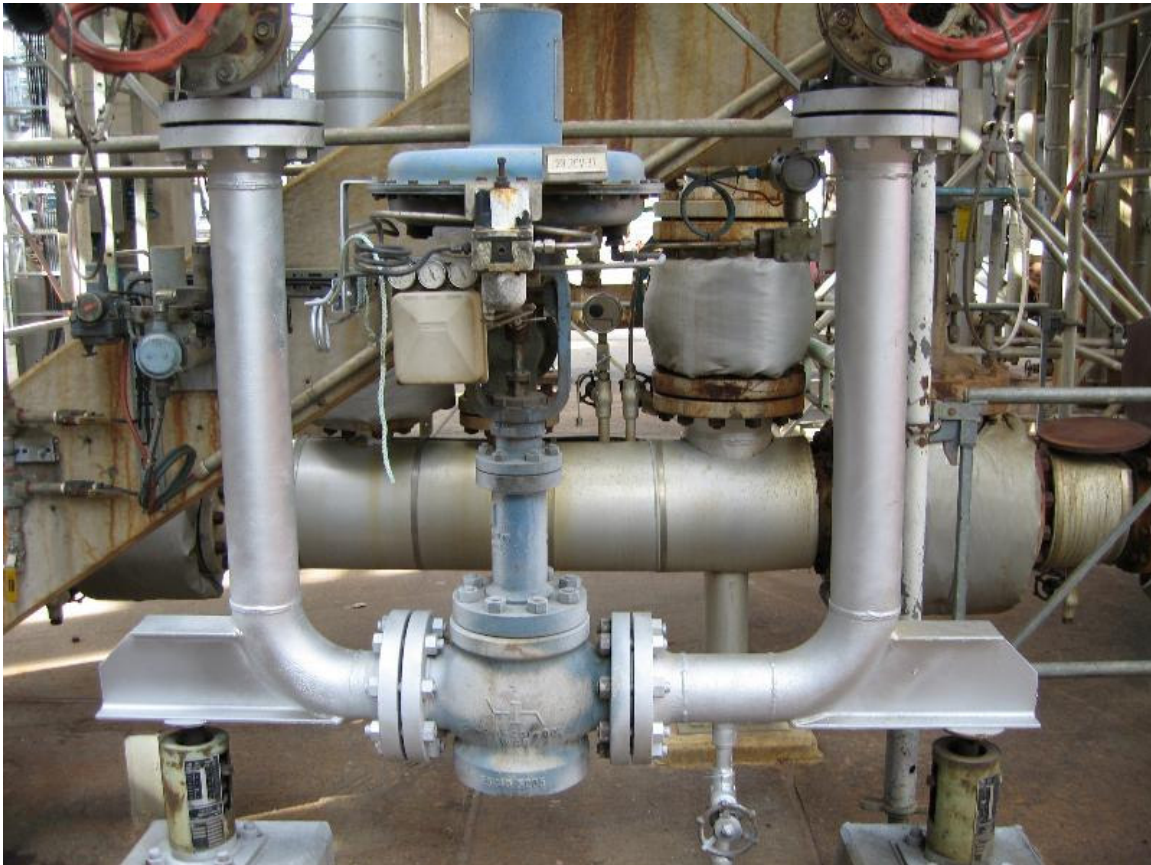
FIGURE 23 – Sweden refinery piping coated with TMIC.

In 2006, a gas refinery in Sweden specified TMIC for new insulated piping within the plant that would later operate up to 350 °C (660 °F). Figure 23 shows pipe sections after coating and installation.

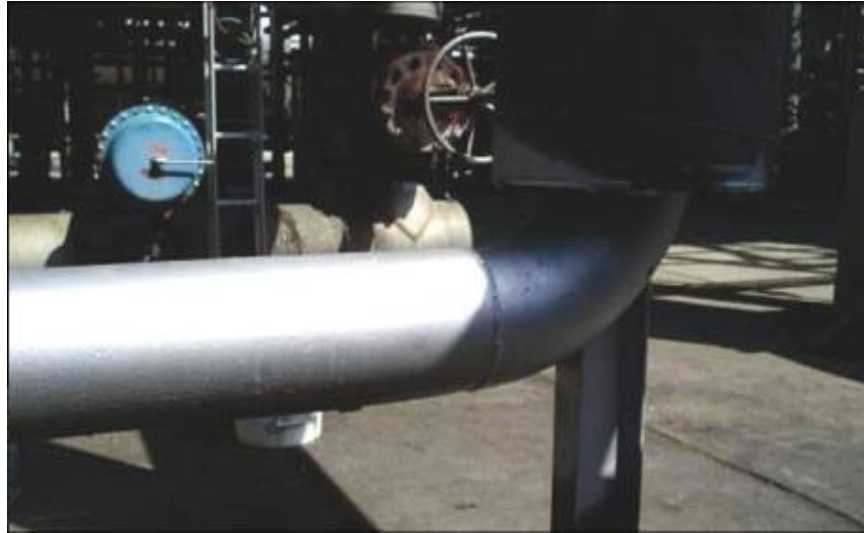
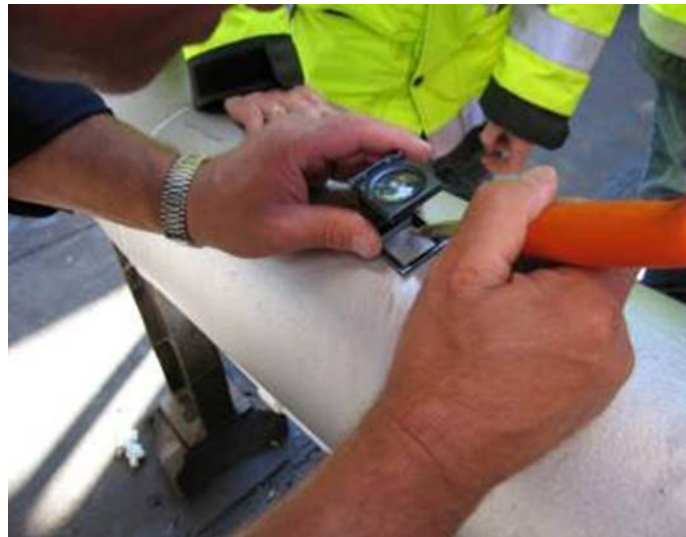
FIGURE 24 – Sweden Refinery Piping – condition of TMIC after 2.5 years service.

FIGURE 25 – Sweden Refinery Piping – condition of TMIC after 2.5 years service.

After one year in service the piping was inspected and the insulation was found to be wet. After 2.5 years in service the piping was re-inspected and no indications of coating deterioration or CUI were found. Figures 24 and 25 show the condition of the piping during the inspection.

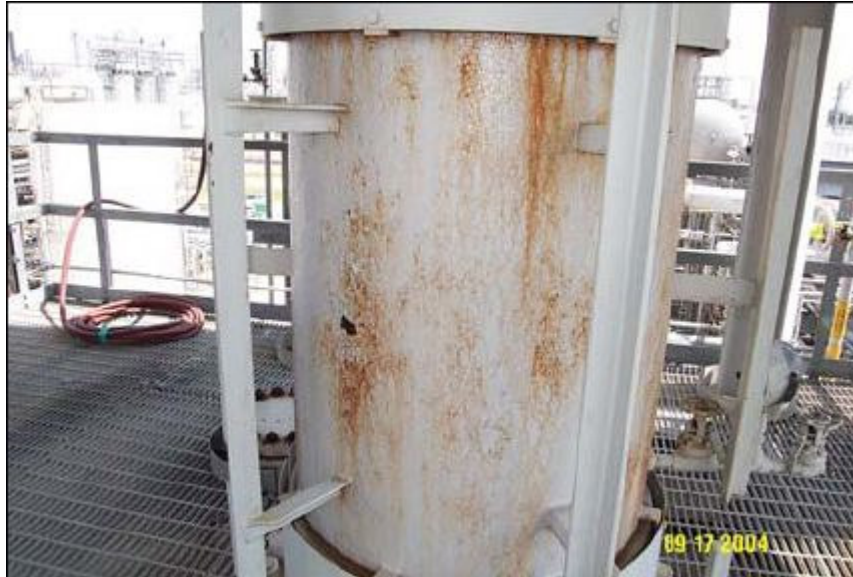
FIGURE 26 – Texas refinery gas dryer unit showing breakdown of traditional high heat coating after 12 months in service.

Gas dryer units in a Texas refinery with a history of rapid deterioration of under insulation coatings were selected for the first industrial field trial of TMIC technology. The dryer units cycle between -12°C (10°F) and 200°C (400°F) over a 4-5day cycle. Previously several different polymeric coating technologies had been used to protect the dryers, and in all cases the coatings had failed within a period of 6-12 months in service. Figure 26 and 27 show the condition of the dryer after the last coating failure. Due to the lack of success with other coatings, and the inability to apply TSA to the on-site structures, the refinery decided to try TMIC in hopes that this would solve the CUI problem.

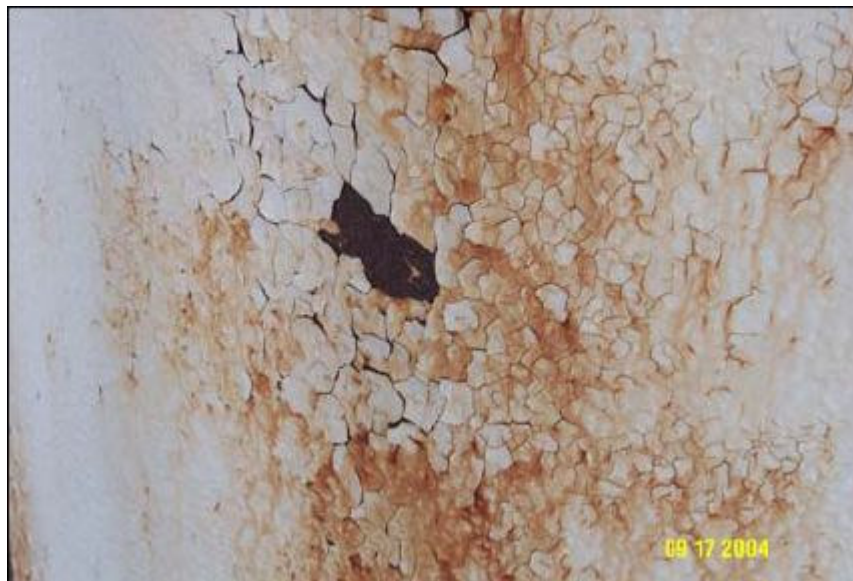
FIGURE 27 – Close view of Figure 26 showing severe coating degradation.

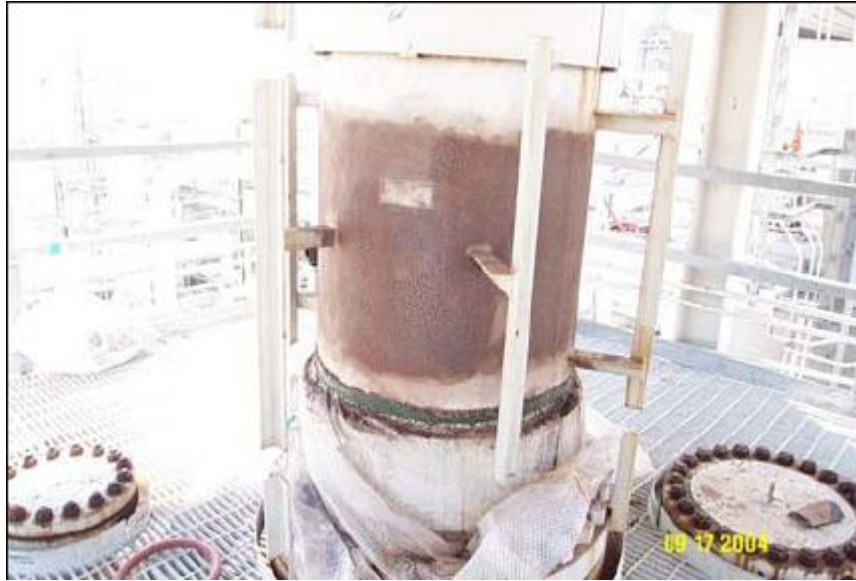
FIGURE 28 – Surface preparation of gas dryer unit prior to application of TMIC.

In 2004 the TMIC coating was applied to the dryers. Due to site safety and operational limitations, abrasive blasting was not possible, so the surface preparation prior to the TMIC coating application consisted of SSPC-SP2 and SP3, hand and power tool cleaning. Figure 28 shows the surface preparation prior to the application of the TMIC. The TMIC was applied in two coats for a total DFT of 8-10 mils (200-250 microns).

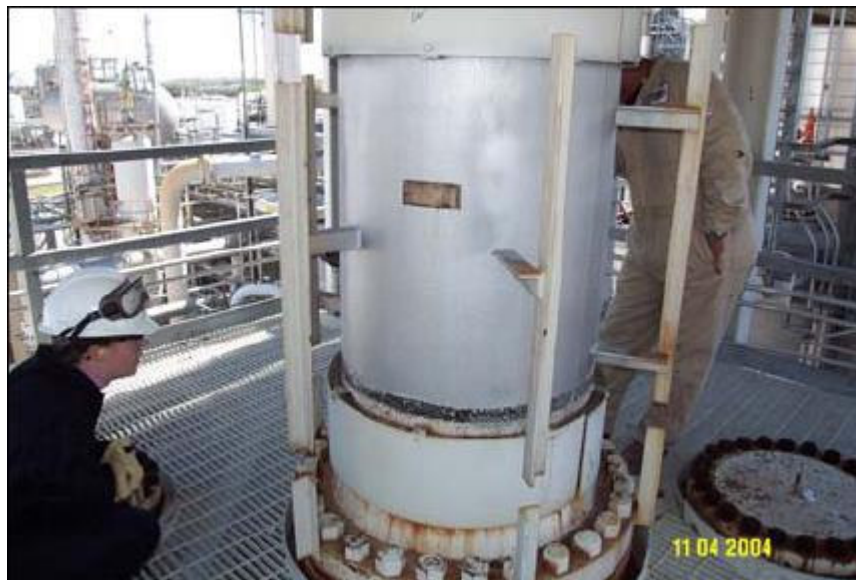
FIGURE 29 – Inspection of TMIC after 1 year in service showing no coating breakdown or rusting.

One year later, the dryer units were inspected showing no rusting or coating degradation present, as shown in Figure 29. At present, the dryers have operated for 5.5 years without any indications of CUI.
