OVERVIEW OF HVAC TRANSMISSION LINE INTERFERENCE ISSUES ON BURIED PIPELINES

Philip D. Simon, PE
Principal Engineer – Corrosion Consulting Services
DNV (Det Norske Veritas) Columbus, Inc.
4904 Spinnaker Drive
Freeland, WA 98249

ABSTRACT

The paper is an overview of the various interference problems that may affect pipelines in common right of ways or near high voltage AC power (HVAC) transmission lines. Safety, AC assisted corrosion damage and mitigation options will be discussed as well as data from several case histories.

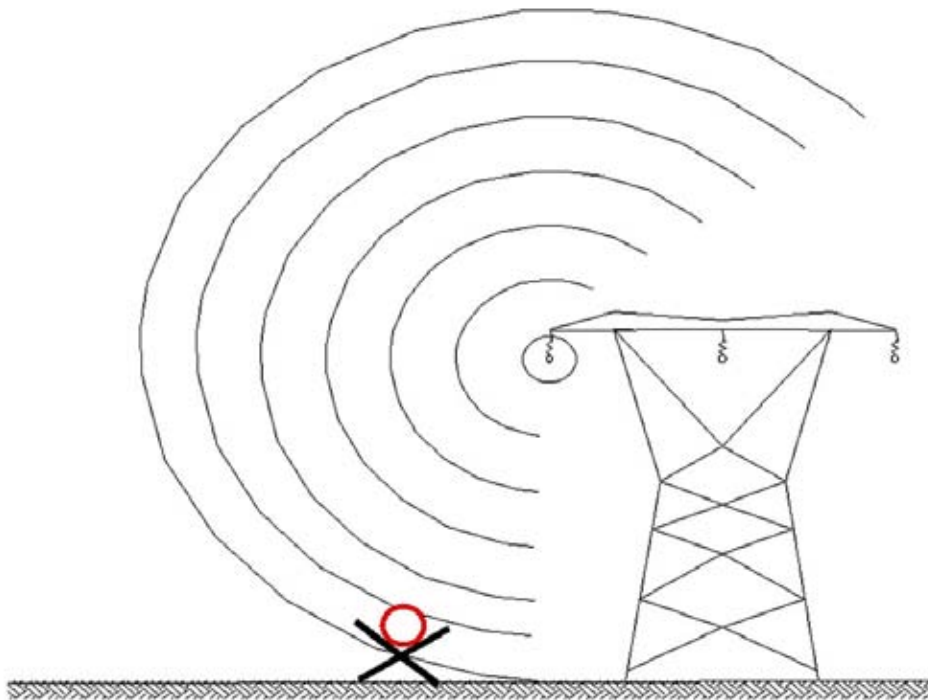
FIGURE 2: Capacitive Coupling of Pipeline Section on Skids

Besides the obvious lethal hazard of equipment contact with an energized overhead HVAC conductor, high AC potentials can be generated on sections of pipe strung on skids in preparation for lowering into the ditch. When the pipe sections are on skids it is suspended in the electromagnetic field of the HVAC line with no contact to the ground. Even relatively short pipeline sections will have an AC potential due to the capacitive effect of the high dielectric strength of the coating in air. Figure 2 is a sketch of this capacitive coupling.

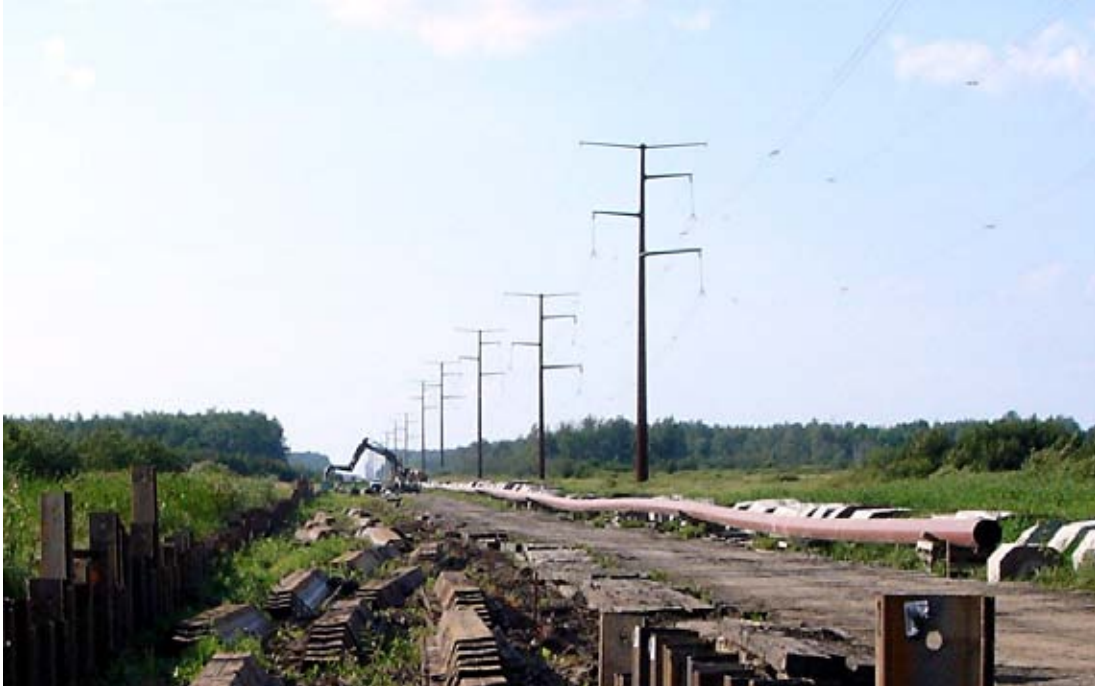
FIGURE 3: Example of HVAC Hazard during Pipeline Construction in HVAC ROW

Figure 3 is a pipeline under construction in a common ROW with a single 345 kV HVAC line. The 20-inch (50.8 cm) diameter FBE coated pipe section on the skids is approximately 2,000 feet (600 meters) long and laying on wooden skids over a wetland (bog). In this example 178 VAC to ground was measured at this end of the section (Figure 4) and 177 VAC at the other end. In this example standard safety and mitigation procedures were not being followed.

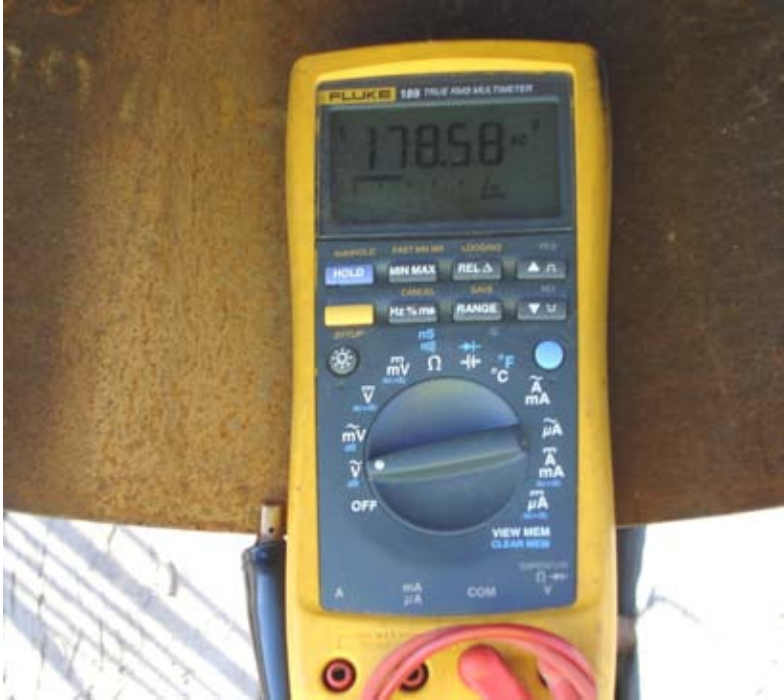
FIGURE 4: Pipe-to-Soil AC Potential at End of Pipe in Figure 3

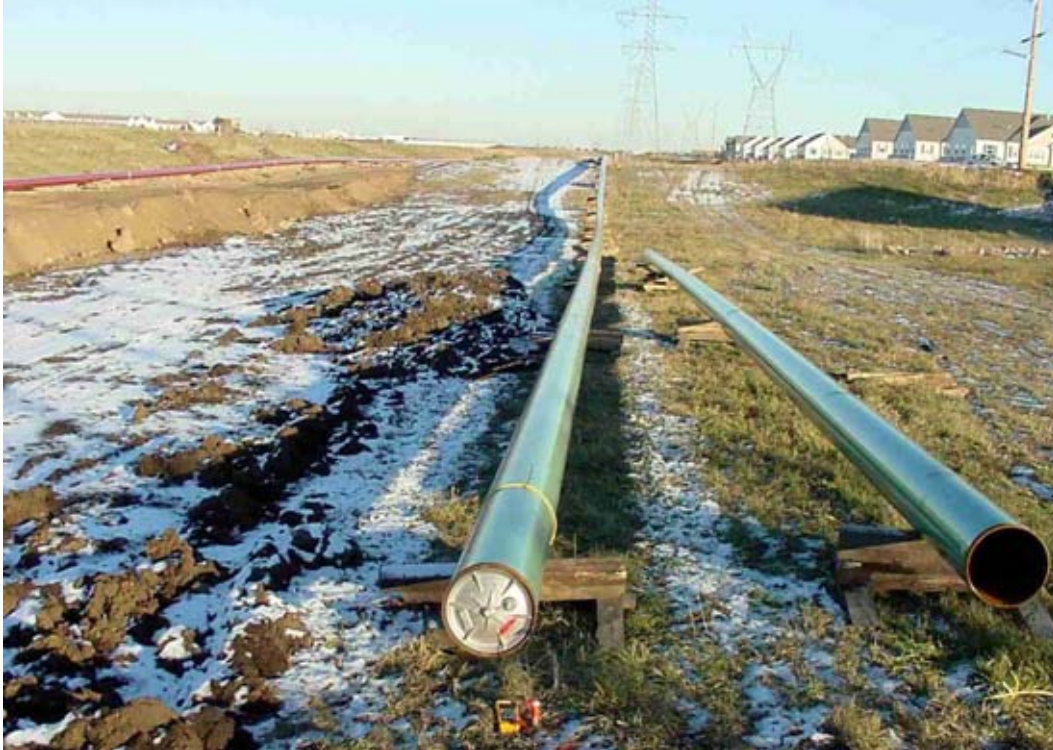
FIGURE 5: Various Length Pipe Sections on Skids in HVAC ROW

A second example includes several shorter section of pipe in a HVAC ROW with three circuits. Figure 5 is a photograph of the ROW showing three sections of the 16-inch (40.6 cm) FBE coated pipe on skids. The longer section (left green coating) is approximately 1,500 feet (460 meters) long and the short section 80 feet (24 meters) long. Here the observed pipe-to-soil (P/S) potential was 243 VAC at the long section and 7.2 VAC at the short section.

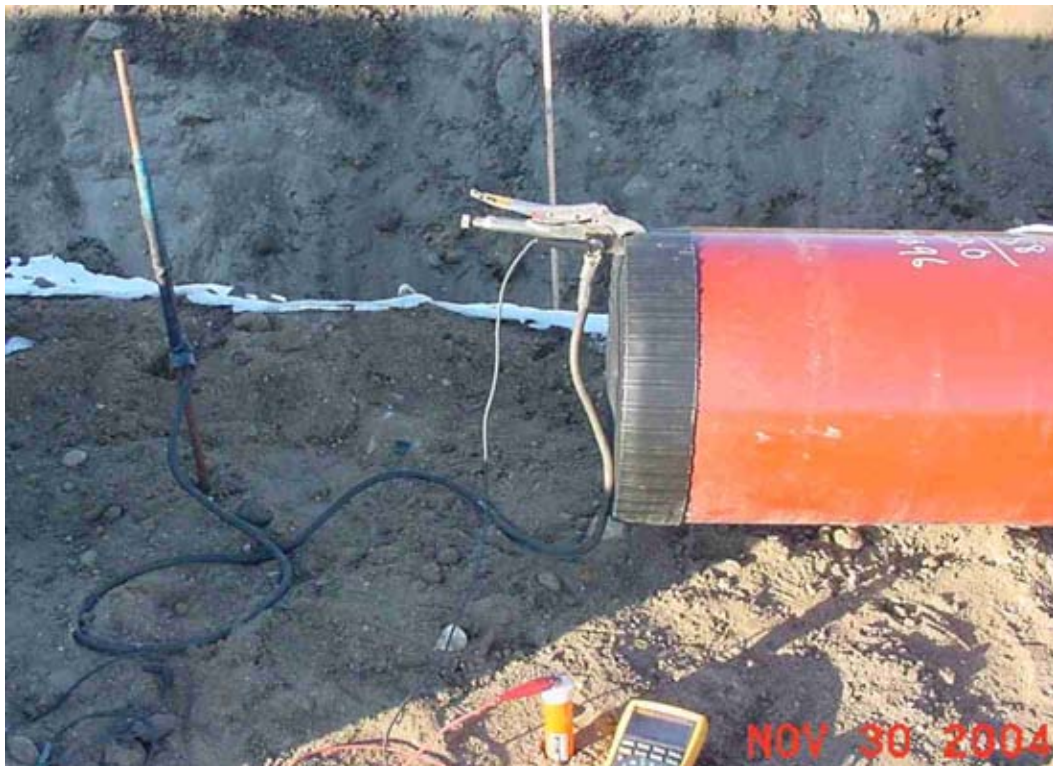
FIGURE 6: Capacitive Coupled AC Temporary Grounding Mitigation

Neither of these two pipeline sections had any mitigation at the time of the site visit. Both the CSA and NACE standard include very definitive safety procedure for induced AC safety during pipeline construction in HVAC shared ROW. These procedures include daily P/S potential measurements, record keeping and temporary grounding mitigation to maintain the induced potential below 15 VAC. The pipeline section to the far left (red FBE coating) did have mitigative grounding in place even though it was the furthest away. Figure 6 is a photograph of the mitigative grounding for this approximately 1,500-foot (460 meter) long section. Although the clamping method to the pipe is crude, the mitigation was effective. With the ground rod connected the induced AC P/S potential was 0.69 volts and with it removed it was 65.2 VAC. The drain current to the ground rod (measured with the added resistance of the meter and leads) was below 1 mA. This is well below the safety threshold, however this pipeline section was over 200 feet (60 meters) from the HVAC towers.

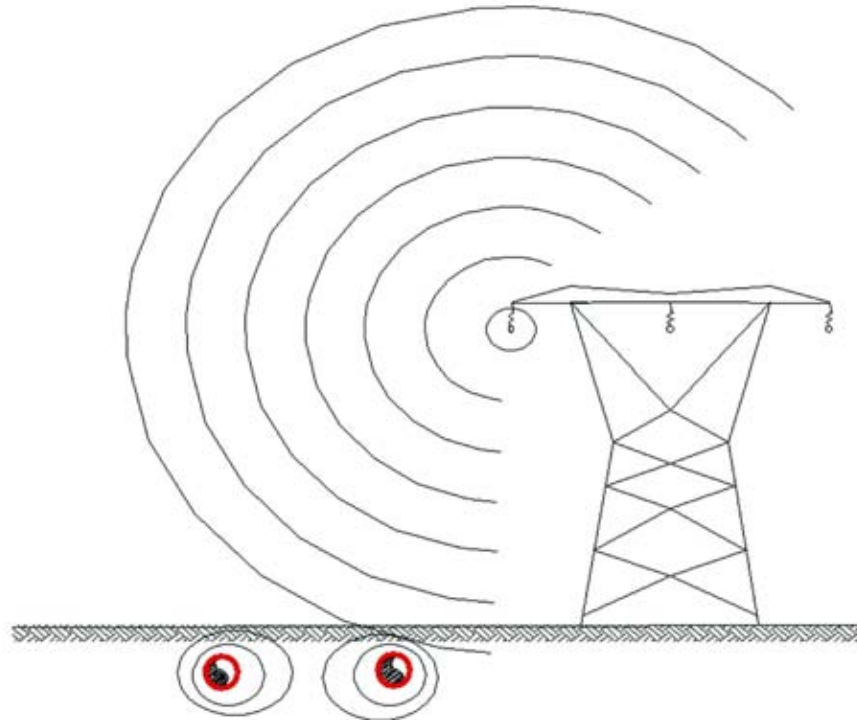
FIGURE 7: Inductive Coupling of Collocated Buried Pipelines

The level of induced AC from an HVAC power transmission line on an adjacent pipeline is a function of geometry, soil resistivity, coating resistance, and the transmission line operating parameters. The geometry characteristics include separation, depth of cover (DOC), pipe diameter, the angle between pipeline and transmission line, tower footing design and phase conductor spacing and distance above the ground at the towers. These remain constant over the life of the installation. The coating resistance, power system ground resistance and soil resistivity may change slightly with the seasonal variations and as the installation ages but remain reasonably constant. The AC voltage induced on the collocated pipeline is generated by the electromagnetic field in the soil. This field is much weaker than the field in the air above but it still exists and over long collocations can generate significant AC P/S potentials. Because the pipeline is grounded (has a finite resistance to ground even with a good coating) and has a longitudinal conductivity it becomes part of the transmission circuit. This is much like a transformer in a normal electrical circuit. In the steady-state (normal) HVAC line operation there is no significant AC ground current even near the tower footings or counterpoise. Figure 7 is a sketch showing this inductive coupling on a collocated buried pipeline.

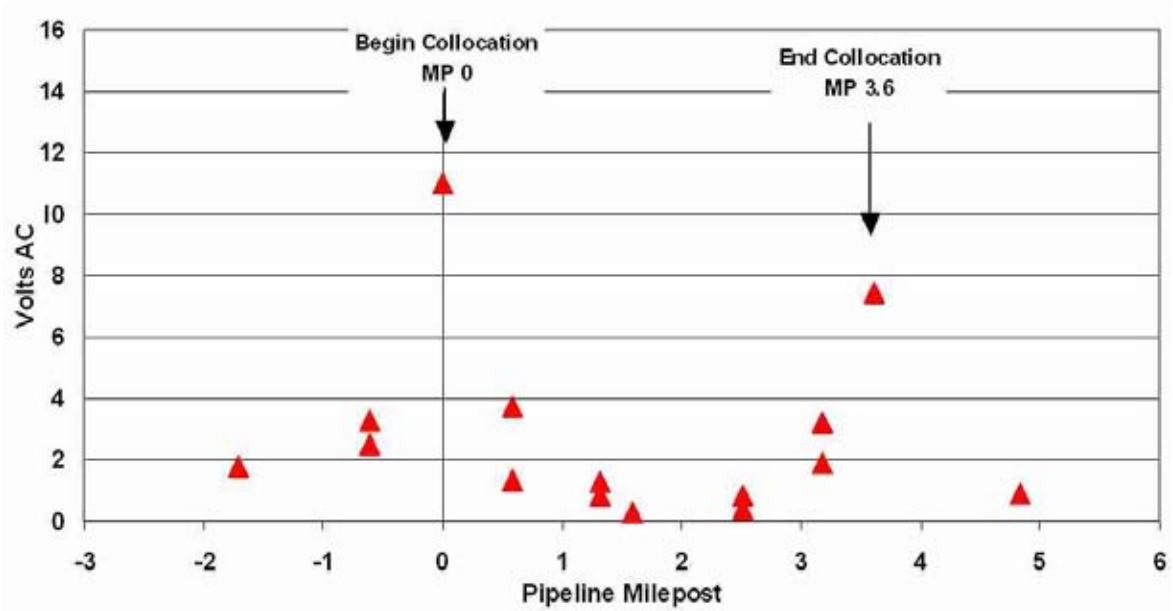
FIGURE 8: Observed Induced AC Potentials on a Short 3.6-mile Pipeline / HVAC Collocation

Experience and predictive modeling of induced AC on collocated buried pipelines show that the highest AC P/S potentials are found at the beginning and end of a simple common ROW. However, typical configurations have changes in geometry, soil resistivity, coating resistance along the ROW that affects the induced AC potential profile. Grounding features such as terminal/pump station grounding isolation and CP system anode beds also affect the potential profile. These all lead to induced AC potential profiles that are often very complicated. With high dielectric coatings in good condition and high resistivity soils elevated AC potentials can be found miles downstream or upstream of the HVAC collocation. Figure 8 is a plot of observed induced AC potential versus pipeline milepost for a relatively simple and short configuration. Figure 9 is a plot for a more complicated example.

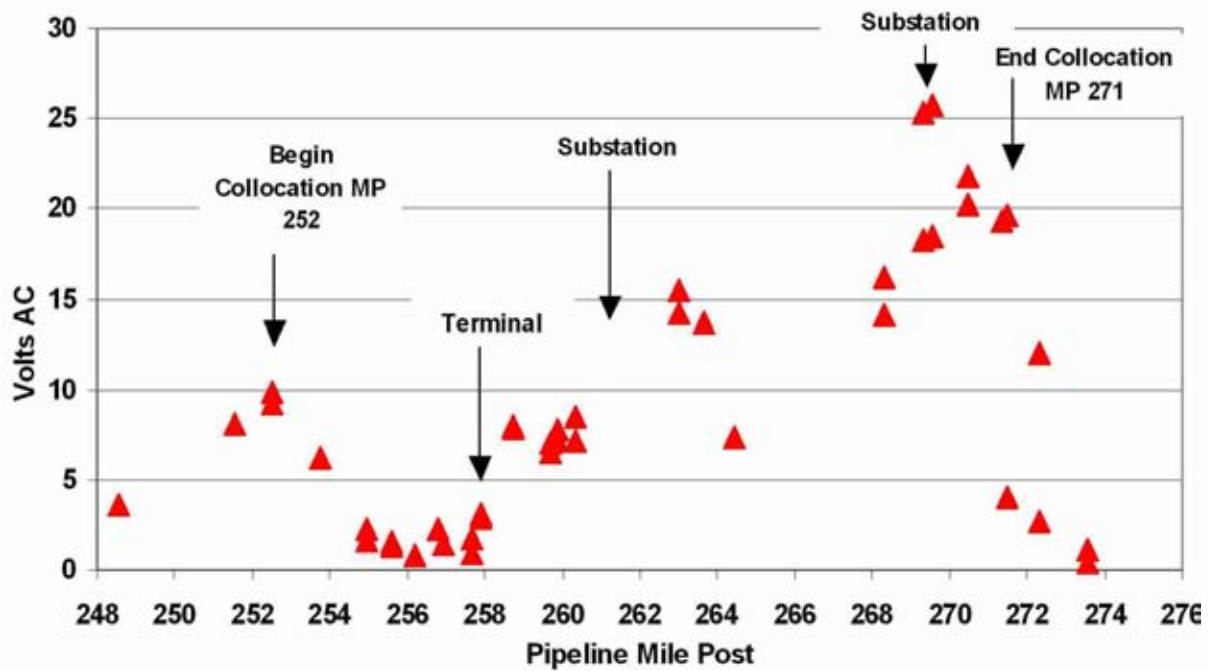
FIGURE 9: Observed Induced AC Potentials on a 19-mile Complicated Pipeline / HVAC Collocation

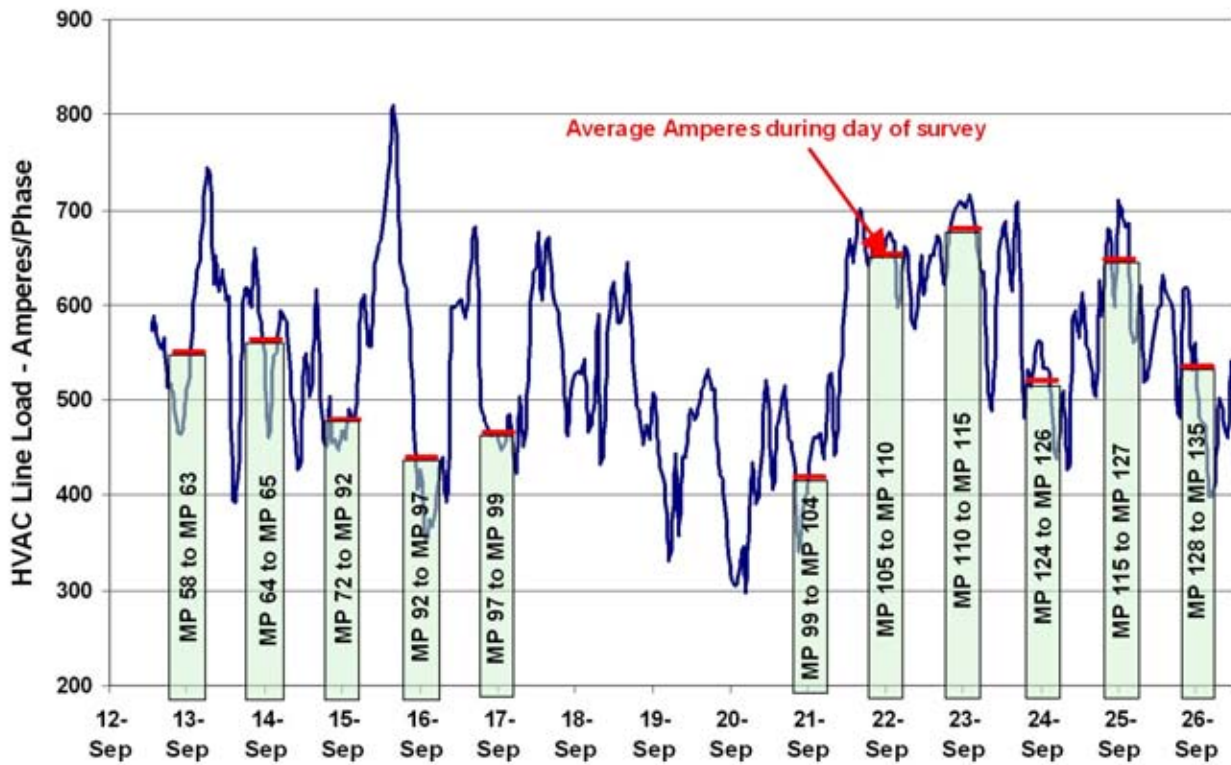
FIGURE 10: Example of HVAC Line Loads versus Time and Typical Potentials Survey Data Collection

potential all along the pipeline is constantly changing. A common way pipeline operators monitor the level of induced AC on their collocated sections of pipe is to include AC P/S potential measurements during annual cathodic protection (CP) potential surveys. Typically the CP technician will complete a continuous section of the pipeline in one day and move to another section the next day. These sections may not be continuous from day to day depending on the base location of the technician. Because the HVAC line load is changing the AC potential readings may not represent the true induced potential profile. In addition the readings are typically taken during the day and the HVAC line load is normally very different at night. Figure 10 is a plot of the 345 kV HVAC line load of versus time with the time period and MP location of a sample recorded AC potential data set on an adjacent pipeline. In this example the day of the measurement was recorded but not the time of day. It was also assumed that the readings were taken during typical working hours of 8:00 AM to 5:00 PM. The HVAC line operator supplied the recorded hourly average load (Amperes/phase) over the time period of the pipeline survey. The red bars in the figure indicate the average load during the time it was assumed the technician took the readings. Not only is there a large variation in the load from day to day but also there is a large variation during the testing each day. Note during the first half of the testing the load averaged much higher at night than when the potentials were recorded. However during the last half of the testing the nighttime loads were about the same or a little less than during the testing.

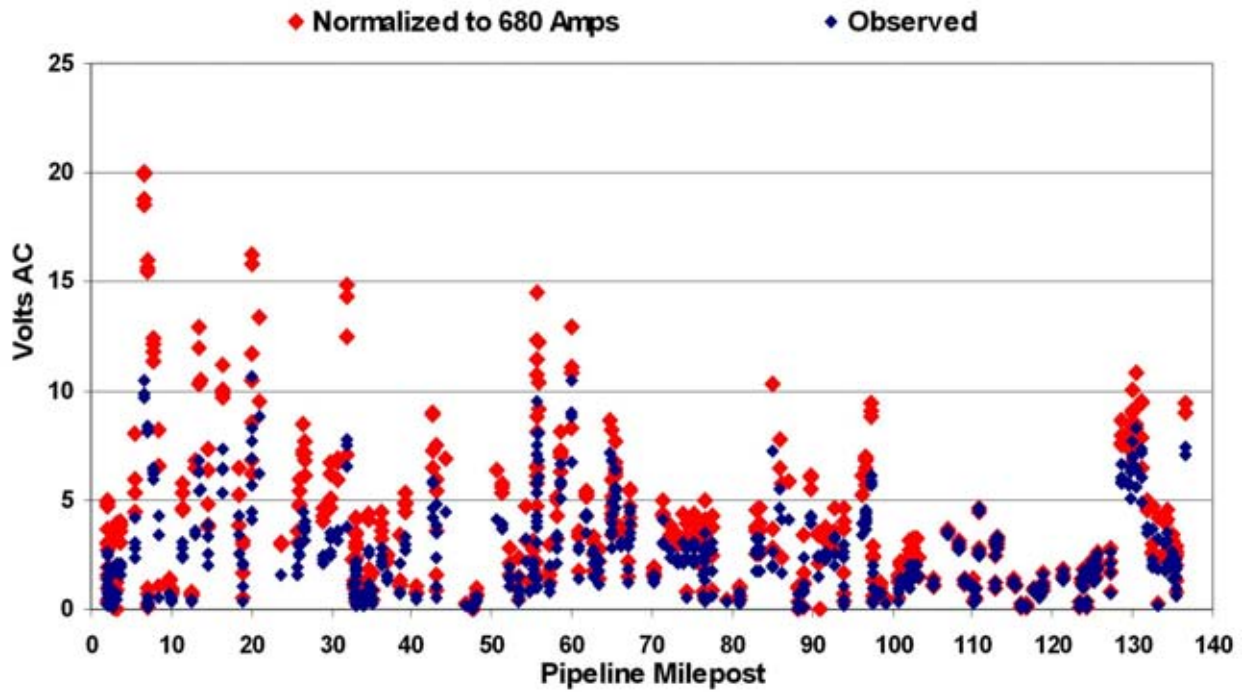
FIGURE 11: Observed and Normalized (to Maximum Day Average Load) Induced AC Potentials versus Pipeline Milepost

It would be unrealistic to time stamp each AC P/S potential and correlate it to the HVAC line load at that moment. HVAC line operators are reluctant to release load data and CP technicians already have plenty to do. However the dynamic nature of induced AC potentials should be considered when evaluating field data. Figure 11 is a plot of the observed induced potentials and the potentials normalized to the 680-ampere load level. With all other factors remaining constant the induced potential will be a linear function of the HVAC line load. In this case the maximum average testing day load was 680 amperes (Sept. 23). The observed potentials from each test day were normalized to this level by the ratio of the average that day. Although both data sets show a similar profile, the normalized potentials are generally higher. All of the observed induced AC potentials are below the 15 VAC safety threshold while several of the normalized potentials are above 15 VAC. The point is that although the recorded AC potentials on your pipeline may indicate the locations of the highest induced AC interference there are times when it is likely they are higher than any of the observed readings.

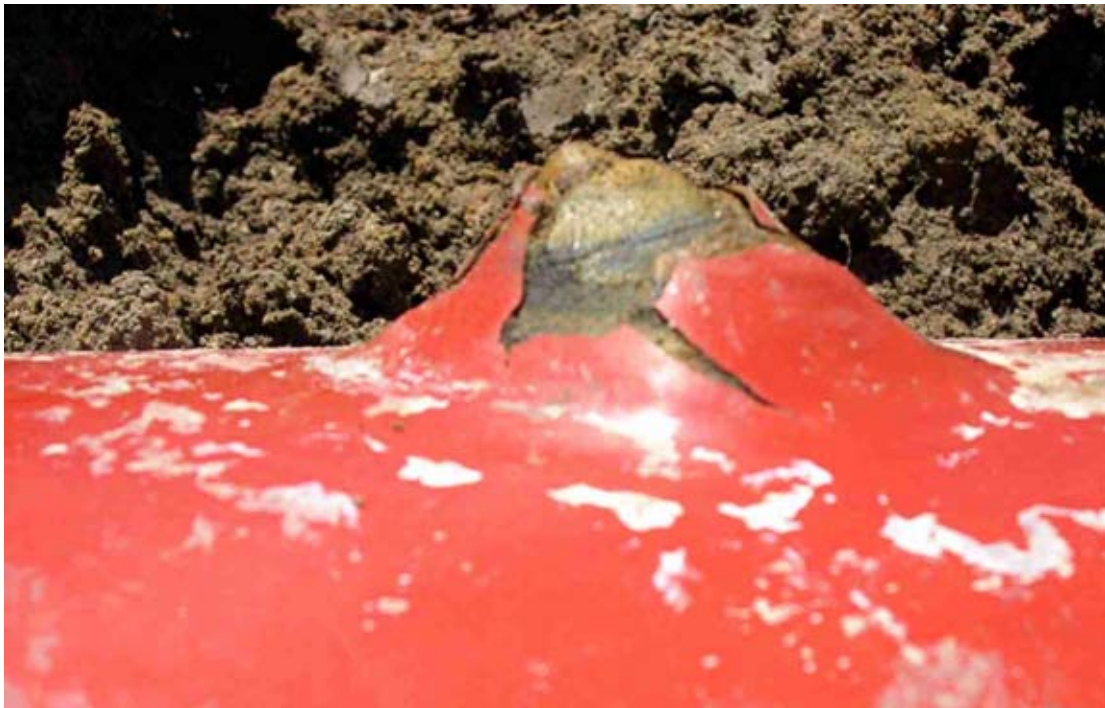
FIGURE 12: Typical AC Assisted Corrosion Product Formation

AC assisted corrosion damage has a distinct morphology. The corrosion product typically remains next to the pipe surface forming a hard dome shape and forces the coating up off the pipeline. The underlying pit has a geometric shape often with a brown fringe. Figure 12 is a photograph of typical AC assisted corrosion damage showing the corrosion product. Figure 13 is a photograph after the coating and corrosion product were removed. In this case the measured induced P/S potential was 7.2 VAC and the soil resistivity 1,293 Ohm-cm at the dig site. The DC P/S potential was -1,590 mV to CSE (CP current applied) with a pH of 11 at the pipe surface indicating adequate protective DC polarization.

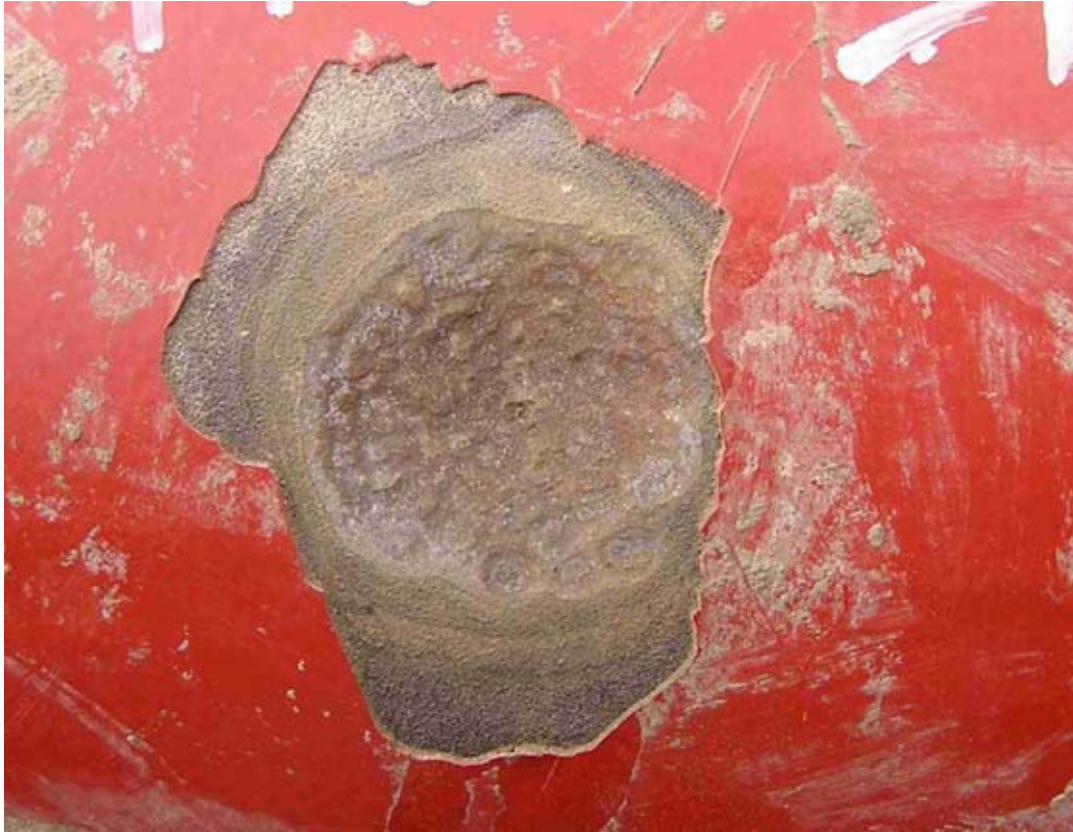
FIGURE 13: Figure 12 with Corrosion Product Removed

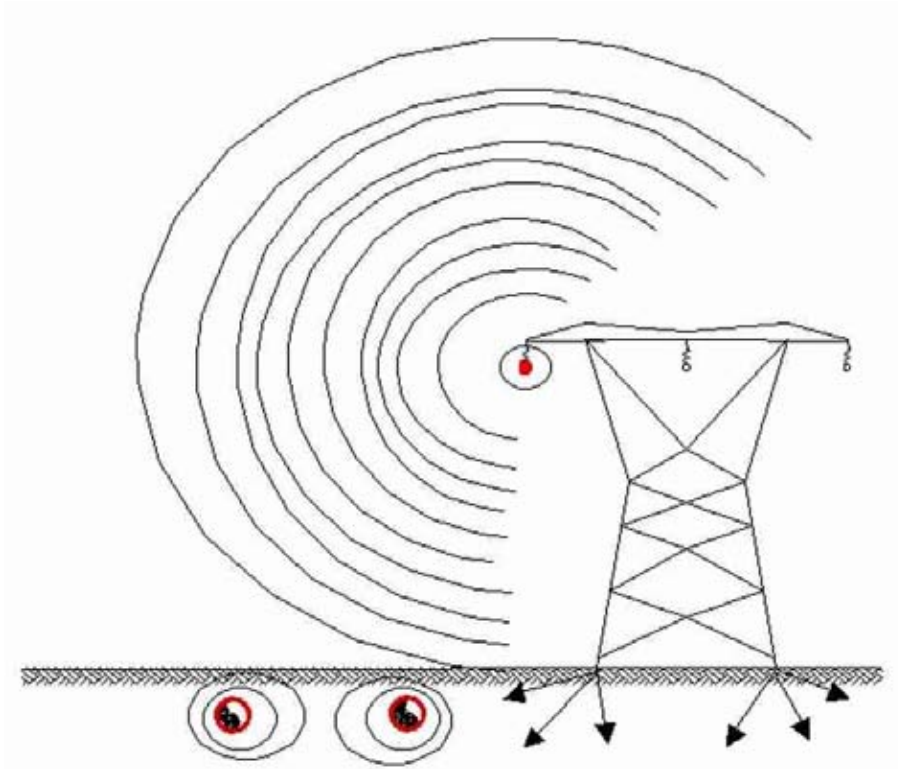
FIGURE 15: Example of Mitigation of Induced AC on Simple Pipeline Configuration

Mitigation of steady state induced AC potentials on collocated pipelines is covered in both the CSA and NACE standards. Generally mitigation involves the installation of grounding at strategic locations along the pipeline. This mitigation is normally most effective when installed at the beginning or end of the common ROW. However in complicated pipeline/HVAC line geometries grounding installations are required at locations along the entire collocation. These installations can be parallel wire (bare copper or zinc ribbon), individual vertical rods or anodes, horizontal ground beds or wells. All these installations should be connected to the pipeline through DC decouplers to prevent galvanic couples and impressed current CP shielding (parallel zinc ribbon has been found to shield ICCP). Care should also be taken not to install too much grounding mitigation as the more grounding installed the higher the conductive AC fault current. Figure 15 is a plot of induced AC potential versus pipeline MP for a simple collocation with and without mitigation at one end. In this case the mitigation at MP 0 included several vertical wells (total resistance of 0.31 Ohms) connected to the pipeline through a solid state DC decoupler.

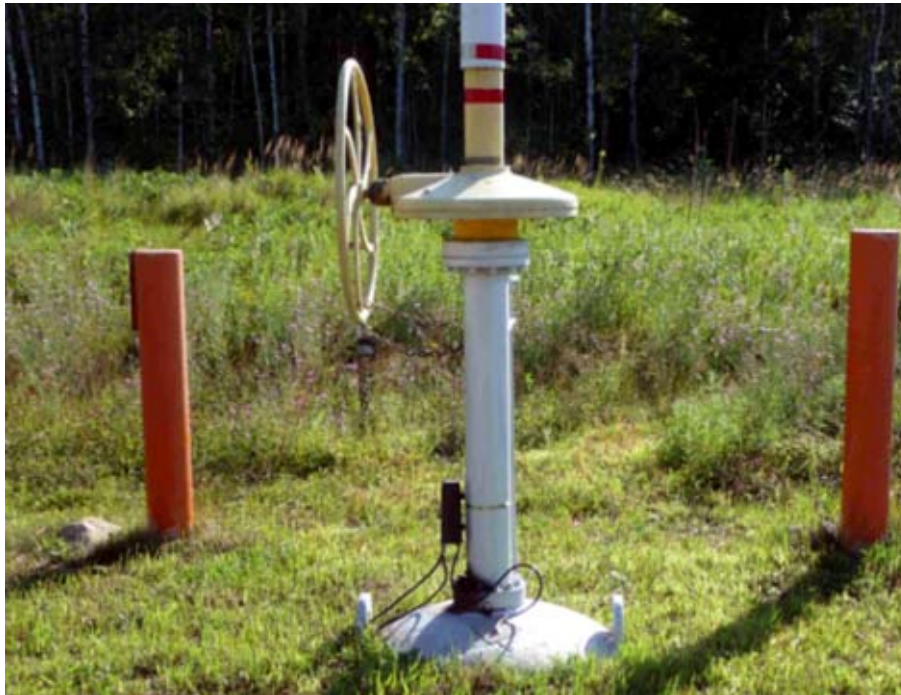
FIGURE 20: DC Decoupler at Mainline Valve Ground Mat

It is not practical to mitigate fault induced AC potentials to below 15 VAC or even safe short-term substation level touch voltages. The strategy for fault safety on pipelines is to minimize exposure to unsafe voltages with gradient control (grounding) mats and gravel pads at pipeline appurtenances such as valves where access may be required at any time. A steel, copper cable or zinc ribbon ground mat will raise the local ground potential around the appurtenance to near the potential of the pipeline to minimize the touch potential. The gravel pad will increase the foot contact resistance to limit the body circuit current. CP test stations should be of dead front design and metallic casing vents should be shielded to prevent accidental contact. Figure 19 from the CSA standard show the layout of a zinc ribbon gradient control mat. Figure 20 is a photograph of a mainline valve with a DC decoupler as recommended with a gradient control mat. Figure 21 shows a typical casing vent shield.

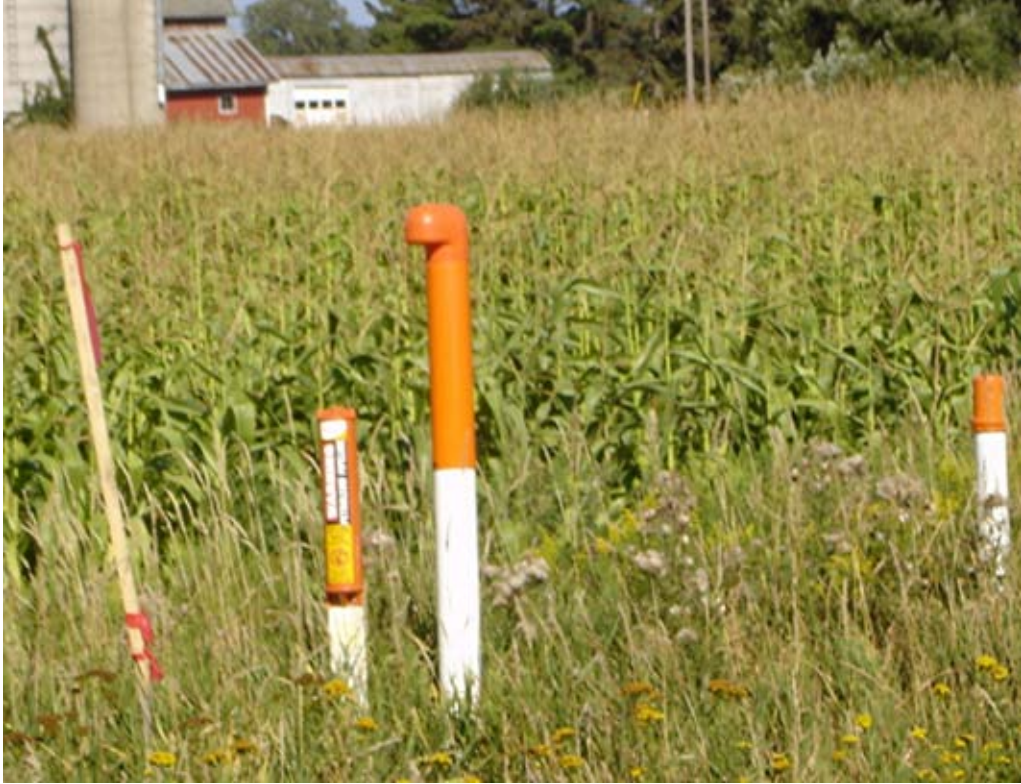
FIGURE 21: Casing Vent Shield
